Blueprint Building Inspections  
60 Symons Street  
Toronto, ON M8V 1T9

# Inspection Report

33 Jellicoe Avenue  
Toronto, ON

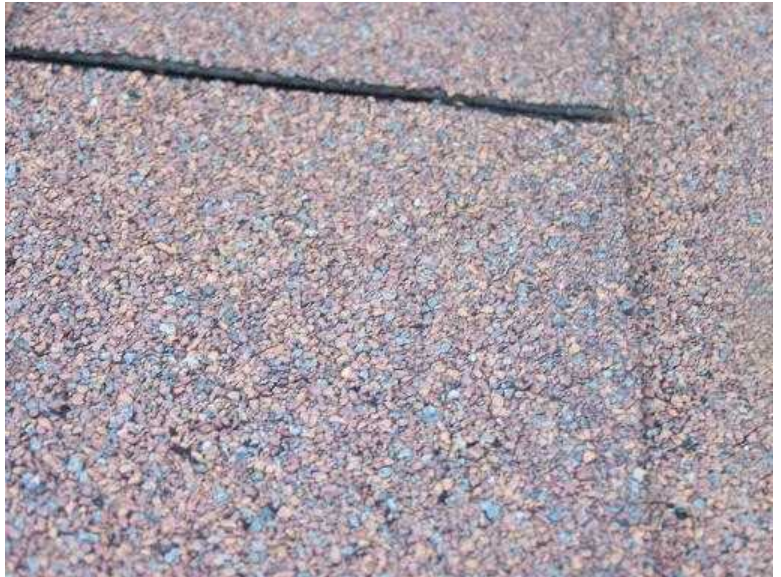
### Porch Roof Surface

2. Method of Inspection: Ladder at edge
3. Acceptable Material: Asphalt shingle:  
Shingles in good condition showing no wear

4. Approximate Age: Newer (0-5 years): Most roofs are designed to last 15 years. Note that the age estimate is based upon the appearance of the shingles. They may be older or younger, but the wear patterns indicate the age that was recorded by the inspector. Roofs in first few years of life show little wear so they are categorized together in terms of age estimate.

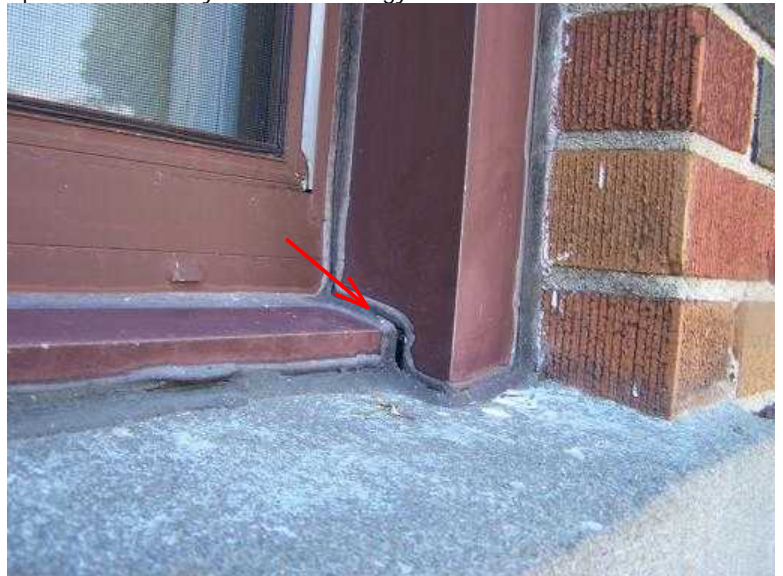
### Windows

4. Acceptable    Window Materials Metal
5. Acceptable    Window Operation Fixed, Sliders
6. Acceptable    Thermal Characteristics Thermal pane at top with single pane sliders at bottom: The top thermal pane portion of the windows is a good thermal barrier, but the single pane sliders are less so. Metal frame windows also conduct cold through their surface more so than new vinyl windows. Since these windows are so sturdy and low in maintenance, we never recommend replacement except as an optional upgrade, but obviously they do not perform thermally as well as EnergyStar rated windows.
7. Acceptable    Window Trim Metal clad wood:  
Maintenance required: recaulk where joints are opening

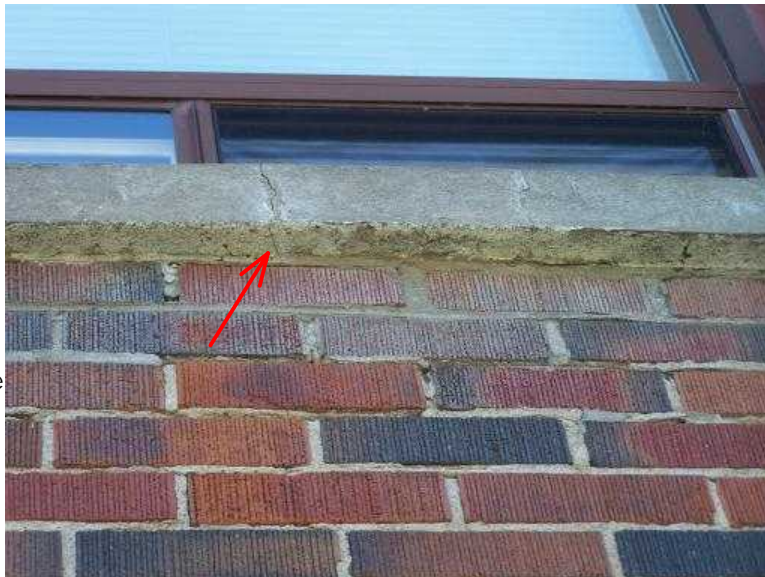
8. Acceptable **Window Sills Concrete:**  
Typical condition: Joints in sills frequently crack and allow moisture to penetrate - monitor regularly, Repair mortar & minor cracks by "tuck-pointing". Note that modern window sills have a drip edge to break surface tension of water, thus preventing it from running down the wall. It is possible to cut little grooves in the underside of the window sills to improve the situation here. The only negative aspect of the current configuration as this time is minor staining of the bricks under the window sill (which can be washed off). Given the age of the house, this is not a "need to do" in the short term.

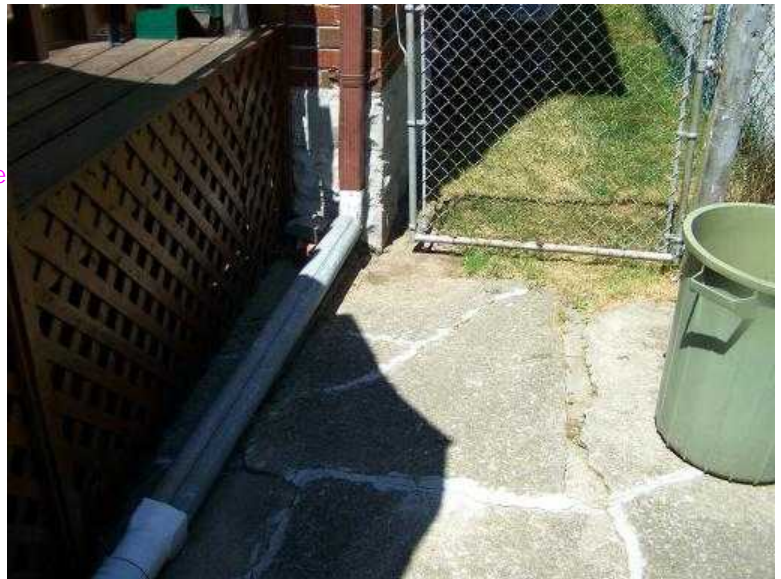
1. Restrictions: Under deck, Vegetation
2. Acceptable Driveway: Asphalt
3. Acceptable Steps: Wood: Suggest a handrail be mounted to the rear stairguard
4. Acceptable Porch: Wood
5. Marginal Patio: Concrete: Cracked and unevenly settled at SE corner. A solid surface might impact favourably on basement dampness, because it would prevent moisture saturation of the soil.

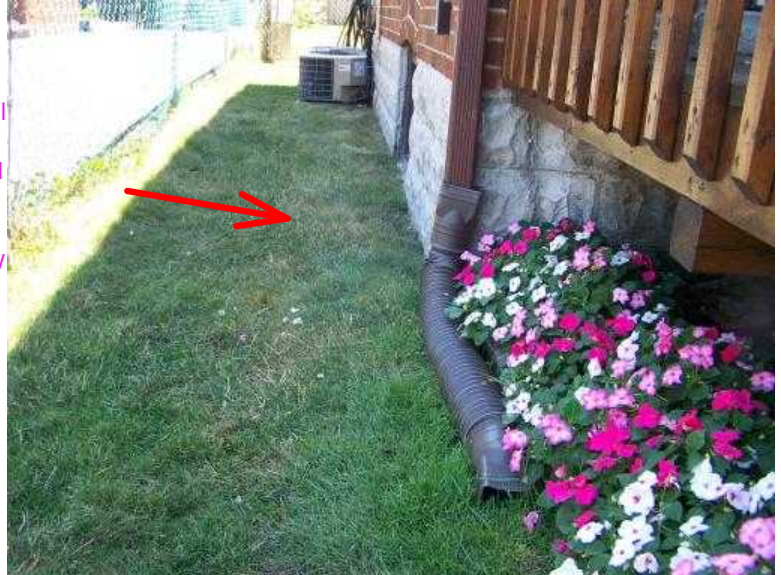
Grading: Inconsistent slope:

Improper soil slope towards foundation - at a minimum, recommend the addition of topsoil to improve grade (usually recommend a minimum slope of 1 inch every 2 feet). Monitor drainage patterns in heavy rains or during spring thaws to properly assess grading. Lower spots need to be raised up. This is THE most common recommendation that we make.

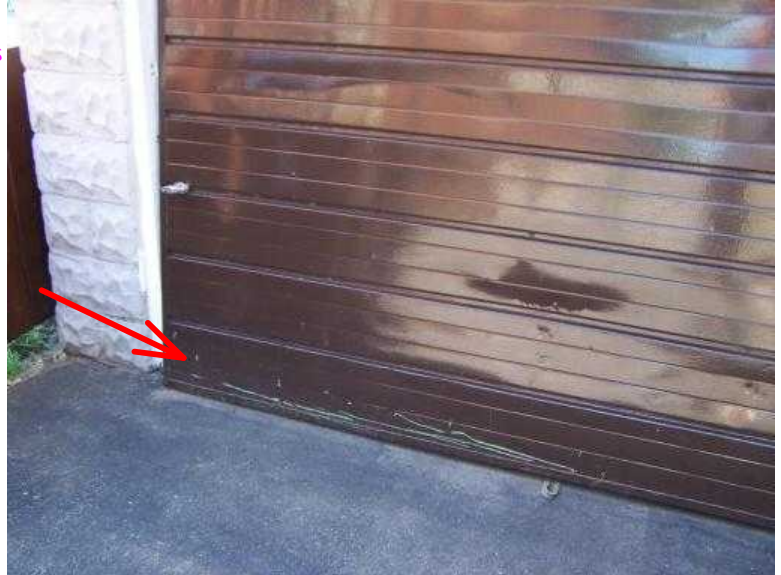
Door Operation: Manual:

Note that the overhead door does not shut and thus cannot be latched because there is an asphalt ridge along the entrance to the garage. This ridge exists to keep rainwater from entering the garage.

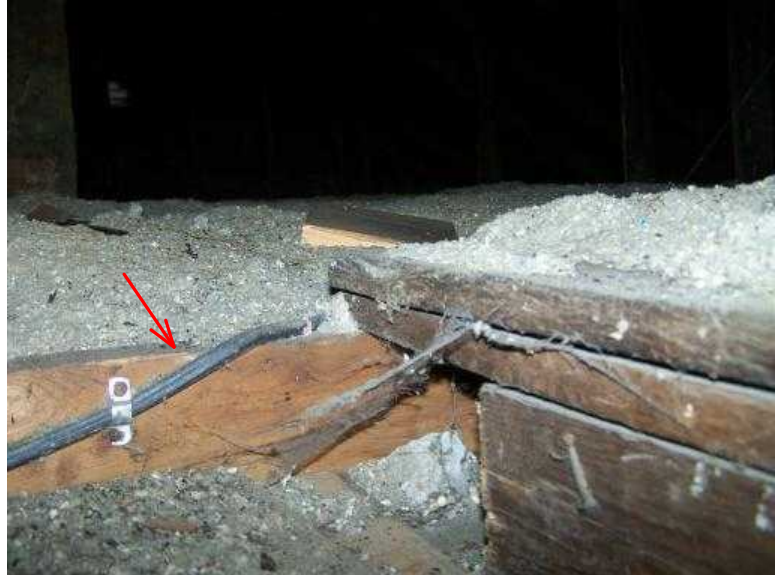
9. Acceptable      Wiring/Lighting: 110 VAC:  
Appears to be newer grounded  
wire and not air cooled knob &  
tube wire. This can be confirmed  
by a licensed electrician while  
doing other work in the house.

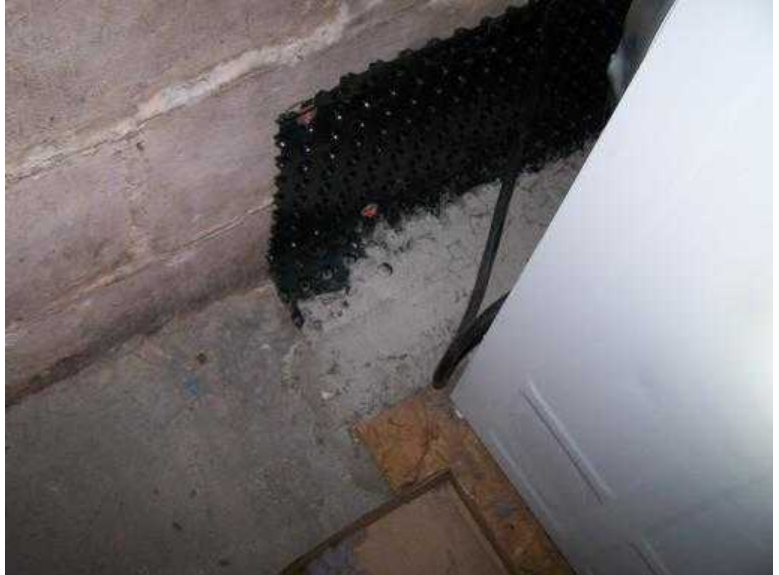
Weeping tile came into common use in the 1940s, so older houses like this do not have it. Newly installed dampness control measures (dimple membrane and weeping tile) along the interior back portion of the foundation should be effective at controlling any possible moisture entry but today's inspection is a one day snapshot - monitor dampness over time. Consider DryLok paint from Rona (see [www.ugl.com](http://www.ugl.com)) and more air-gap membrane to keep any future basement finishes dry.

Suggest removal or trimming of expanding foam in mortar joints - gaps in mortar could be tuckpointed and trimmed foam can be painted over with Dry-Lok.

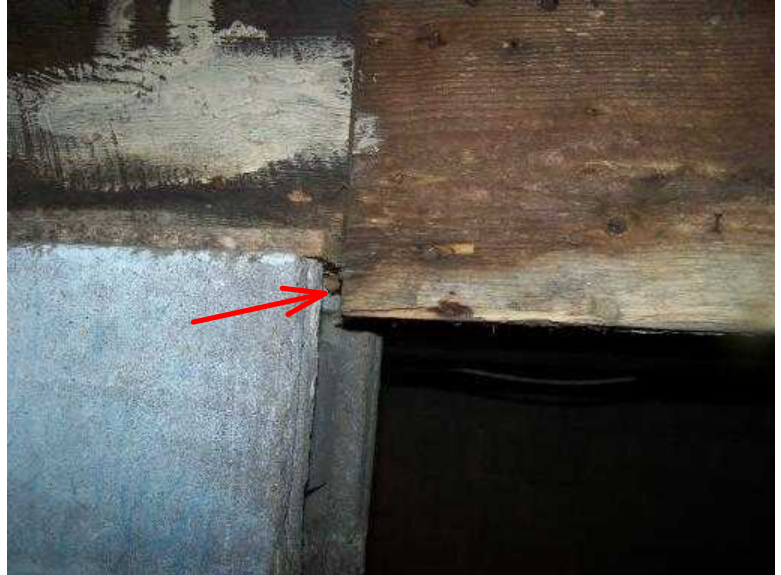
4. Investigate Beams: Laminated wood:  
Needs improvement at the rear pillar where one of the pieces of wood is unsupported (just stops short) and has settled. Have evaluated by a professional contractor.

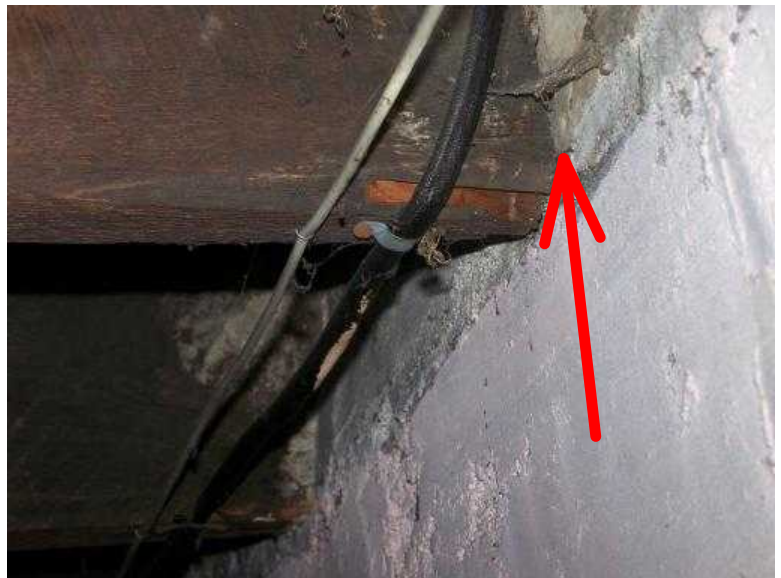
6. Investigate Joists: 2x8: One joist on west wall is not supported at the foundation end (gap visible between the wall and the end of the joist) but no settlement has occurred. Nonetheless, it would be prudent to have repaired by professional contractor when the beam support issue (see above) is addressed.

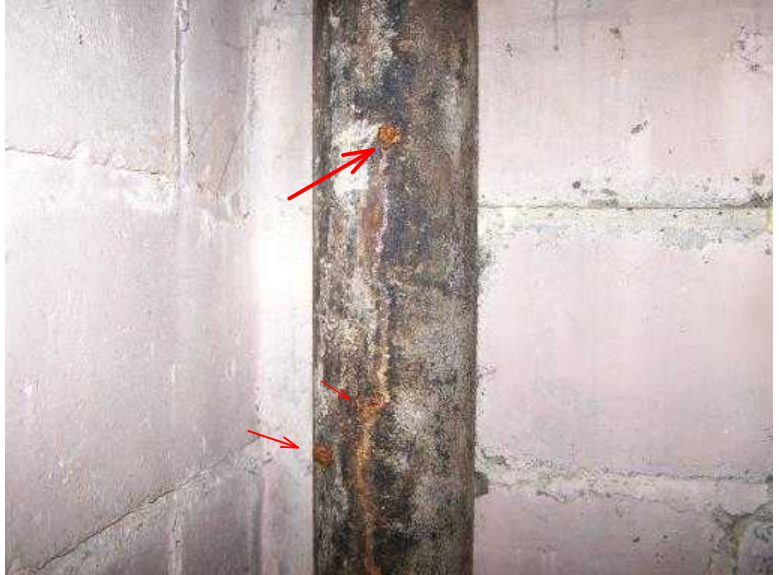
Drain Pipes: Cast iron, ABS:

Leak evidence in cast iron pipe in basement, although it appears that the leaks have temporarily sealed themselves because of the corrosion. Suggest that this portion be replaced with ABS plastic before it starts to leak again. A licensed plumber is recommended to evaluate and estimate repairs

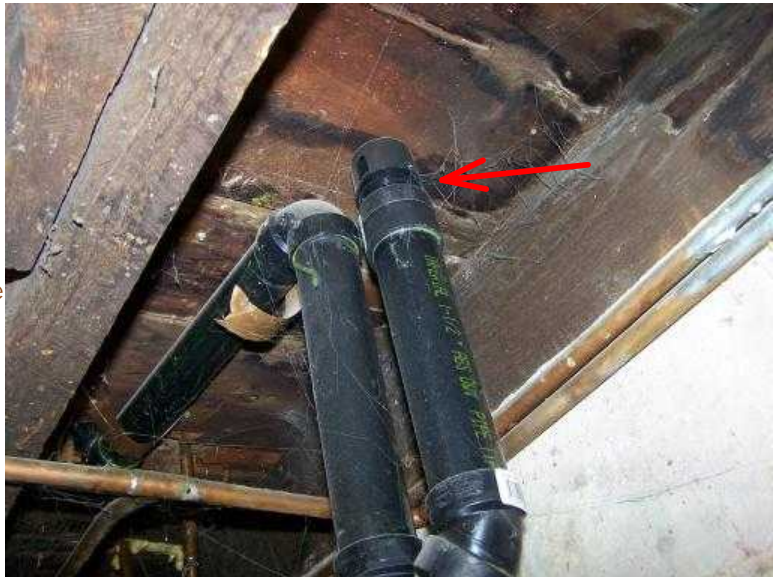
Use of mechanical "cheater" vent is not uncommon in older buildings. A mechanical vent allows air in behind the draining water to prevent a vacuum via a spring loaded rubber membrane, which reseals to keep in fumes when the vacuum pressure subsides. Although they are only technically allowed in trailers, they can function quite effectively. Suggest that a licensed plumber investigate the

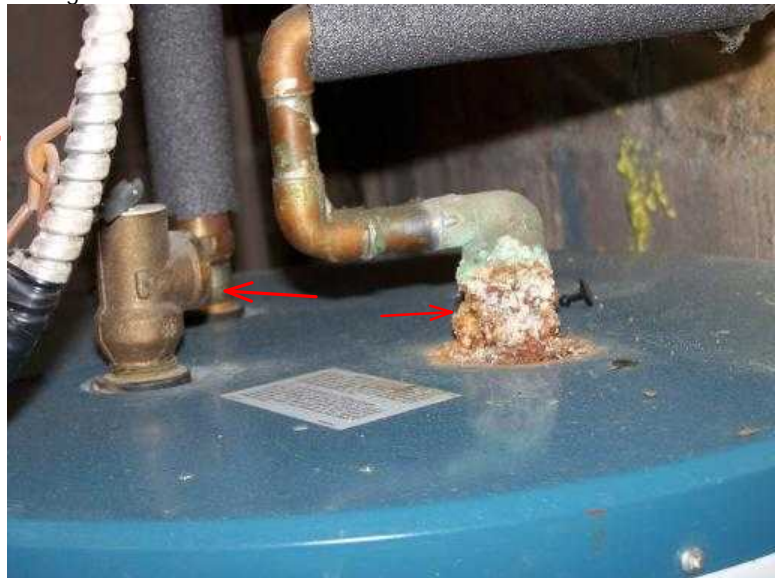
11. Defective TPRV, Drain Tube, Fittings:  
Brass valve: Missing drain tube will splash hot water at anyone in vicinity if pressure valve releases, Add tube to direct water within 6" of floor. Relatively simple repair. There is corrosion on one of the top fittings where the water supply pipes connect - recommend replacement of fittings before it begins to leak.

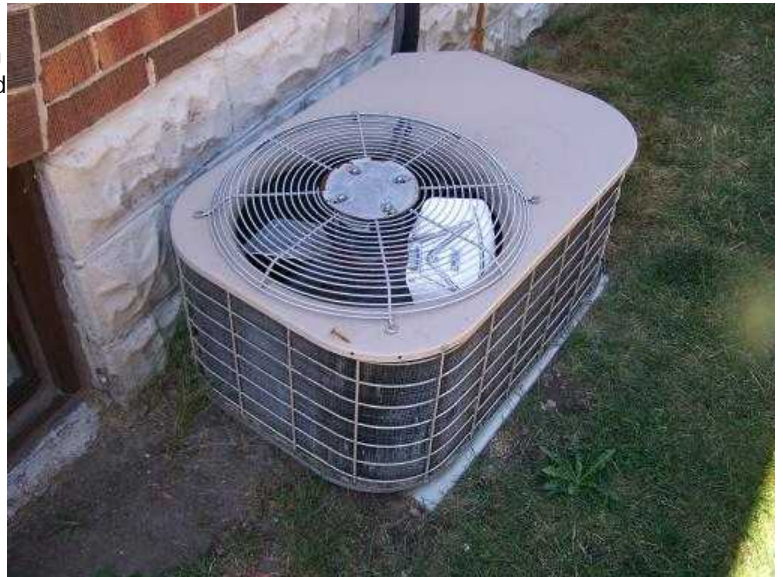
### Exterior AC System

1. Acceptable A/C System Operation:  
Functional: Expected life span in our area is +-15 years. A qualified air conditioning contractor is recommended to evaluate and do annual maintenance on system to gain more information on its condition and performance.

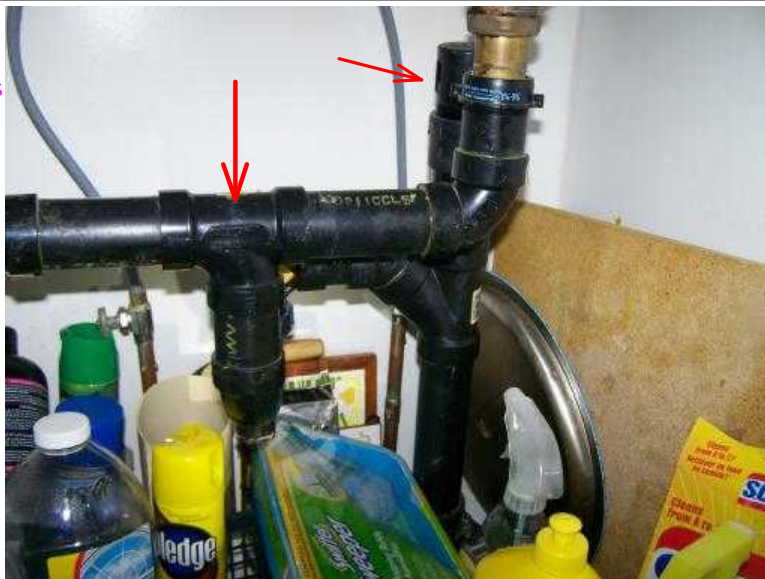
Traps: Trap has cleanout:

Another mechanical vent exists (see Plumbing - venting). There is an incorrect drain configuration. The sideways T-fitting restricts the flow of water from the right bowl. Amateur work - we consider a correctly installed trap and drain to be more reliable. A licensed plumber recommended to replace the trap.
