Blueprint Building Inspections
60 Symons Street
Toronto, ON M8V 1T9

Inspection Report

130 Lake Crescent
Toronto, ON

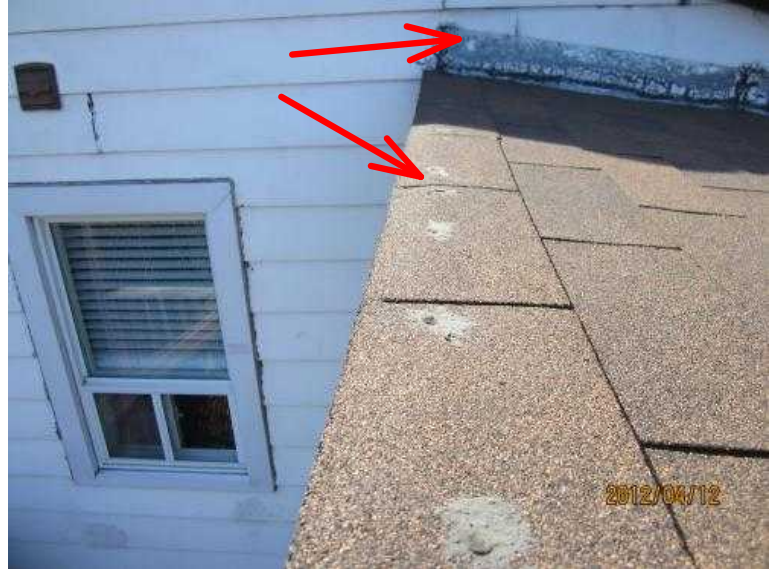
10. Marginal

Wall Flashing: Metal: Suggest minor improvement to rear roof flashing. Also, top edge of shingles over rear entrance door should be flashed.

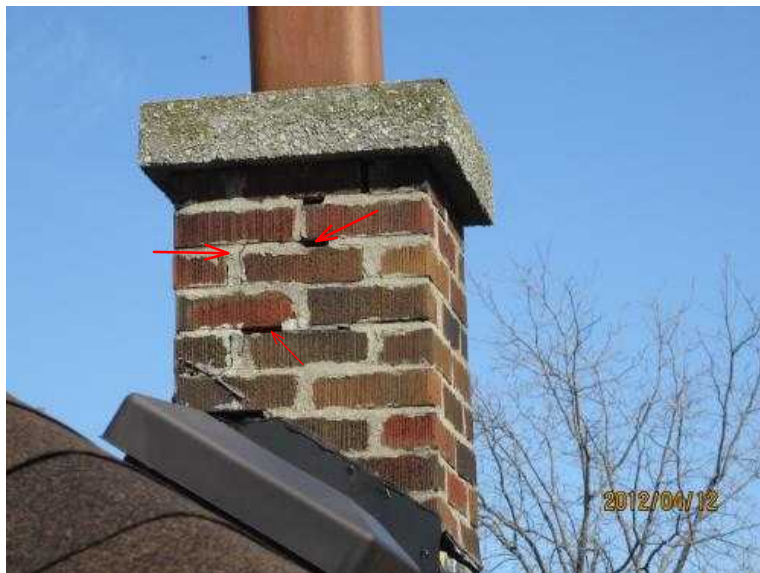
20. Marginal Chimney: Brick: Mortar will need tuckpointing in next 2-5 years - minor repair

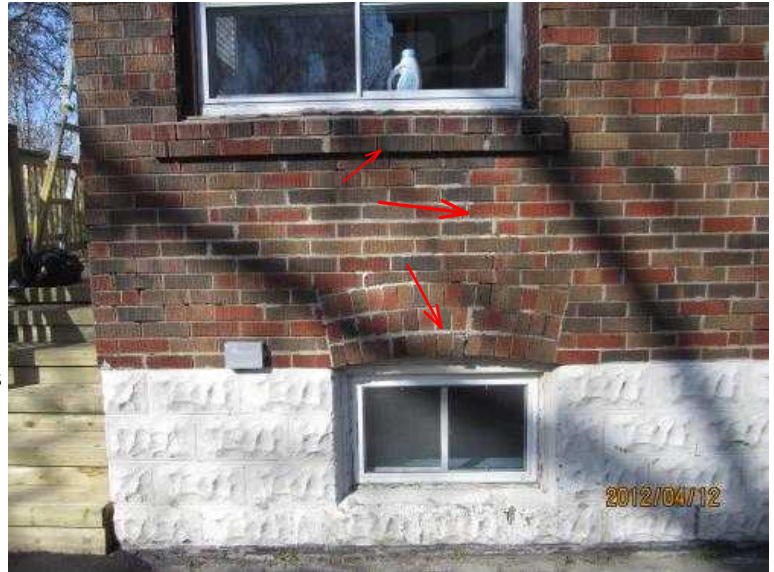
Main Exterior Surface

1. Acceptable, Investigate Type: Brick: Have evaluated/repared by a masonry specialist. Cracks along the mortar in a stepcrack pattern below windows can indicate settlement (not suspected in this case) but often the strongest contributing factor is moisture saturation, freezing and thawing, which causes cracking as the wet mortar expands during freezing. Loose brick in arch over basement window. This is not uncommon in an older brick home.

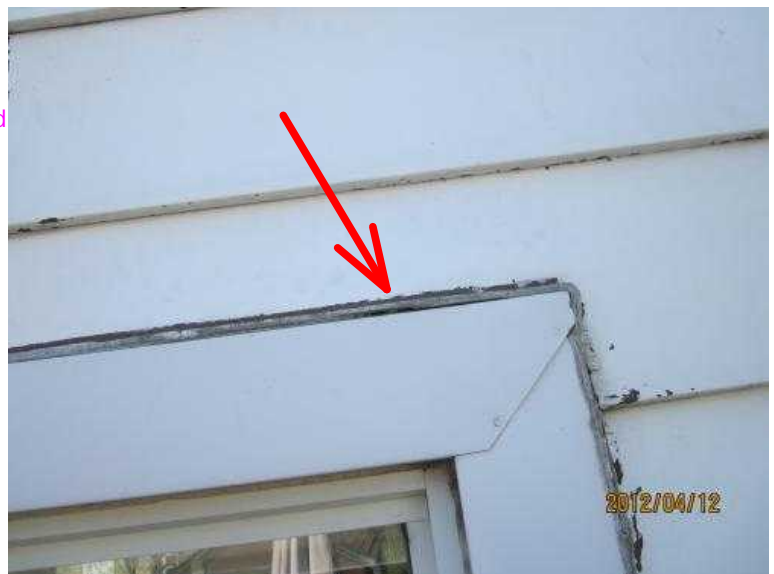
Back Addition Exterior Surface

2. Marginal Type: Aluminum siding: Joints and window trim have had caulk applied, making the joints highly visible. Suggest recaulking around windows to better protect the building envelope against wind and moisture penetration. Corner trim pieces missing also and need attention to prevent water damage.

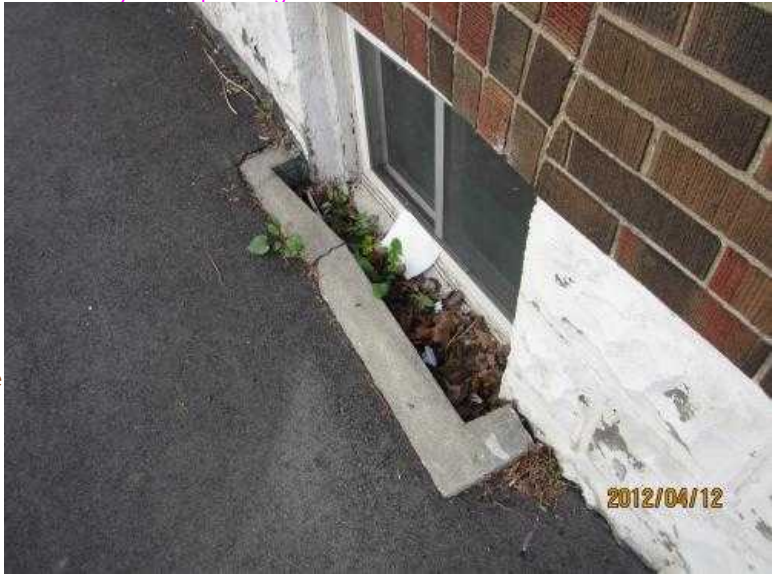
Concrete window sills are there to keep water away from the wood in the windows, but a good solution in the future is to remove all wood framing here and install vinyl windows. Soil/gravel level too close to window sill - may allow moisture to rise and penetrate, Wood to soil close contact in known termite area at window wells. Termites live in the soil and forage for food where wood touches soil (especially soft rotted wood). While no actual termite evidence was found today, the risk is still there. Suggest removing the wood to soil contact or treating the soil with a termiticide. Consider consultations with a termite specialist. |

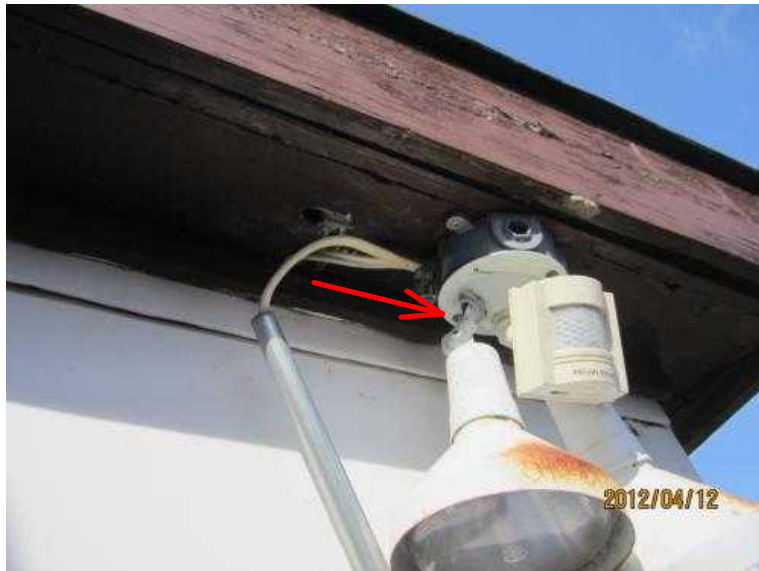
14. Marginal Exterior Lighting: Surface mount, Soffit mount: **Rear spot light has damaged piece - suggest replace**

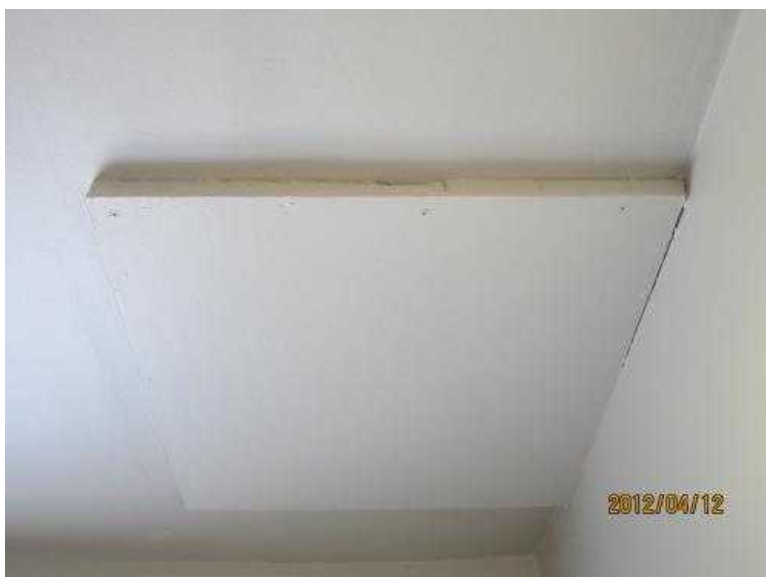
1. Restrictions: 0% visible, No access because attic sealed shut

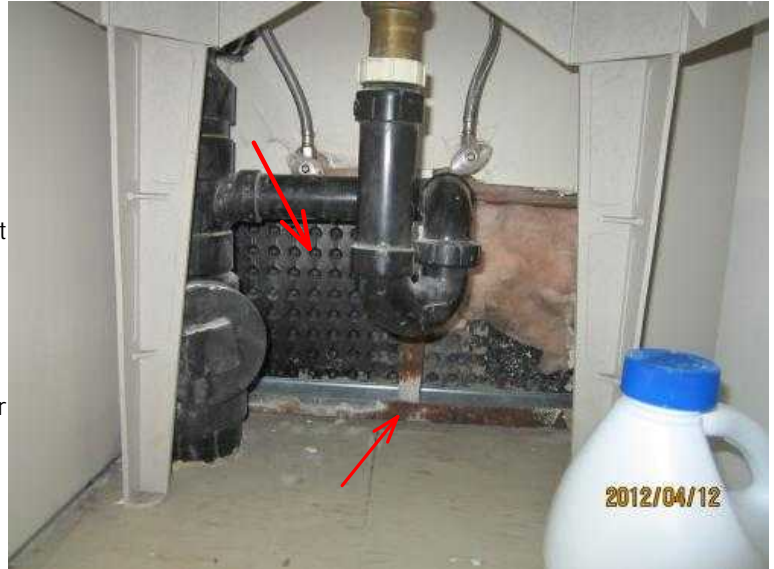
Noted some delta sheeting (air gap membrane - see photo) against foundation under laundry tub inside basement. If this exists throughout the basement, then moisture that does enter would be controlled to some extent. Unfortunately, restrictions in the basement prevent full evaluation (typical). Also noted some rust in the metal framing of the drywall there but dry today - monitor over time.

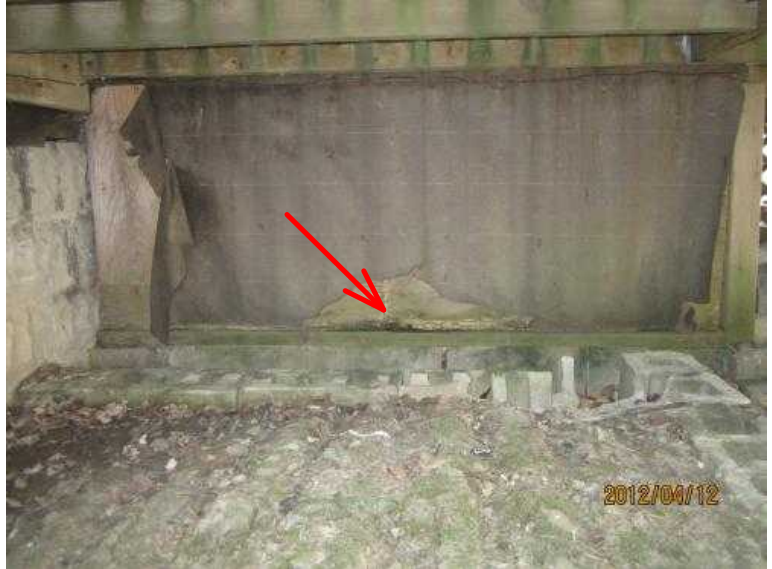
4. Acceptable, Investigate Addition Structure:
Block and wood:
Addition appears to be primarily an enclosed space under the deck. There is close wood to soil contact here and this presents an elevated risk of termite activity. It would be prudent to remove the wood and investigate below this little add-on. The foundation does not appear to be anchored below the frost line, or if it is, it is moisture damaged. Consider this a mudroom with a shorter life span than the house unless improvements are made.

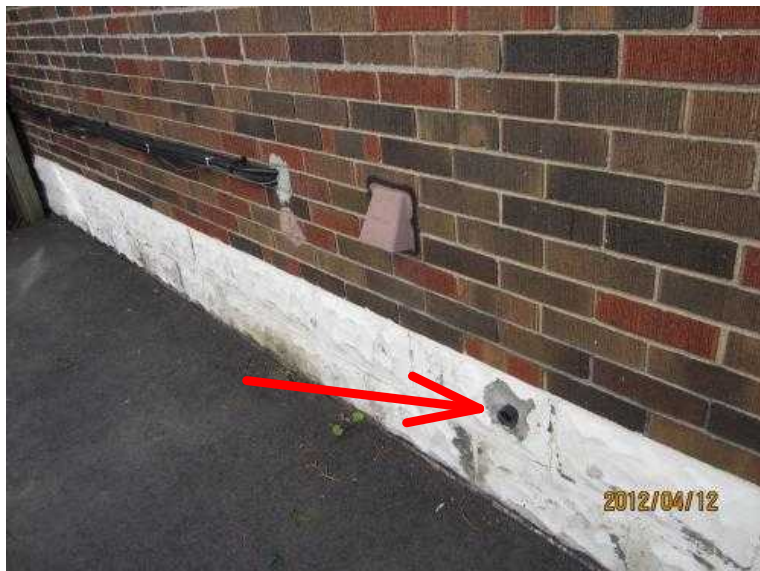
8. Investigate Vent Pipes: Cast iron, ABS:
There are two black plastic ABS pipes coming out of the foundation wall, one near the washroom and one near the laundry room. Suspect these are being used as vent pipes, and they technically are not routed correctly or of appropriate size, even if they function correctly. Consult a plumber to determine if any action is necessary or if the situation can be left as-is for a period of time.
Venting refers to the introduction of air from above a fixture. All fixtures should eventually connect to the plumbing stack on the roof so that atmospheric pressure can help push water down the drain, so that methane gas is vented harmlessly to the exterior, and so that air can be introduced into the drain lines to prevent a vacuum that can inadvertently suck a trap dry as water rushes past from another draining fixture (Bernoulli Principle).

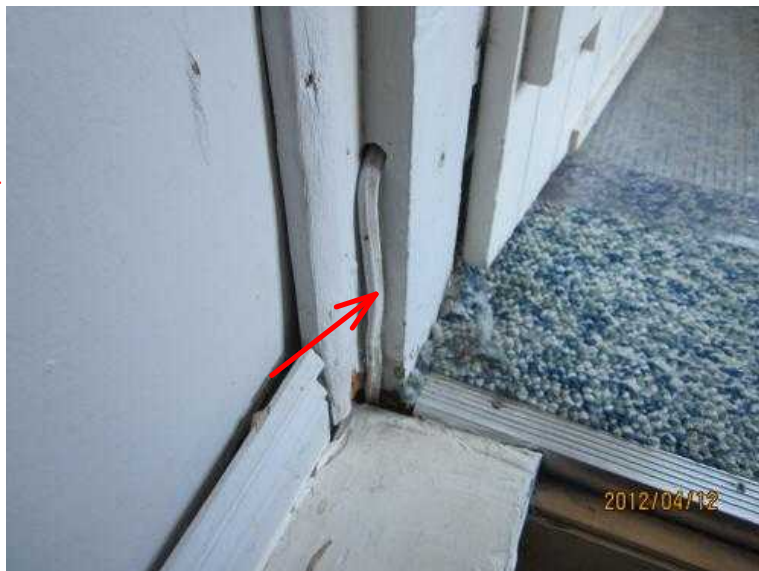
Electrical wire coming out of east basement wall is live and should be terminated in an electrical box to prevent access to the live wires. Protect surface mounted wire on door frame at top of stairs so that it cannot be physically damaged.

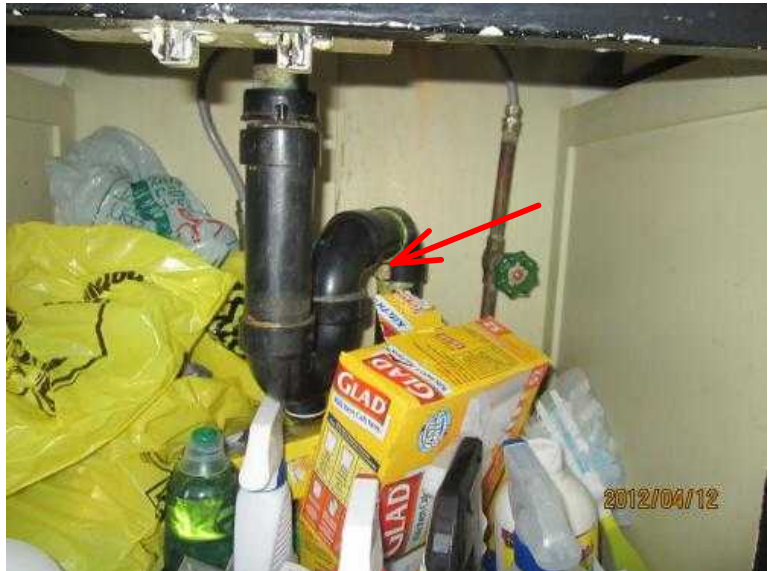
1st Floor Kitchen

2. Acceptable Ventilation: Over the range fan: Suggest installation of venting from exhaust fan to maintain and improve indoor air quality.
3. Acceptable Sink: Stainless Steel
4. Acceptable Electrical: 110 VAC outlets and lighting circuits, 15 amp 3 prong receptacles
5. Acceptable Faucets: With shutoffs
6. Acceptable, Investigate Traps: Trap has cleanout: It is possible that this trap is an unvented S-trap. "S" Type drain traps do not meet modern standards and are probably unvented. Watch for sewer gas smell or gurgling, slow drainage.

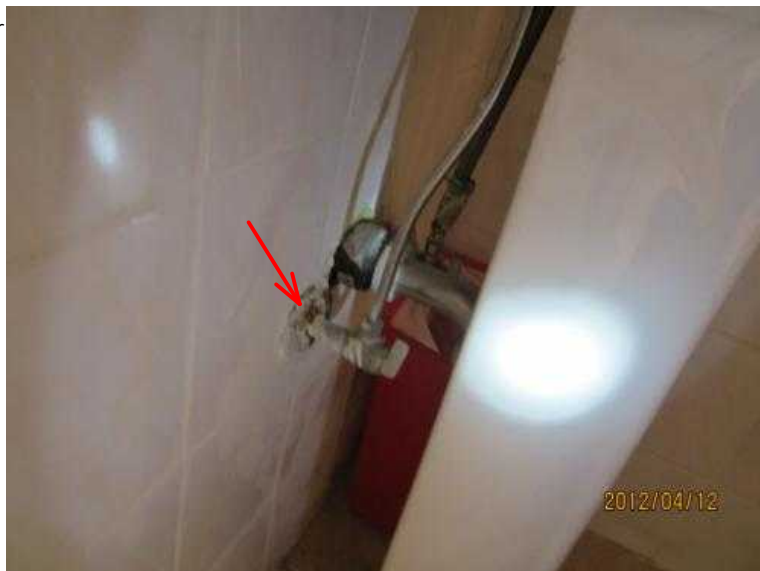
Basement Bathroom

- 2. Acceptable Ceiling: Drywall
- 3. Acceptable Walls: Drywall
- 4. Acceptable Floor: Ceramic tile
- 5. Acceptable Doors: Hollow
- 6. Acceptable Electrical: 110 VAC outlets and lighting circuits, 15 amp GFCI
- 7. Acceptable Sink/Basin: Pedestal
- 8. Acceptable Faucets: With shutoffs: Monitor green corrosion on pipes at shutoff - suggest cleaning off with steel wool

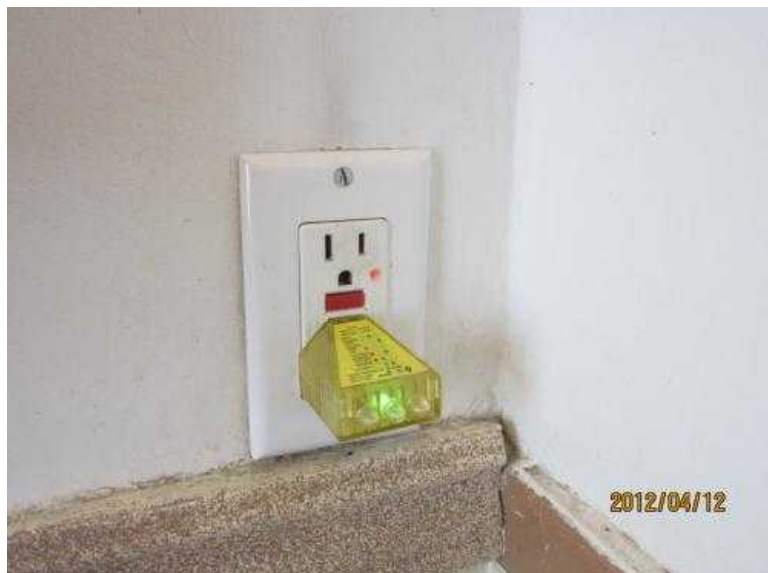
18. Acceptable, Investigate Electrical: 110 VAC outlets and lighting circuits, GFCI protected receptacle: Open or missing ground - suspect ungrounded cable, but it is possible that it may be knob & tube. As wired with a GFCI, this is acceptable, but bears further investigation.

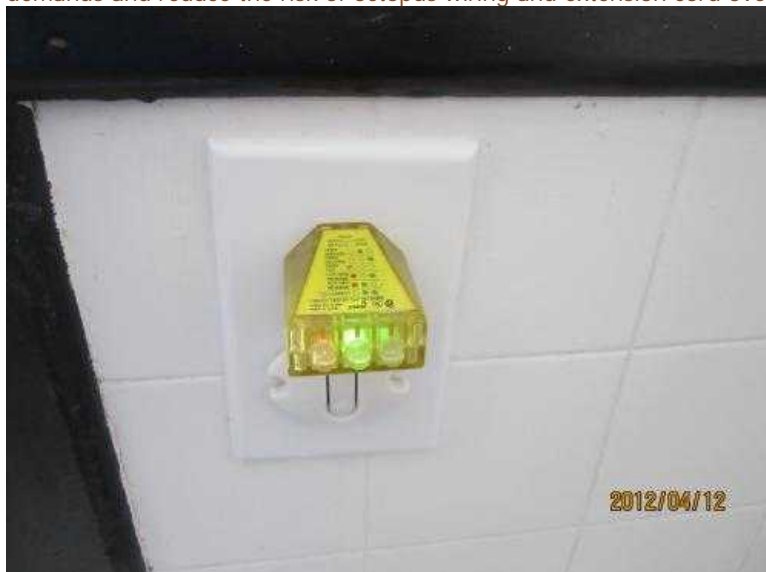
1st floor Interior Space

2. Acceptable Ceiling: Drywall
3. Acceptable Walls: Drywall
4. Acceptable Floor: Ceramic tile
5. Acceptable Floor: Hardwood: Hardwood manufacturers recommend 40-50% humidity in winter to prevent shrinkage. This higher humidity can reduce indoor air quality. Use a hygrometer to strike a balance so that windows and walls do not collect condensation. Keep blinds open slightly for the same reason. If situation persists, an HVI certified HRV (Heat Recovery Ventilator) should be considered.
6. Acceptable Doors: Hollow
7. Investigate Electrical: 15 amp 3 prong (110 volt) receptacles, 110 volt lighting circuits: **Reversed polarity, Scarcity of electrical receptacles noted - suggest addition to better accommodate modern electrical demands and reduce the risk of octopus wiring and extension cord over-use (known fire hazards).**
