Blueprint Building Inspections  
60 Symons Street  
Toronto, ON M8V 1T9

# Inspection Report

87 Edgecroft Road  
Etobicoke, ON

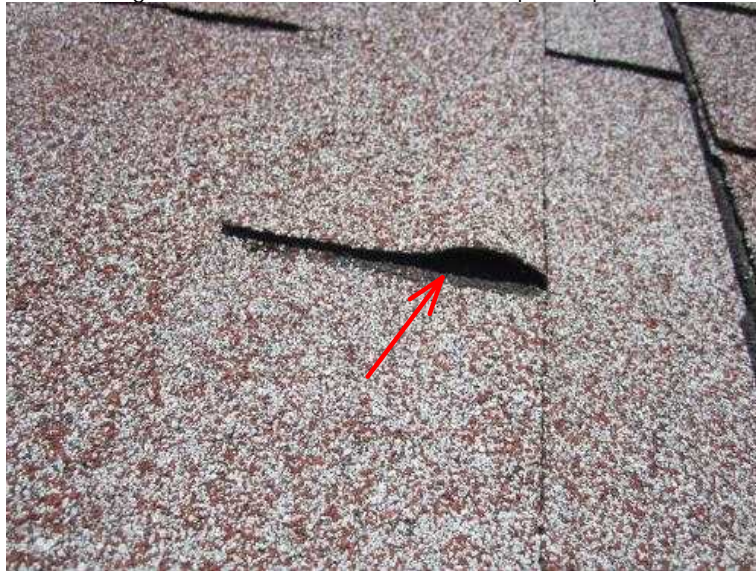
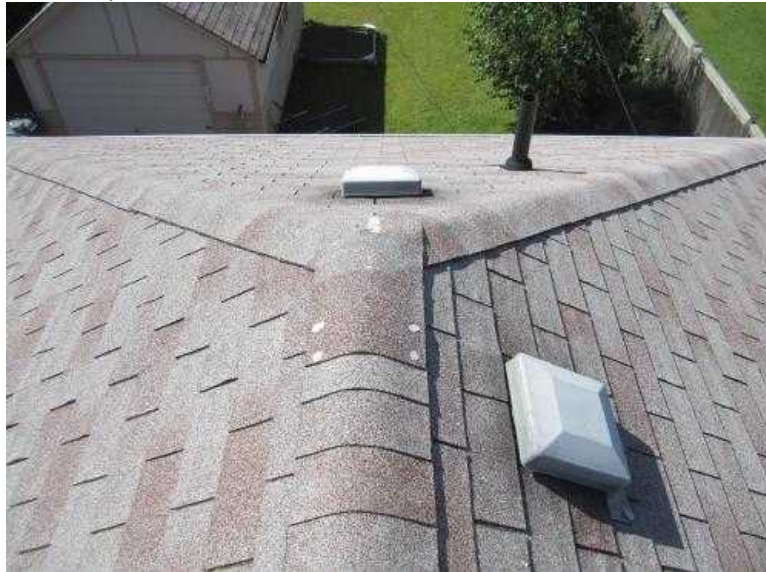
1. Method of Inspection: On roof
2. Acceptable Material: Asphalt shingle: Typical wear and tear - expanded seams, edges wearing, raised edges and fishmouthing, commencement of brittleness. Expect replacement in next 4-5 years approximately

3. Type: Hip
4. Approximate Age: 10-11 years, (entering last third of life cycle): Most roofs are designed to last 15 years. Note that the age estimate is based upon the appearance of the shingles. They may be older or younger, but the wear patterns indicate the age that was recorded by the inspector.
5. Tips **Flashed areas require reapplication of elastomeric caulking in short term. We highly recommend a roof and flashing tune-up every 3-5 years as materials such as caulking deteriorate more quickly than other components of the roof.**
6. Acceptable Wall Flashing: Metal
7. Acceptable Valleys: Metal
8. Acceptable Plumbing Stacks: ABS
9. Acceptable Stack Flashing: Plastic/rubber

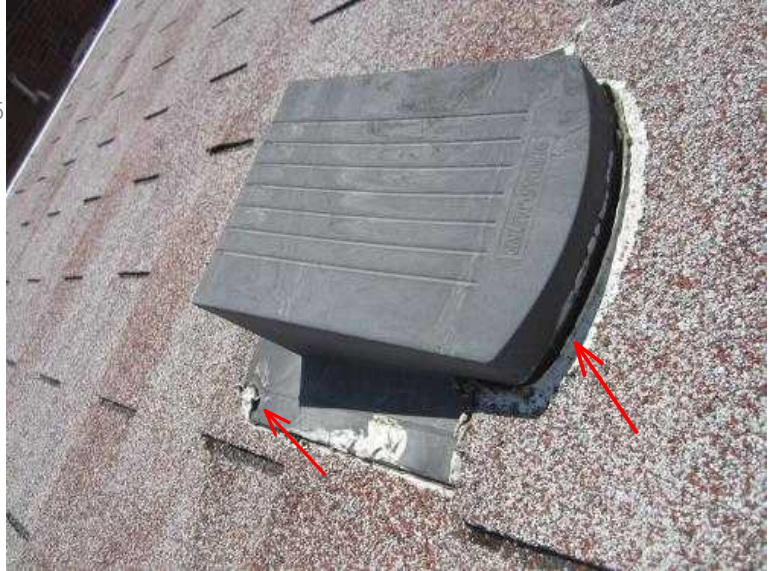
10. Improve

Roof Vents: Plastic, Metal:  
Separated seams exist now,  
Recommend a flashing tuneup in  
the short term, and then every 4-5  
years thereafter.

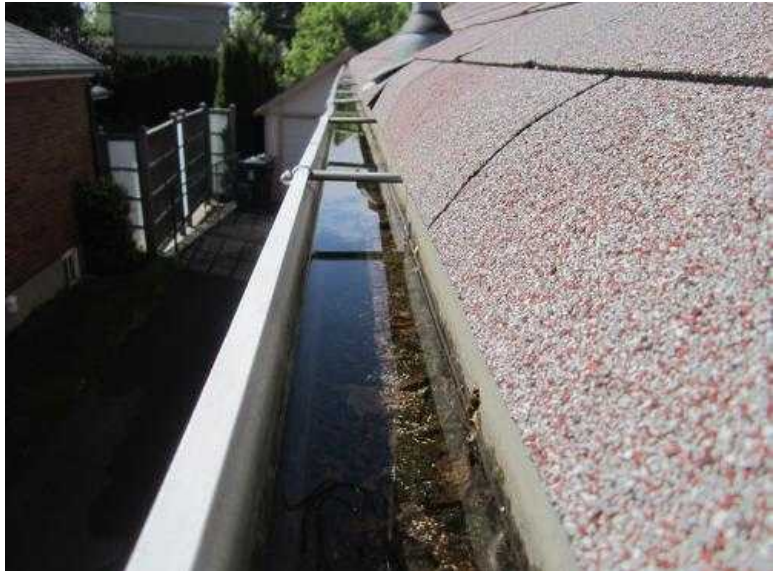
13. Improve

Gutters: Aluminum: Leaves in  
troughs are holding water back.  
Clean out and monitor drainage.

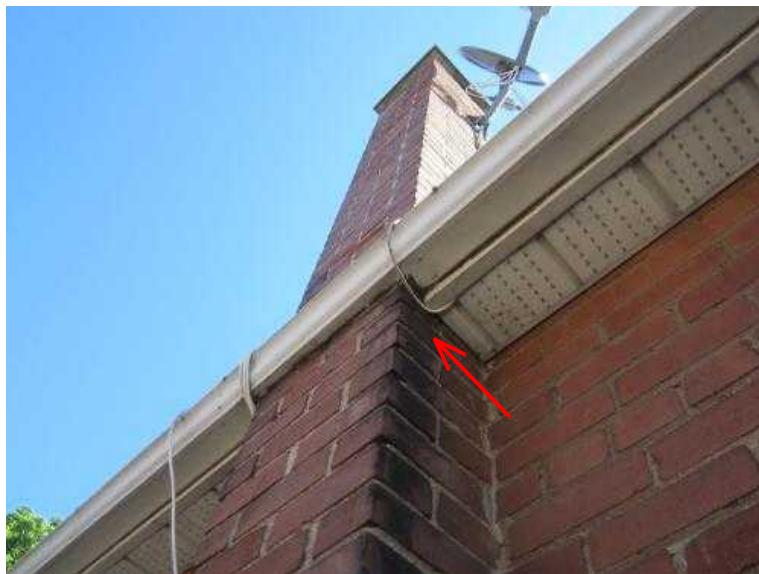
16. Acceptable Chimney: Brick: Monitor eavestroughs for leaks against brick - stains exist on chimney below roof line but these could be older and no damage has resulted at this time.

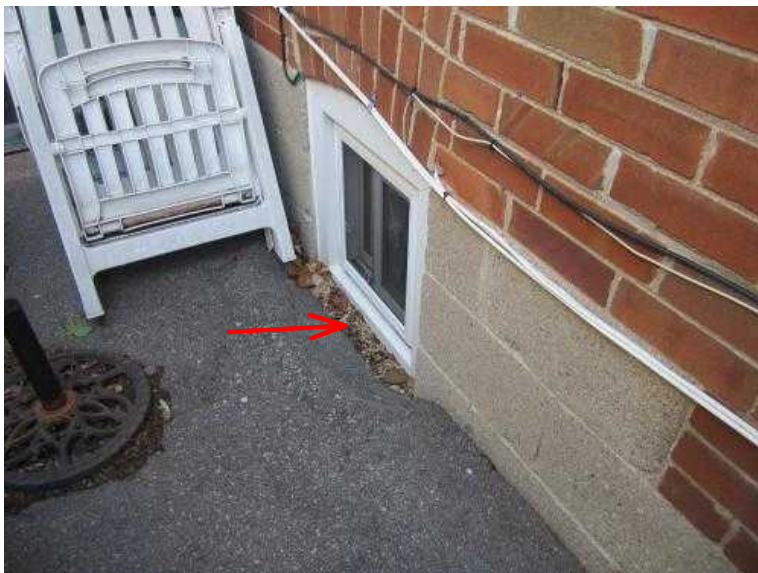
13. Marginal

Window Wells Asphalt: Keep clear of debris/leaves and monitor drainage, Investigate options for adding window wells if dampness occurs

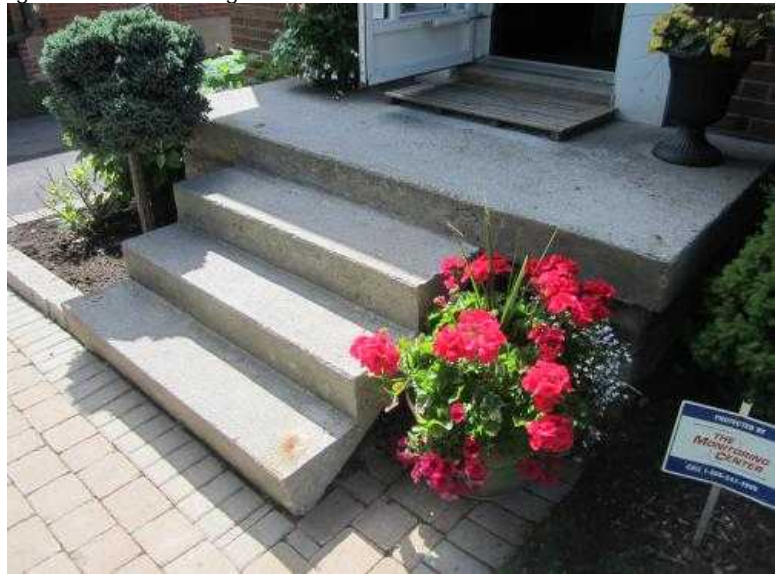
2. Marginal Steps: Concrete: **Missing handrails (safety, liability)**

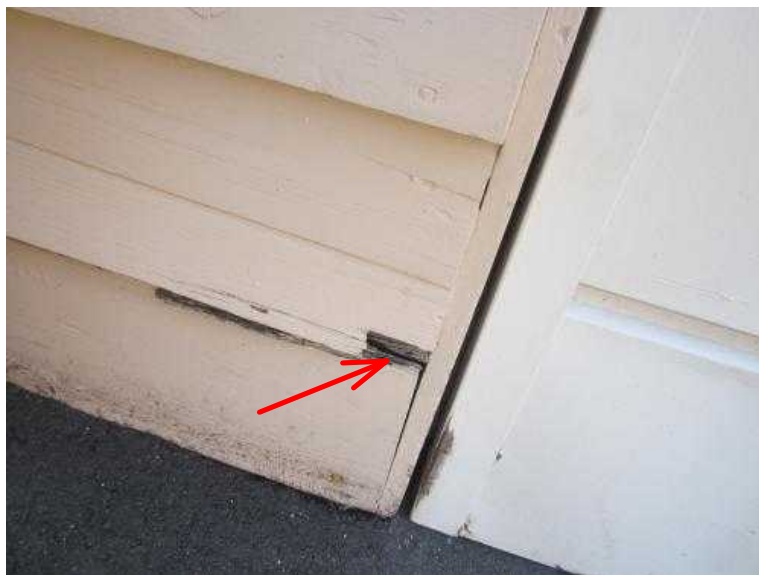
5. Marginal Exterior Surface: Wood siding:  
Some rot noted in bottom panels.  
Keep water away from structure  
and repair as needed.

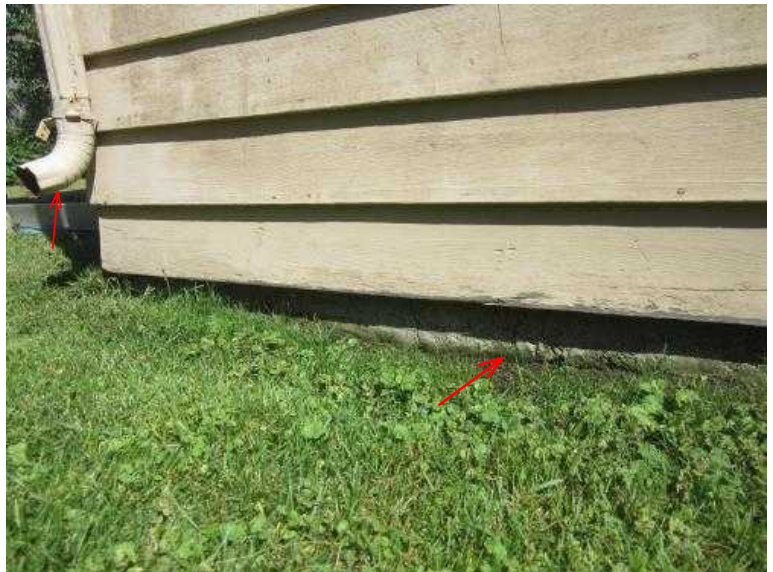
9. Acceptable Floor/Foundation: Concrete: Unable to confirm depth of footings. May just be slab on grade. Keep water away from structure to lessen risk of water creating any adverse effects on the garage. Lower lying areas need addition of soil and downspouts should be extended. Some green stains were visible at concrete where it touches the ground, indicating moisture accumulates in this area.

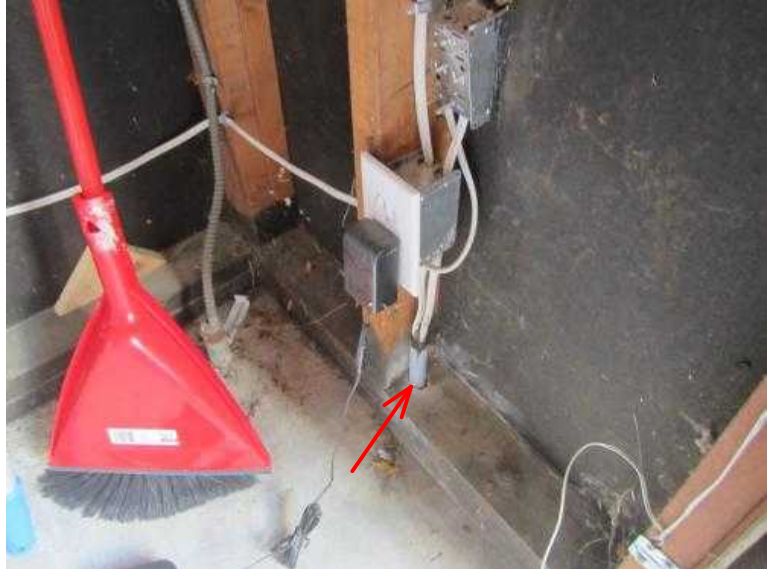
10. Investigate Electrical: 15 amp 3 prong receptacles, 110 volt lighting circuits: See Exterior Electrical notes regarding buried wire. Non-GFCI circuit -recommend GFCI circuit be installed. Wiring stapled to the wood framing/walls should ideally be protected to prevent physical damage (since it is within reach, and garages are locations where sharp instruments and gardening tools are stored).

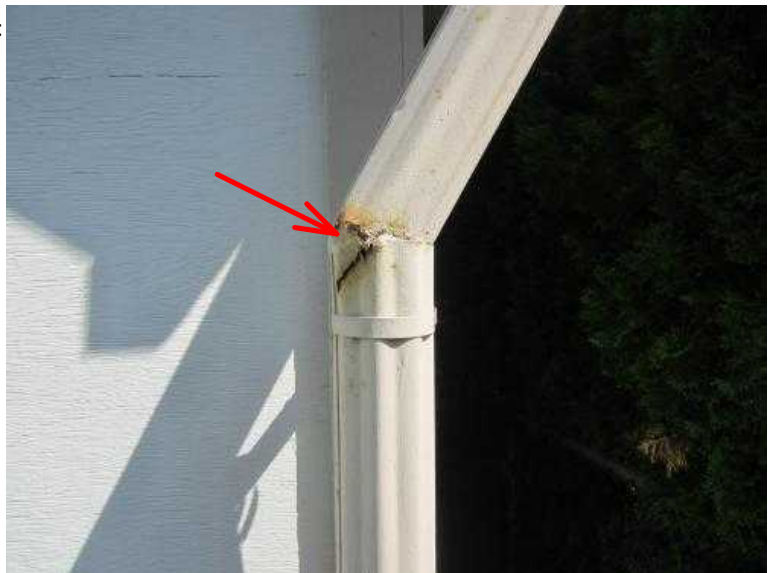
11. Acceptable Gutters: Galvanized: Some corrosion - prone to leaks but not raining so cannot confirm that they do not leak at joints

12. Acceptable, Improve Downspouts: Galvanized: Some corrosion - prone to leaks but not raining so cannot confirm that they do not leak at joints

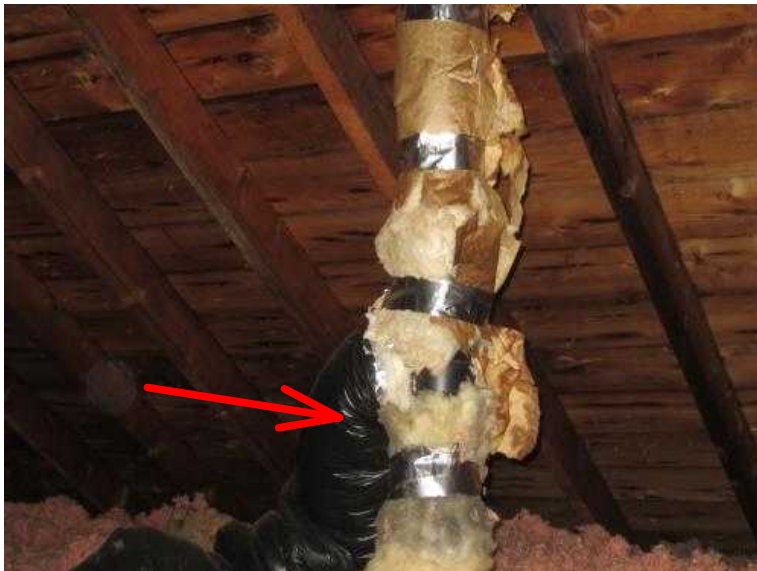
### 9. Acceptable, Investigate Exhaust Fan

**Venting:** Insulated ducting: It is a good setup in one way, in that the bathroom fan does not improperly vent into attic, which could cause condensation/moisture damage to the insulation and any wood in the attic. However, the exhaust fan vents into the plastic plumbing stack, which is unusual. There isn't any obvious negative implication of this configuration, but it would be a good idea to keep an eye on condensation stains around the bathroom and bedroom ceilings. When reroofing, have the roofer add a collared vent and connect the exhaust ducting to this, just to be safe.

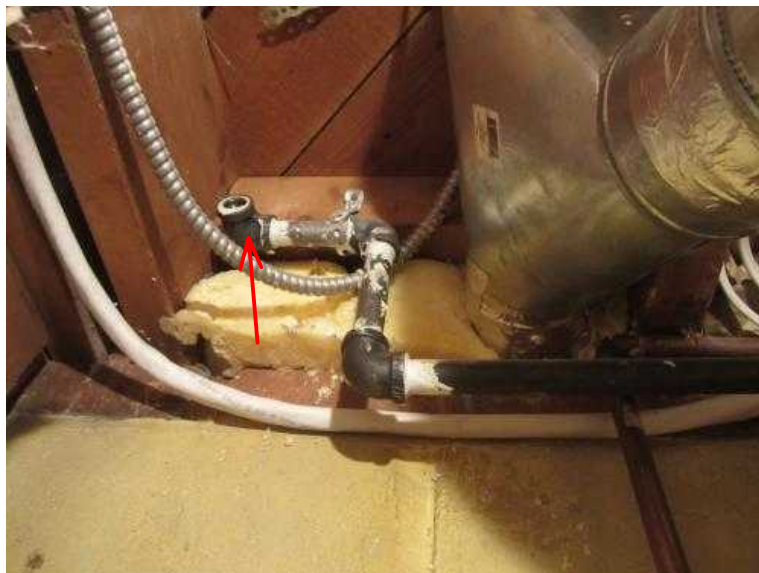
8. Investigate Gas Service Lines: Black pipe, Copper: One open gas pipe (no gas flowing) in electrical closet - unknown if connected to live gas lines and simply shut off. Recommend insertion of a plug to terminate the gas pipe just in case. This would be recommended by any competent gas-fitter and is a very simple procedure.

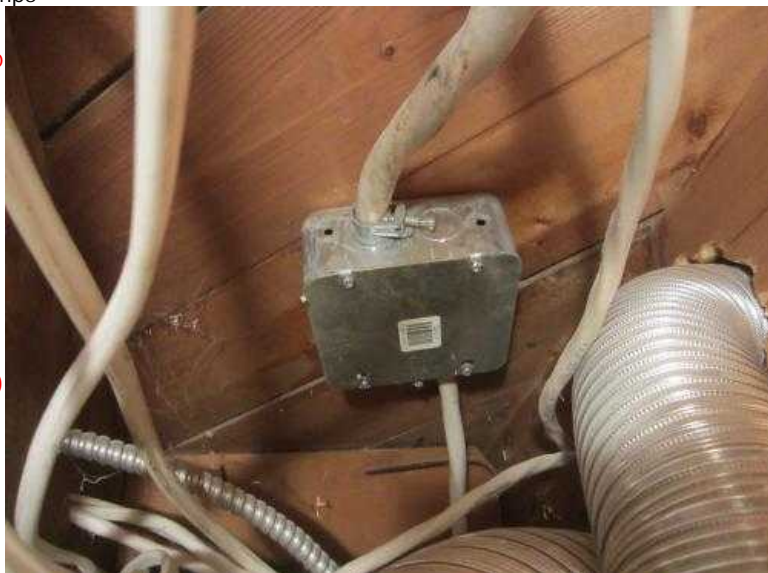
10. Maximum Capacity: 100 Amps
  11. Acceptable Main Disconnect Size: 100 Amps
  12. Defective Breakers: 15, 20, 30, 40, 60 amps: Some overfusing (20 amp and 60 amp breakers are being used to supply wire that is rated for only 15 amps and 40 amps respectively). Photo shows junction box where 60 amp cable is spliced into a 40 amp cable. Bridged breakers are designed to trip together if one side of the circuit is overloaded, and are typically used for wires that are 14/3 (3 conductors plus a ground) to ensure that all devices on a circuits are de-energized at the same time. This is a safety consideration for an electrician working on the circuit, but there are two cases of unbridged breakers. Minor reconfiguration of wiring is recommended for this. Stripped panel screw on top left corner (minor). Have evaluated/repared by licensed electrician.

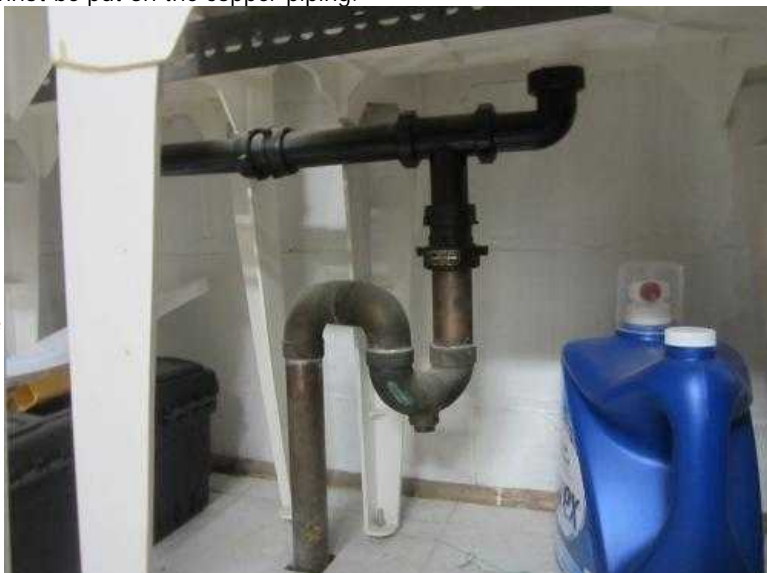
2. Acceptable Laundry Tub: PVC
3. Acceptable Laundry Tub Faucet: No shutoffs: Suggest securing the faucet to a block of wood and then to the wall so that unwanted stresses cannot be put on the copper piping.
4. Investigate Laundry Tub Drain: Copper:

An "S" trap has been used. S traps should be replaced during any new plumbing work as they are subject to siphoning problems. Replacement is sometimes difficult and thus the S traps are common. Care should be taken to keep the trap "primed." Fixtures should be monitored for sewer odor or more likely, a gurgling sound.

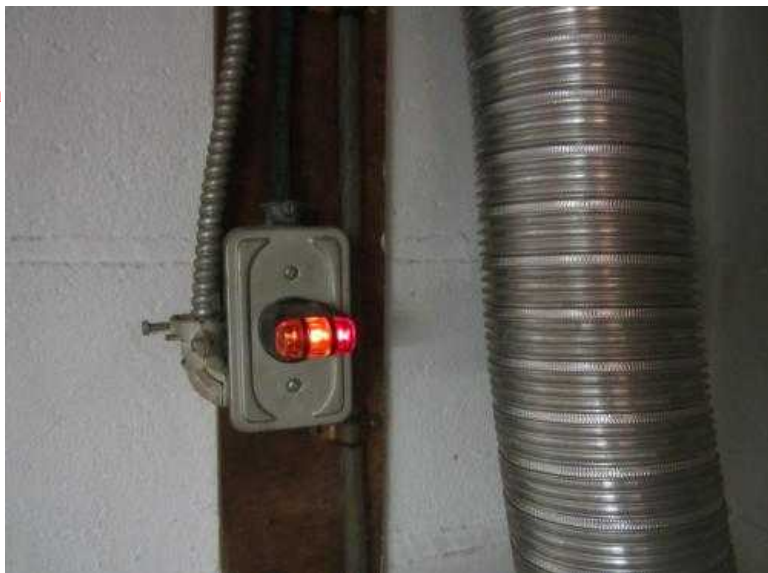
6. Defective Washer and Dryer  
Electrical: 110-220 VAC:  
Reversed polarity, Evaluation by a  
licensed electrician is  
recommended

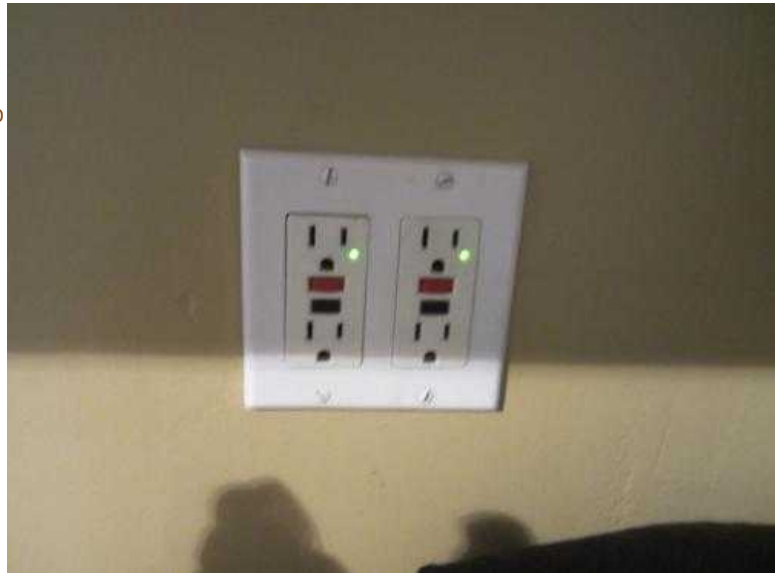
- 3. Acceptable Sink: Stainless Steel
- 4. Investigate Electrical: 110 VAC outlets and lighting circuits, 15 amp 3 prong receptacles: Neither 15 amp split receptacles (formerly used to allow high draw appliances to plugged in without tripping breaker/fuses) nor 20 amp GFCI receptacles (currently used to allow high draw appliances to function in tandem while providing protection against ground fault shock) - suggest adding the latter.

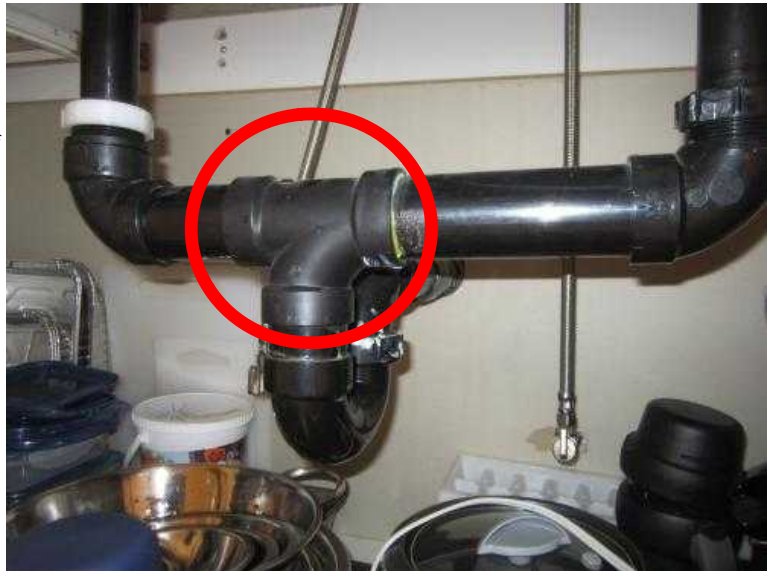
- 5. Acceptable Faucets: With shutoffs
- 6. Acceptable, Improve Traps: Trap can be opened (locknuts): There is an incorrect drain configuration. The sideways T-fitting restricts the flow of water from the left bowl. This can cause water to come up into the left bowl from the drain. Amateur work - we consider a correctly installed trap and drain to be more reliable. A licensed plumber recommended to replace the trap.

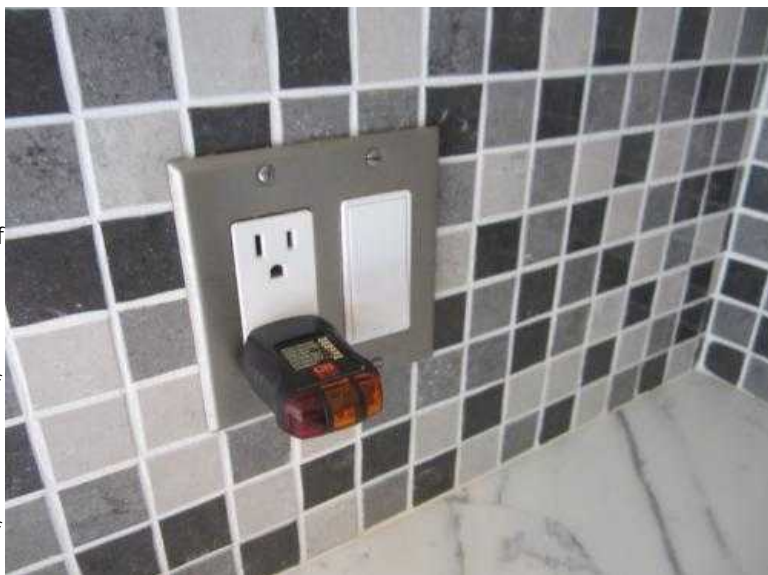
13. Acceptable, Investigate Electrical: 20 amp GFCI circuits, 110 VAC outlets and lighting circuits, 15 amp 3 prong receptacles: 20 amp GFCI may not be fed by a 12 gauge cable - have evaluated and repaired if needed by a licensed electrician. Also, this 20 amp GFCI protects the 15 amp grounded receptacle to the right of the sink. In other words, if the GFCI trips due to a detected ground fault, the receptacle to the right of the sink also is shut off. However, the switch that operates the light is separately powered but exists in the same device box. It is possible for an electrician to shut off the power to one circuit but still work on an energized electrical box unexpectedly because two circuits should not run into one box - this is a shock hazard to the electrician. A licensed electrician is recommended to evaluate and estimate repairs

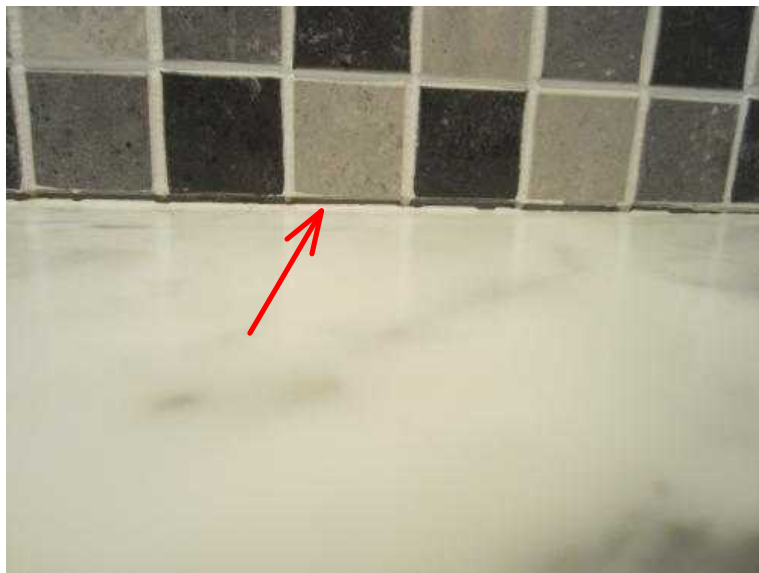
16. Acceptable Counter Tops: Marble or marble-like: Suggest adding flexible caulk at seam between countertop and tile backsplash. Minor cracks/seams by faucet - no action required unless it changes.

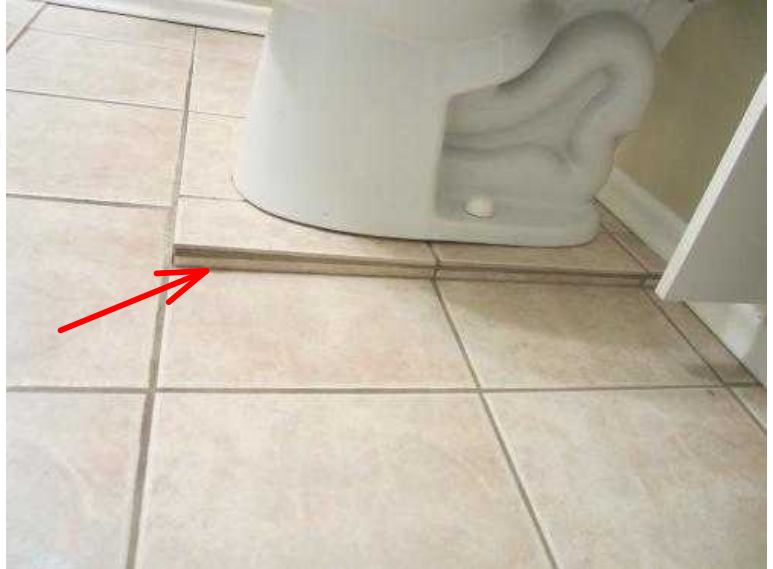
4. Acceptable, Improve Floor: Ceramic tile: Add a piece of quarter round trim to prevent toe stubs at the toilet. Suspect this was done to keep the toilet level on a non-level floor.

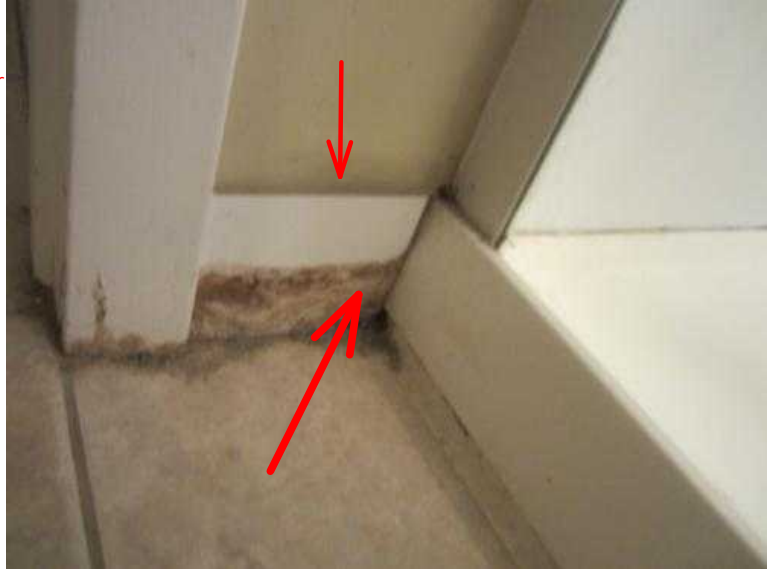
10. Defective Shower/Surround: Fiberglass pan, Fiberglass surround:  
Replace old caulking at the shower pan. This type of unit is prone to leaking in outside corners - some staining and slightly elevated moisture readings in wall beside bathroom door. The drywall here is softened from repeated moisture. Needs repair in the short term

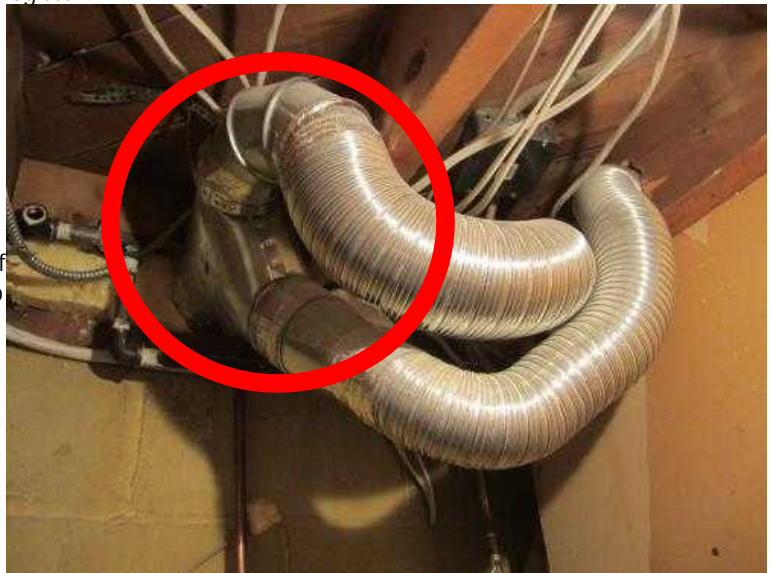
13. Acceptable, Investigate Ventilation: Electric fan: The exhaust duct from the kitchen exhaust fan and the bathroom fan tie into one exhaust vent on the exterior wall. This can allow blowback from one into the other - suggest the installation of a one-way check valve to prevent this, or just add a new exhaust vent in the wall.

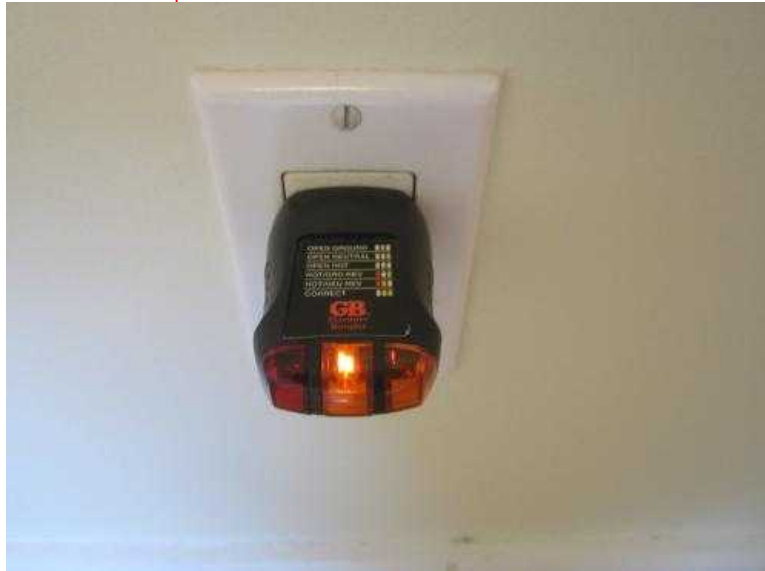
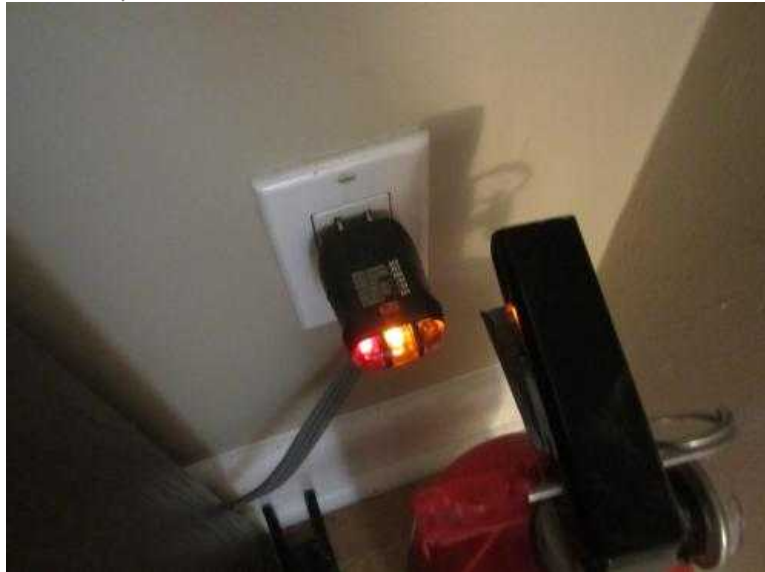
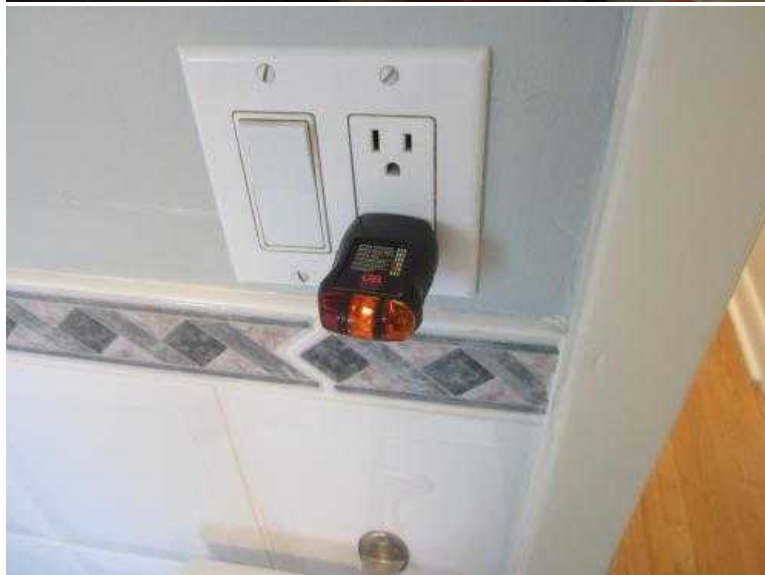
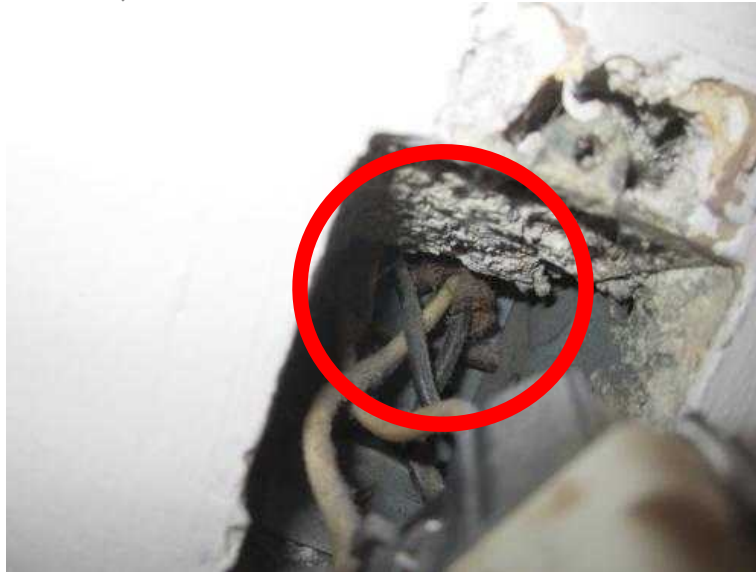
8. Defective

Electrical: 15 amp 3 prong (110 volt) receptacles, 110 volt lighting circuits: **Open or missing ground - ungrounded cable (visible in circle in the fourth photo), but not knob & tube. Add GFCIs to provide level of protection against ground faults. Reversed polarity in some receptacles also. Scarcity of electrical receptacles noted - suggest addition to better accommodate modern electrical demands and reduce the risk of octopus wiring and extension cord over-use. A licensed electrician is recommended to evaluate and estimate repairs**
