Inspection Report

73 Twelfth Street Toronto, ON

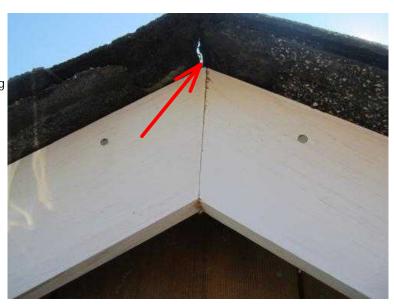
Material: Asphalt shingle:
Typical wear and tear - expanded seams, edges wearing, minor edge curl, commencement of brittleness, some granules missing exposing substrate of shingle.
Expect replacement in next 4-5 years approximately. Add caulking/tar at front peak shingle over porch where cracked. Keep ivy away from roof line at NE corner

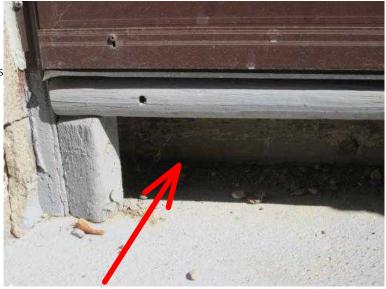
Entry Doors: Metal: Suggest adding a piece of styrofoam insulation under the side door threshold to reduce heat loss at this location. Side screen door has no self-closer.

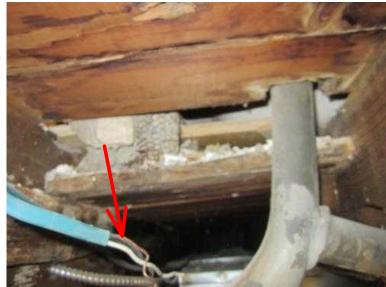
13. Marginal

Electrical defects Furnace utility room: Cap off unterminated wire under bathroom floor - should terminate in a box.

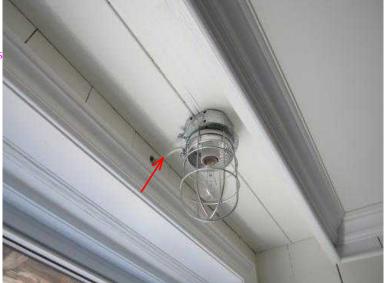
14. Marginal

Electrical defects Kitchen: Wire feeding light over sink is exposed and technically should be run through conduit. However this is a low risk issue.

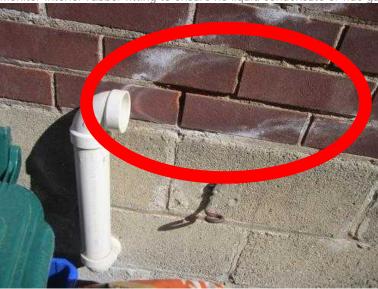
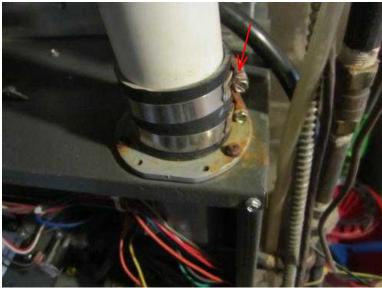
Flue Pipe: White plastic (class IIA gas vent): Turn the top elbow of the exhaust duct away from the brick face. Note the moisture stains on the brick now - this pattern will eventually show up as a wear pattern on the brick and mortar.

Monitor interior rubber fitting to ensure no liquid condensate or flue gases are leaking.

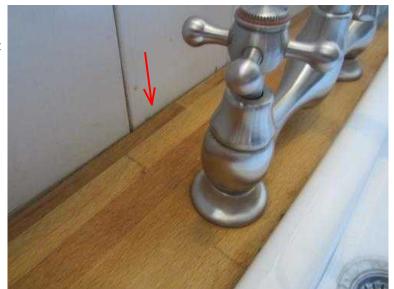
butcher block: Suggest caulk at wood counter joint

against wall.
