Blueprint Building Inspections  
60 Symons Street  
Toronto, ON M8V 1T9

# Inspection Report

89 Argyle Street  
Toronto, ON

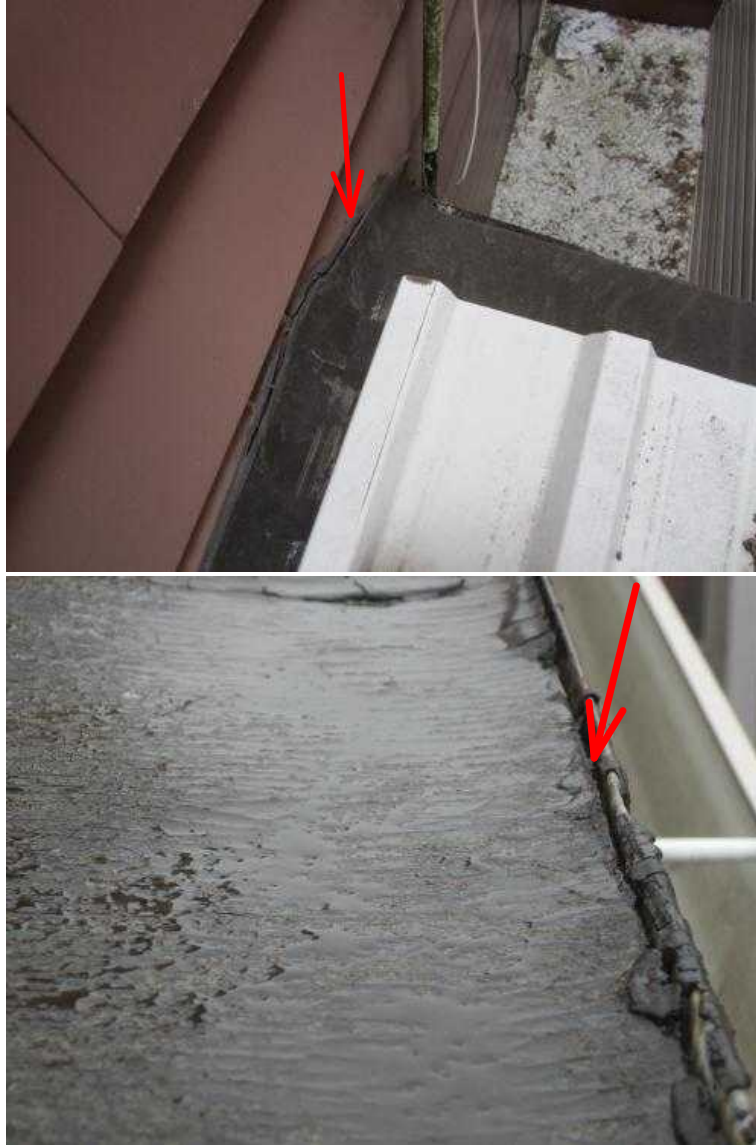
10. Marginal

Wall and Ridge Flashing: Metal, Rolled roof material: **Prone to possible leaks where peeling - professional attention required, Minor separations exist now, Recommend a flashing tuneup in the short term, and then every 4-5 years thereafter. To delay maintenance is an invitation to leaks**

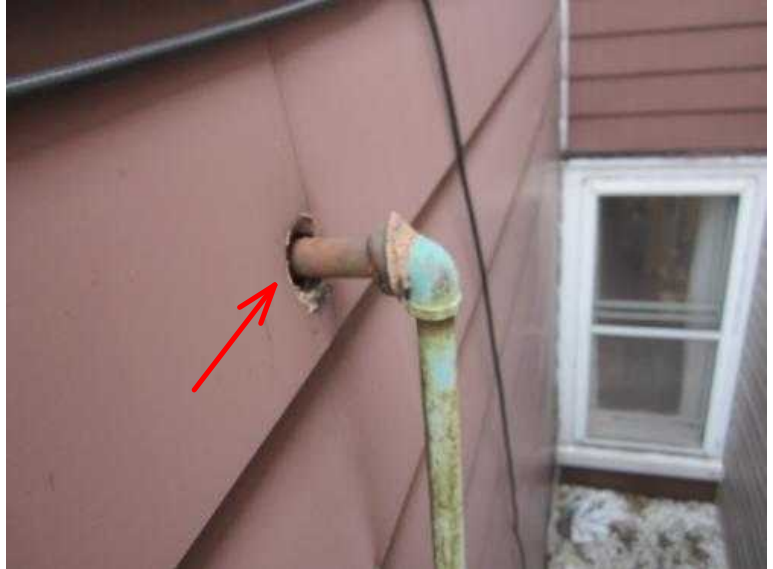
3. Acceptable, Improve **Type:** Aluminum siding:  
Gaps not properly sealed at openings and at window trim - suggest the services of a professional caulking company to improve the weather tightness.

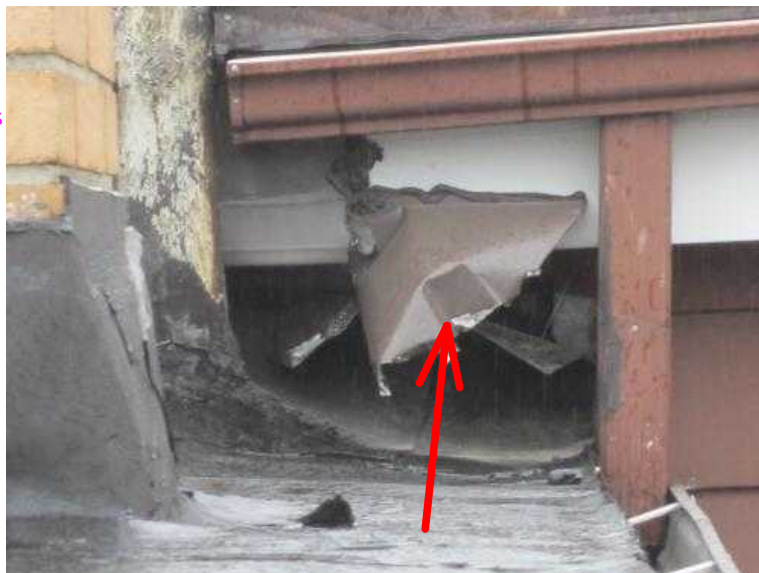
9. Marginal Fascia: Aluminum: Loose at back SE corner (top). Also loosened by an animal at junction between two top flat roofs. Needs repair to maintain animal resistance.

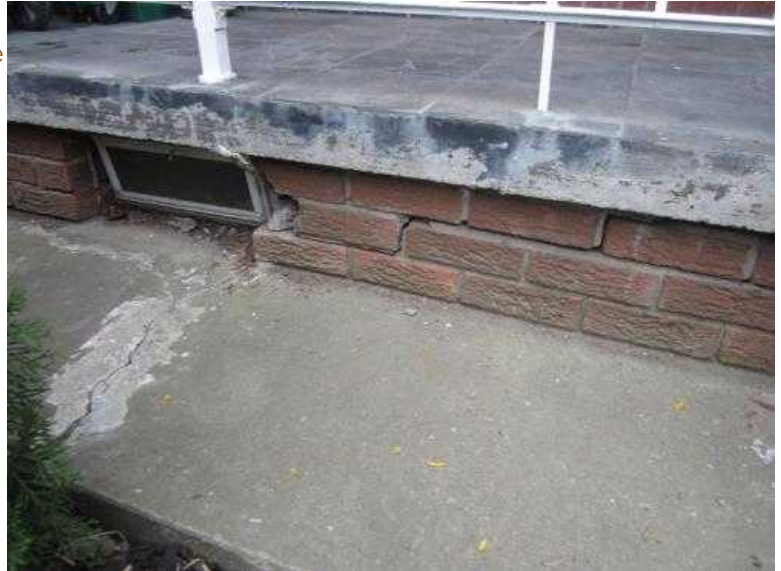
brick needs repair where moisture damaged (freezing in winter is the likely culprit). No urgency to this repair - monitor. Front railing is loose at the base. Wood to soil close contact under porch in known termite area. No evidence of termites on the property on the day of the inspection, but risk factors remain.

They also can be found in cemeteries, along railway tracks, and wood piles. They require close wood to soil contact in order to access the wood they feed on. Since termites dry out when exposed to air, they build sand coloured shelter tubes when they hit the open air. Any found shelter tubes should be broken - if termites are active, they will rebuild them. Any wood to soil close contact should be eliminated. Consider consulting a pest control

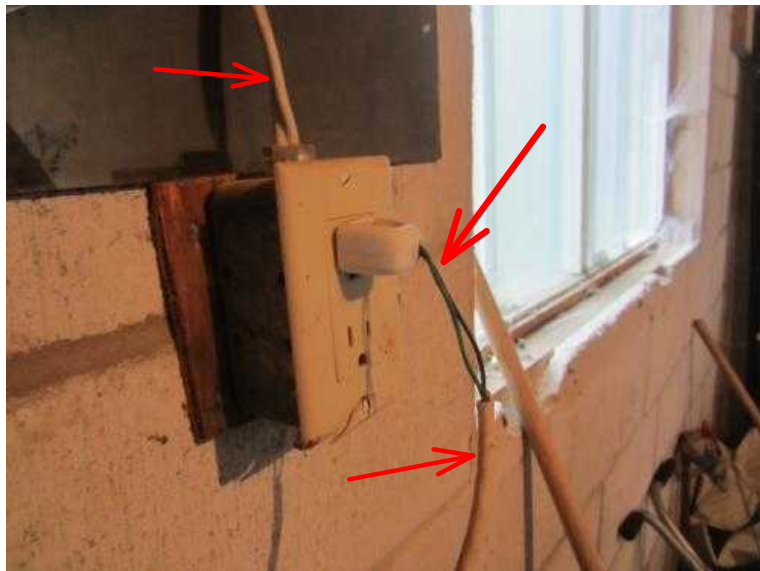
2. Type of Structure: Detached Car Spaces: 1
3. Acceptable Garage Doors: Metal
4. Acceptable Door Operation: Manual
5. Acceptable Exterior Surface: Block
6. Acceptable Roof: Metal
7. Acceptable Roof Structure: Rafter
8. Acceptable, Improve Service Doors: Wood: Improve door security into backyard.
9. Acceptable Floor/Foundation: Concrete
10. Defective Electrical: 15 amp 3 prong receptacles, 110 volt lighting circuits: Use of extension cords, wired on plugs, surface mounted wire - all of these are generally unsafe practices. Non-GFCI circuit -recommend GFCI circuit be installed, A licensed electrician is recommended to evaluate and estimate repairs

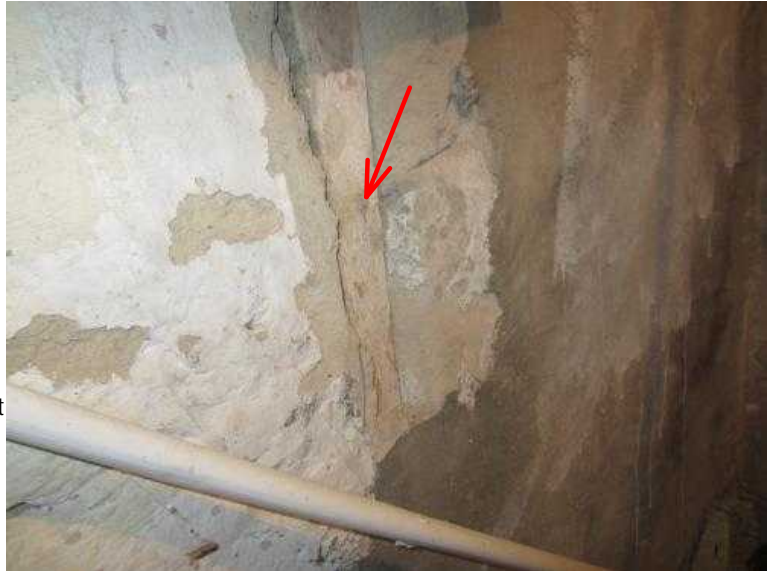
3. Acceptable Foundation: Block, Concrete:  
Older concrete foundations are more porous than newer poured concrete, and typically allow dampness to permeate it. Older foundations have no weeping tile to drain exterior moisture. Block foundations are more impervious to water than brick or stone, but not as good as concrete. Moisture which does enter often does so through the mortar joints. Once moisture does penetrate the block into the cavities within the block, it can take some time before it dries out. Sometimes, a dehumidifier can accelerate this process of drying out if the block is damp. Note that some wood was part of the foundation wall at the front under the electrical panel, and we recommend removal.

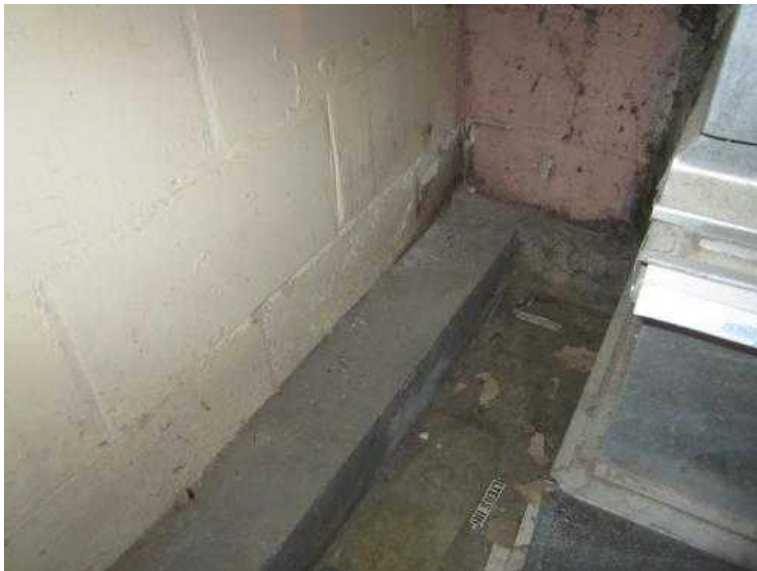
6. Acceptable Floor/Slab: Non-structural concrete, Dug-out basement: Concrete curb indicates that basement was dug out - moisture readings negligible at this location.

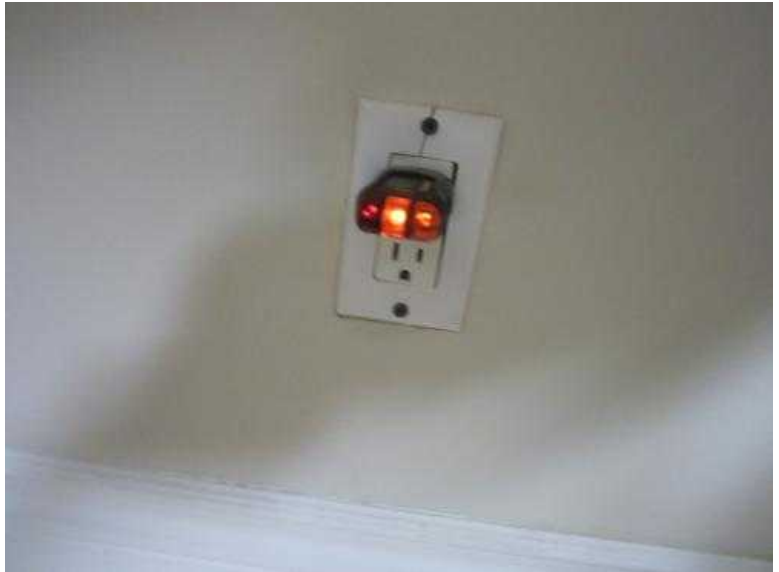
6. Acceptable, Defective Electrical: 15 amp 3 prong receptacles, 110 volt lighting circuits: One ungrounded receptacle needs repair - is the receptacle with a cracked cover plate and wood screws holding in the cover. A licensed electrician is recommended to evaluate and estimate repairs

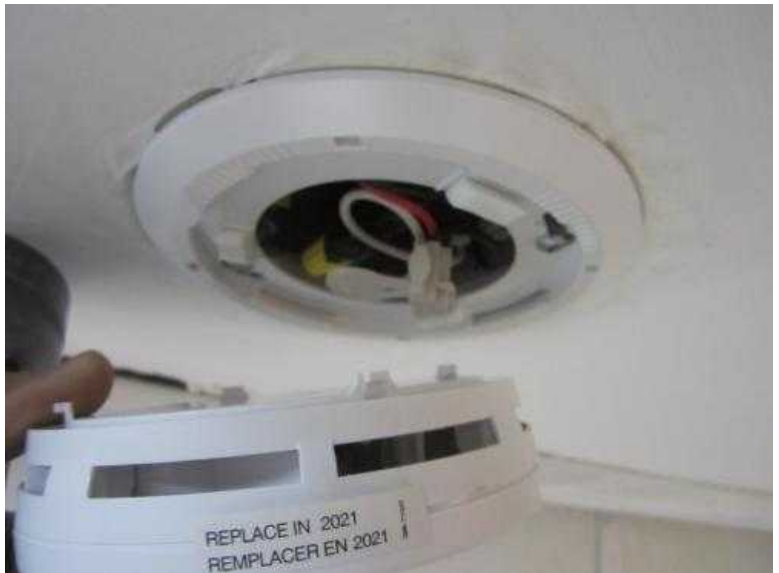
7. Acceptable Smoke Detector: Battery operated: Note that detector COULD be replaced with a hard-wired type, which can activate alarms on other floors if it activates and is interconnected.

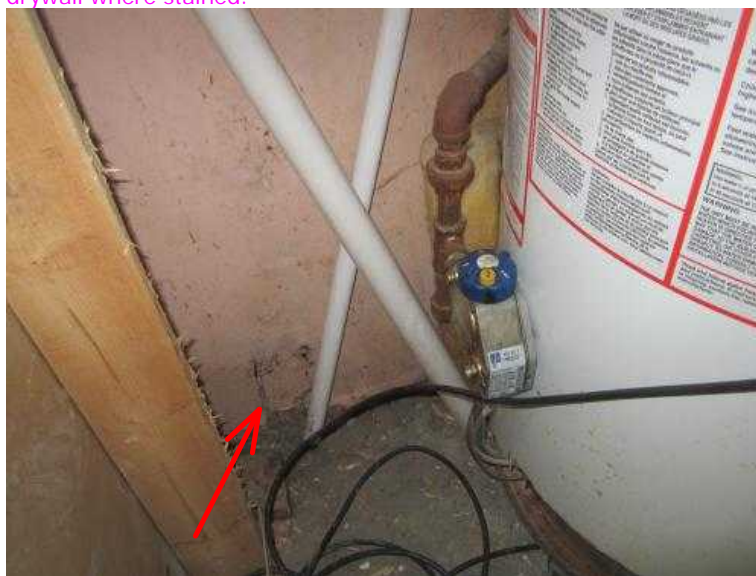
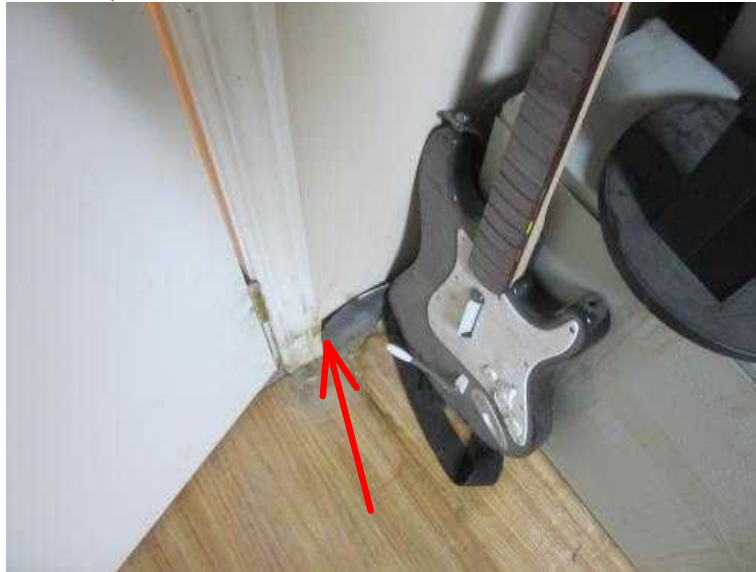
13. Marginal Reading: 26-30%: Highest readings were in wall beside water heater, at back door, near furnace where condensate from air conditioner is discharging. These all could be caused by something other than basement dampness. Moisture readings below 20% are desirable, because mold, mildew and fungi start to grow (especially on wood or cellulose based products) at around the 20% mark. During wet spring conditions, moisture levels can rise. Monitor exterior drainage to ensure that water runs away from foundation. May have to make use of a dehumidifier on a consistent basis. Moisture/humidity readings tend to be higher in the spring - since inspection is a one-day snapshot, you must monitor relevant changes over time. Older homes usually have basements that are more likely to have moisture penetration, so it is even more important to control exterior water management as noted in "Lots and Grounds" and "Roof" sections, Needs further investigation, as conditions are conducive to rot/mould growth. May have to remove some sections of drywall where stained.

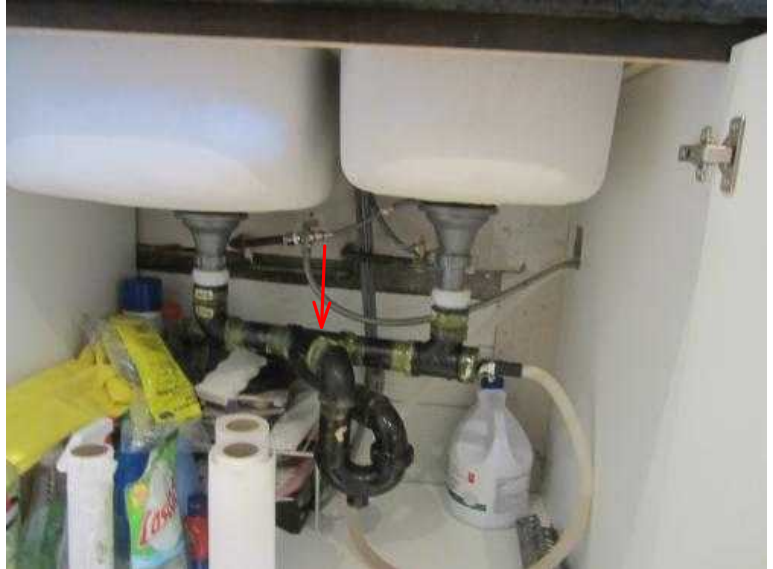
6. Defective

Traps: Trap has cleanout:  
There is an incorrect drain configuration. The sideways Y-fitting restricts the flow of water from the right bowl. This can cause water to come up into the left bowl from the drain (from the dishwasher also). Amateur work - we consider a correctly installed trap and drain to be more reliable. A licensed plumber recommended to replace the trap.

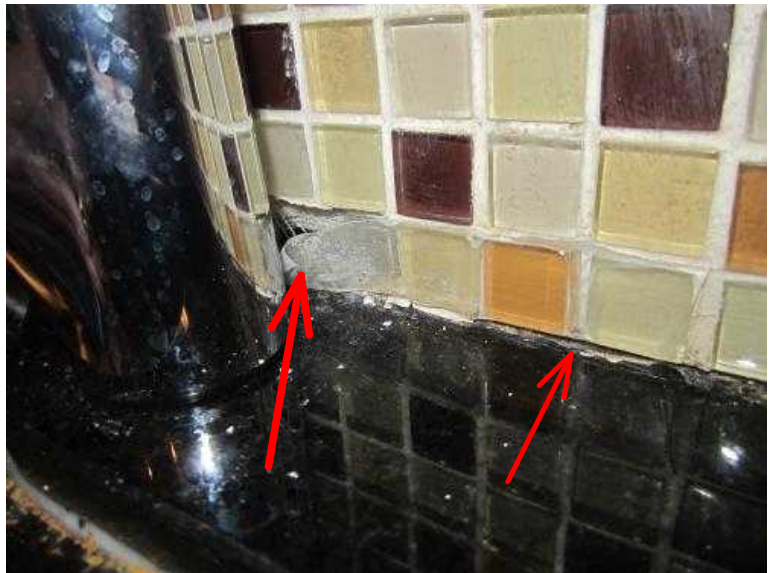
9. Marginal

Walls: Drywall, Tile: 2-3 tiles behind the faucet are loose and need to be re-installed. Caulk at the tile to countertop connection.

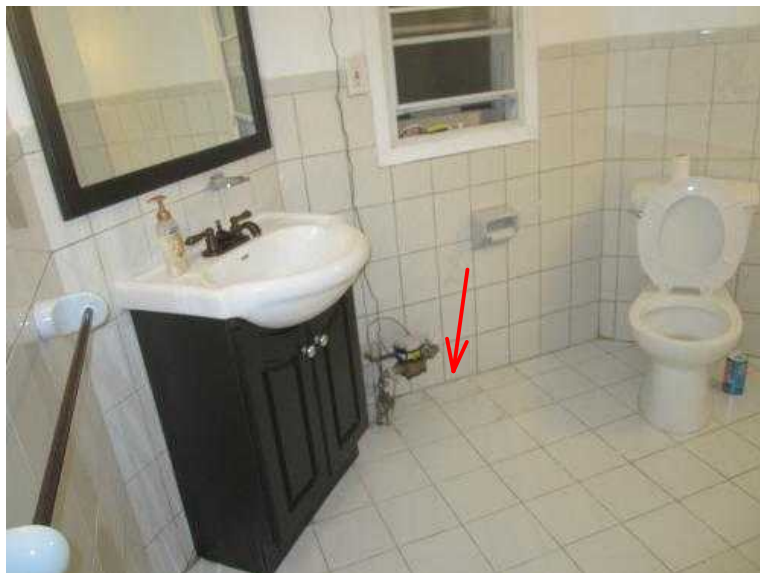
- 2. Acceptable Ceiling: Drywall
- 3. Acceptable Walls: Drywall, Tile
- 4. Acceptable Floor: Ceramic tile: Water stains on floor could be condensation from water pipes. Less likely but possible is water entry from the front window. Monitor.

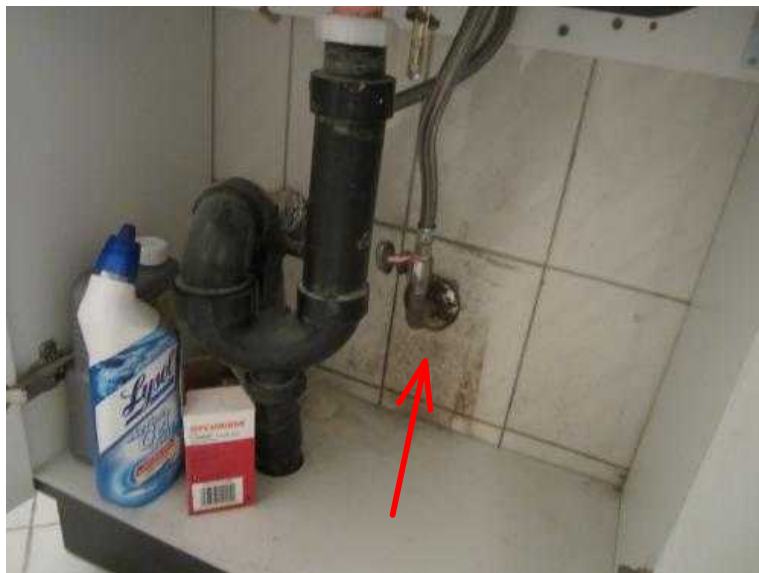
7. Acceptable, Investigate Counter/Cabinet:  
One piece with sink:  
Clean mildew off of tiles  
below sink and monitor.  
Looks like older stains,  
but with no exhaust fan,  
condensation can cause  
unhealthy air.

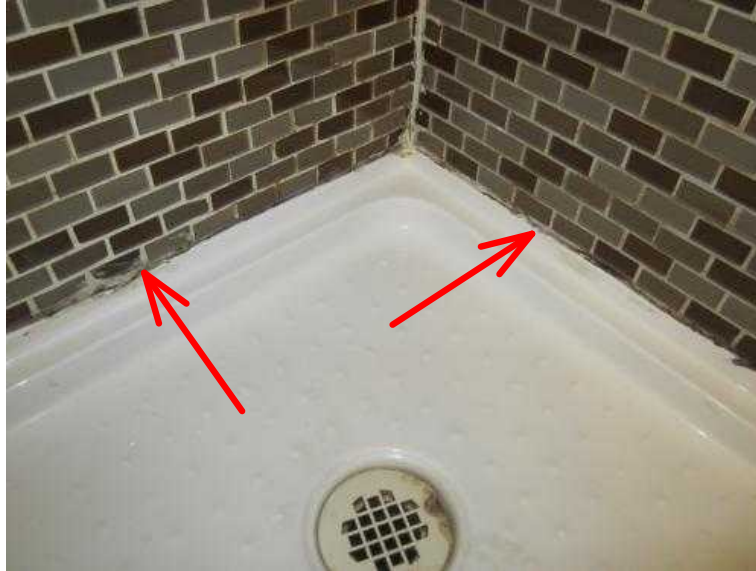
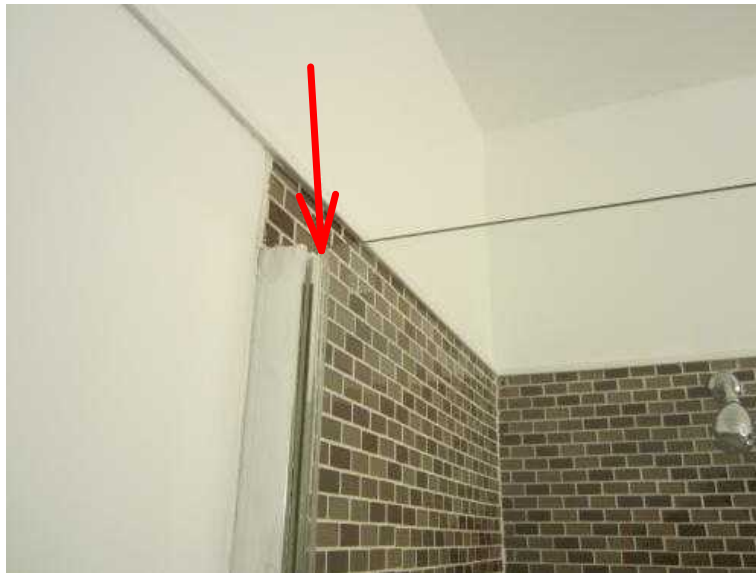
22. Defective

Shower/Surround: Fiberglass pan, Glass surround: **Glass surround is loose and separated - allows moisture to exit the shower - needs repair. Tiles loose at bottom and uncaulked. Suggest repair before use, as may allow moisture leakage into wall and floor structure.**
