Inspection Report

12 Westleigh Crescent
Toronto, ON

Inspection Date 04/26/2013

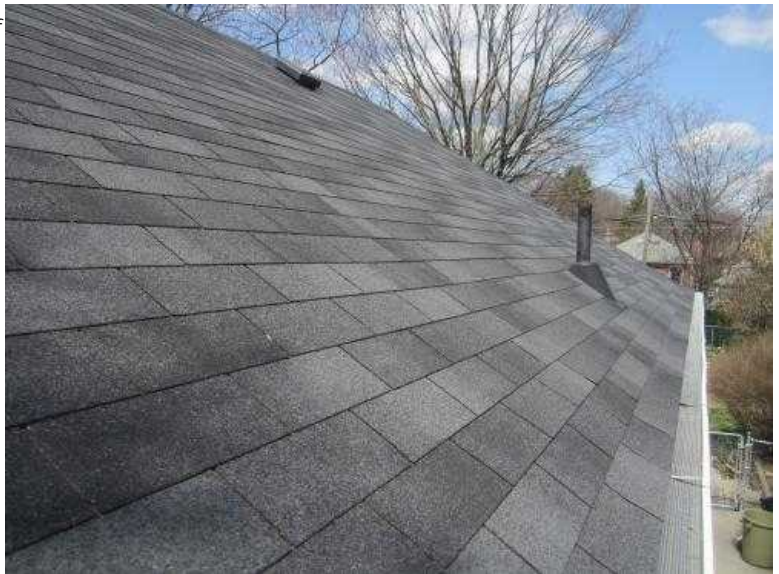
1. Method of Inspection: On roof
2. Acceptable Material: Asphalt shingle: Roof in good condition showing little wear

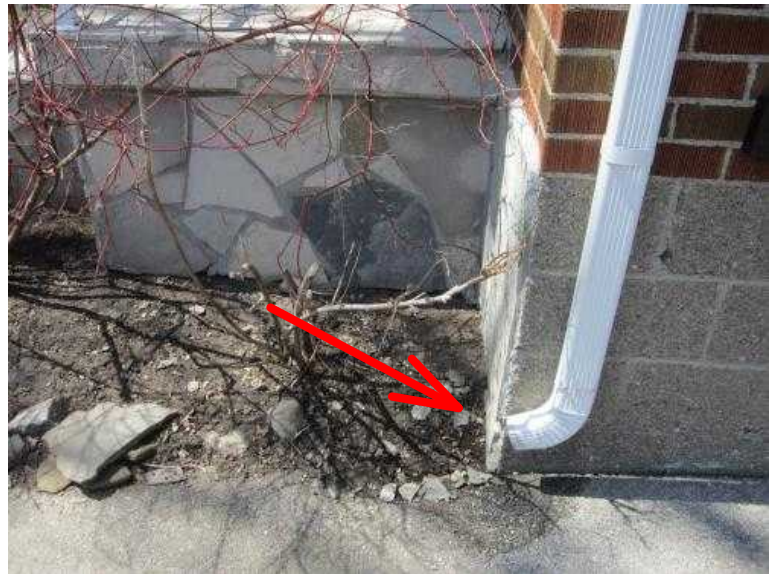
- 7. Acceptable Valleys: Rolled roof material
- 8. Acceptable Plumbing Stacks: Cast Iron
- 9. Acceptable Stack Flashing: Plastic/rubber
- 10. Acceptable Roof Vents: Plastic
- 11. Acceptable Gutters: Aluminum, Screened
- 12. Acceptable Downspouts: Aluminum
- 13. Improve Leader/Extension: Extensions, Missing at driveway: Extend downspouts to move water away from foundation, Monitor the function of the downspout extensions in winter and during heavy rains to confirm that downspouts move water away from foundation, Discharging water against structure at SE corner which could lead to basement dampness if left unchanged, Make angle of extension steeper to discourage icing up in winter

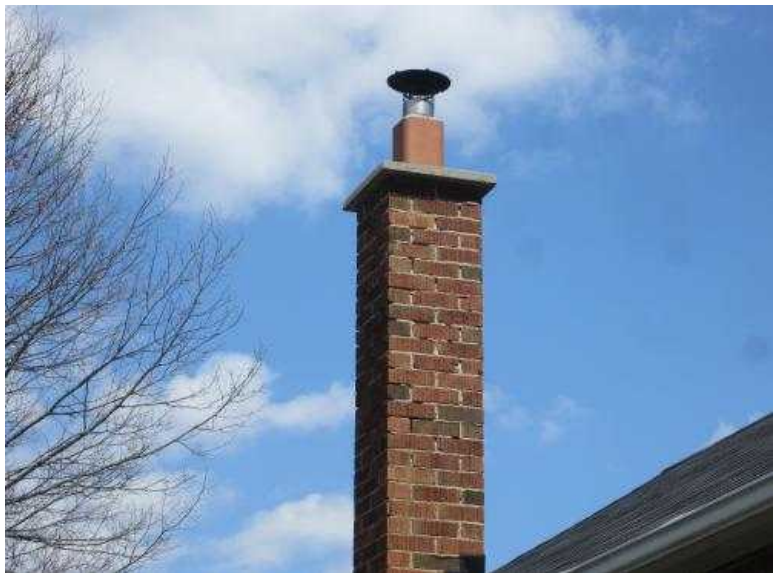
West Chimney

- 14. Acceptable Chimney: Brick: Chimney would benefit from tuck point repairs within the next 5 or so years, although waiting longer could lead to more expensive repairs. For now, consider this a maintenance item that can be deferred a little.

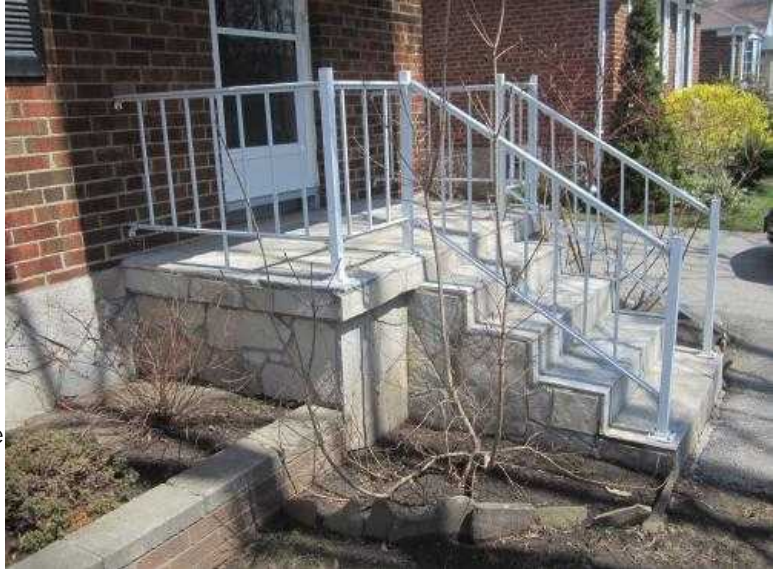
2. Acceptable, Investigate **Porch:** Concrete, Stone tiled: Monitor the stone, as over time the mortar will wear and loosen. Do not use rock salt in winter (ice melter is best). Stair rise is uneven - this is noted primarily because it is a liability/safety issue in that people could trip. Spaces between pickets in the railing are larger than modern standards, but was likely acceptable when the railing was installed.

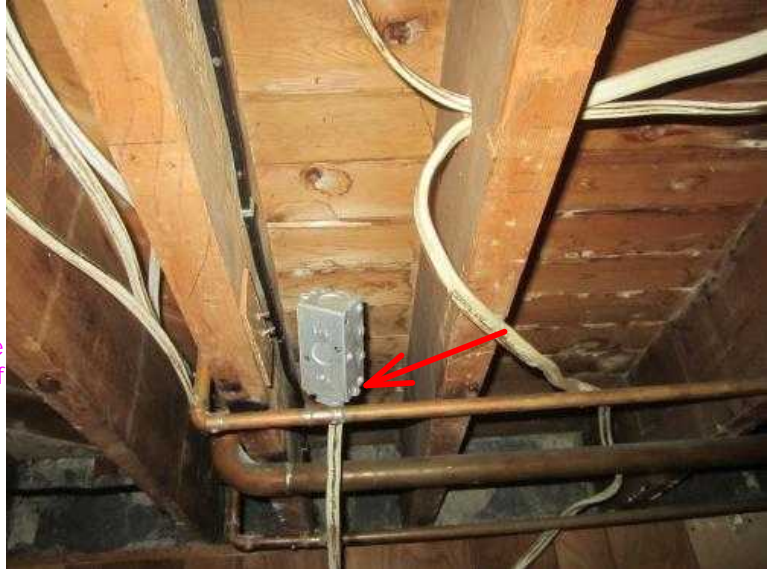
Electrical: 15 amp 3 prong receptacles, 110 volt lighting circuits: Loose hanging switches and receptacles should be firmly affixed to the walls or ceilings. Uncovered boxes should be covered. Relatively minor issues, but because they are hanging on the copper pipes, suggest making this somewhat of a priority. Also, the light switch at the top of the stairs is not a 3-way switch, so the basement lights cannot be shut off from the basement. Consider improving if the basement will be used as a finished space.

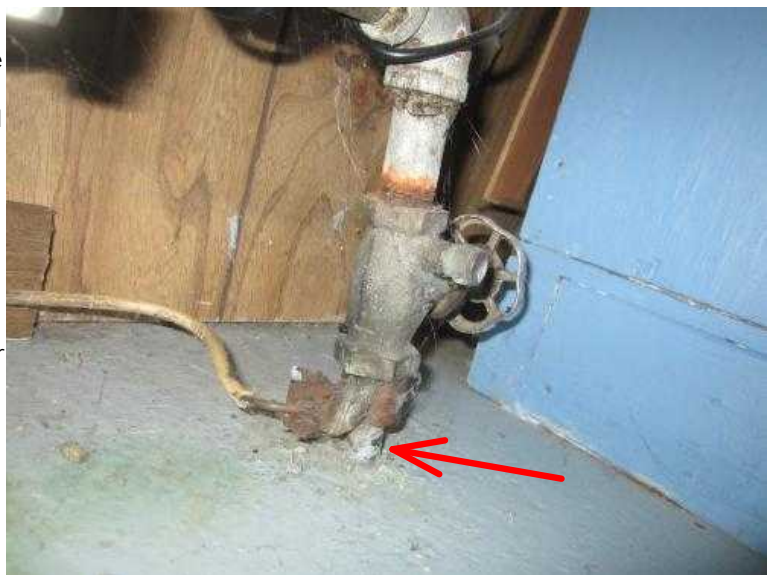
2. Acceptable Service Line: Indeterminable:
A very small section of supply pipe is visible but it is restricted beneath a cabinet. It is suspected to be copper, but there is a chance it is galvanized, which restricts water flow more than copper does over time. Having said that, the water pressure in the shower does not drop significantly when water flows elsewhere, so this does not appear to be an issue either way. This information is noted strictly for informational completeness.

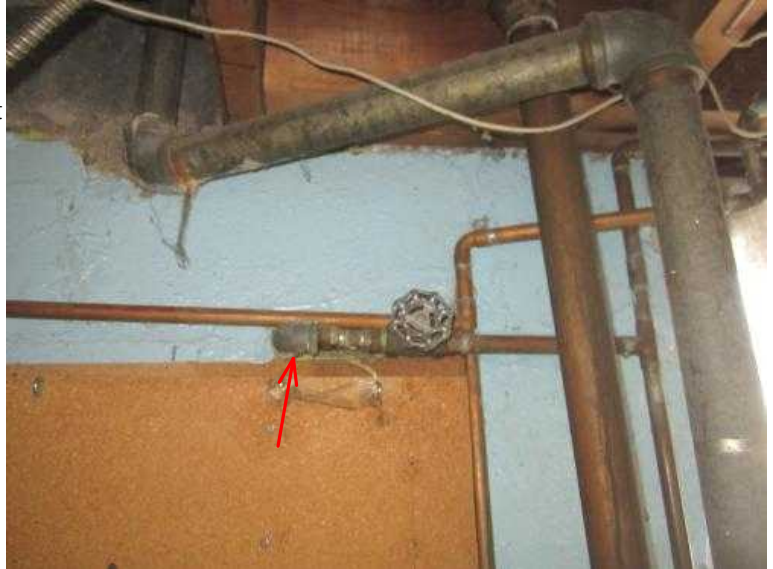
4. Acceptable **Water Lines:** Copper, upgraded from galvanized: Two galvanized elbows can restrict water pressure - one is at the hose bib at the east wall basement and one is at the water meter. Since these are cold water flow areas of piping, they are low risk and also very common in older homes. Monitor them for any signs of leaks, as you would any fittings in the copper section.

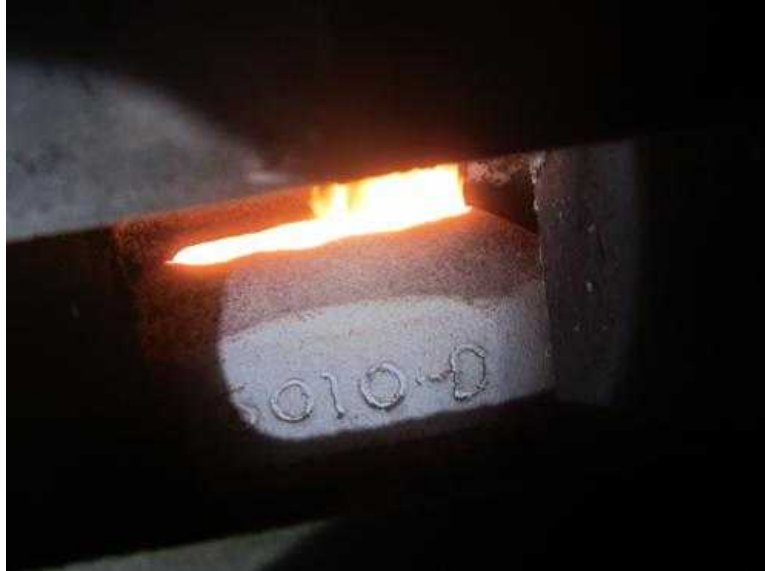
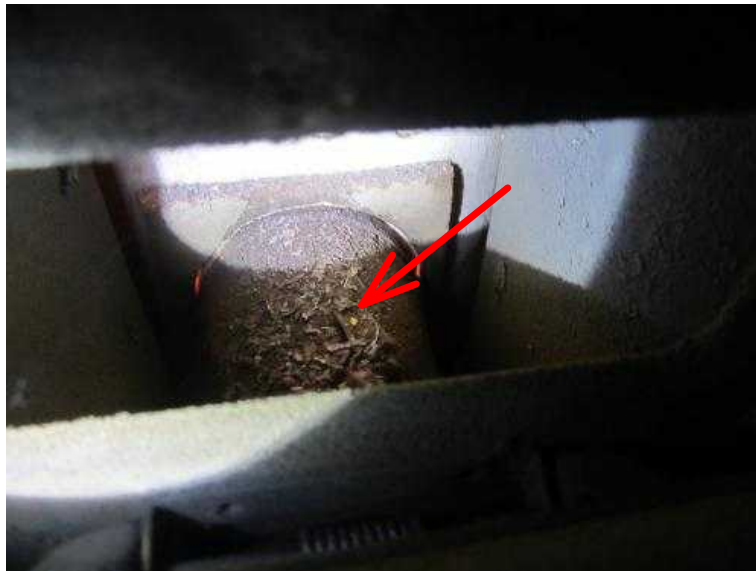
7. Investigate Oil Burner Box: Typically restricted: No cracks visible in exposed area - appears to be newer. The tube from the nozzle to the oil burner box is rusted and perforated and may need replacement. Have evaluated by a licensed HVAC contractor as soon as is feasible.

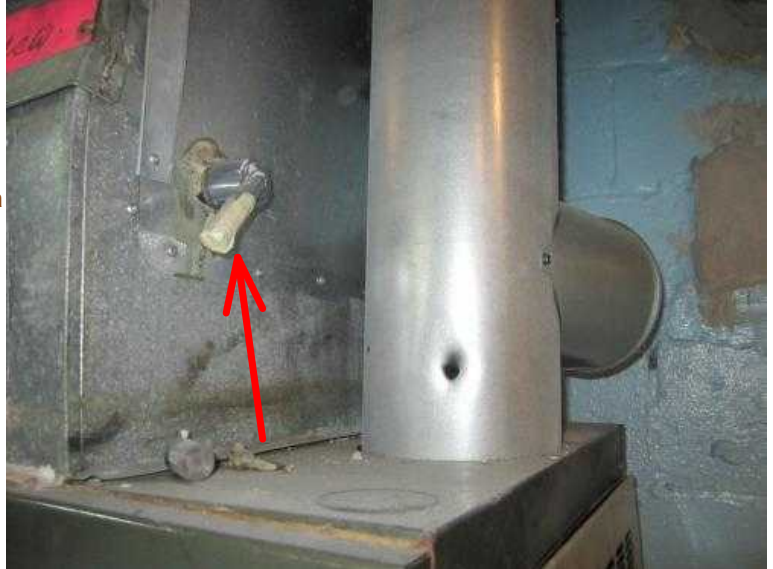
Condensate Removal: No tube: The fact that the condensate drain has no tube and is taped off leads one to question whether the air conditioner is functional. Consider it otherwise until confirmed as operational by a heating contractor.

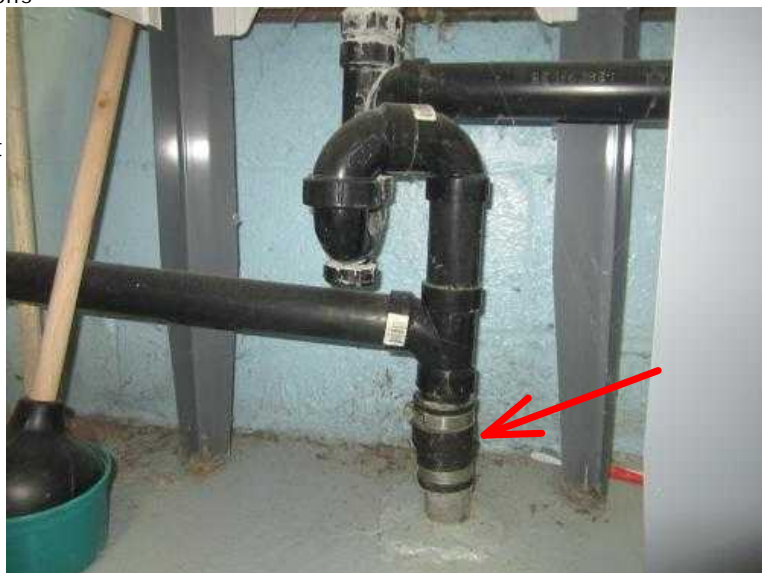
plastic: We know this is nit-picking, but we consider a correctly configured drain to be ideal, and we are required to point out even minor items. The trap is connected with rubber fittings, which are considered less reliable than hard, permanent connections. They will likely work for years without leaking, so simply keep an eye on them.
