Inspection Report

71 Braeburn Drive
Markham, ON

Inspection Date 05/06/2013

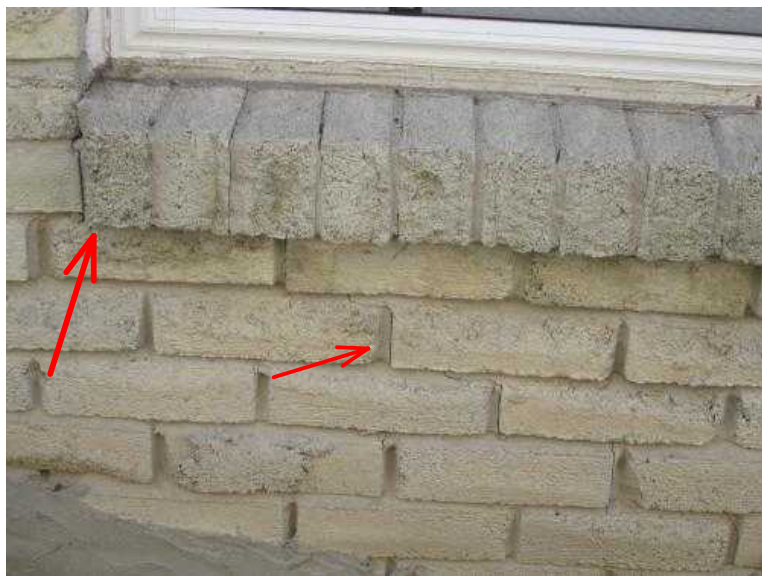
2. Acceptable Type: Brick veneer: Minor typical cracking emanating from window sills - monitor and see notes on sills under Windows (below)

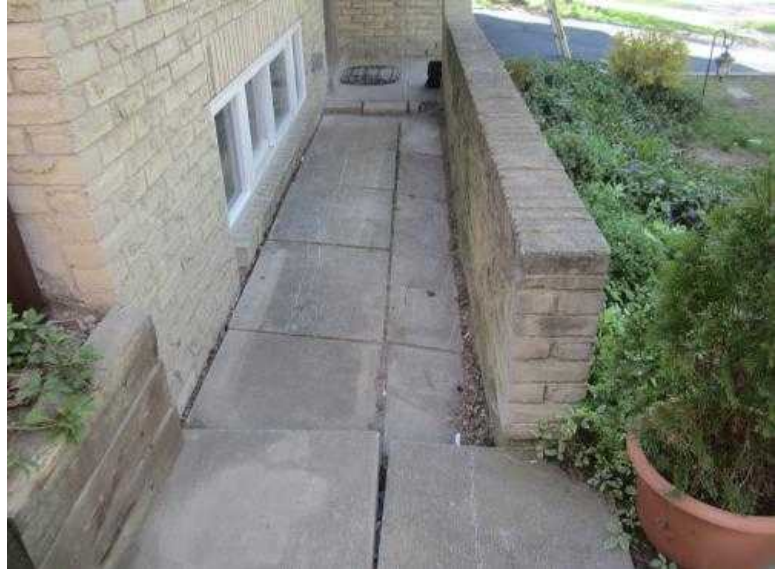
Porch: Stone tiled, Patio slabs: Area to the left of the porch has low lying area that should be raised to prevent moisture seepage into soil and basement., or potential damage to the brick wall. Note there are no signs of water seepage or damage now, this is a preventative measure at this time.

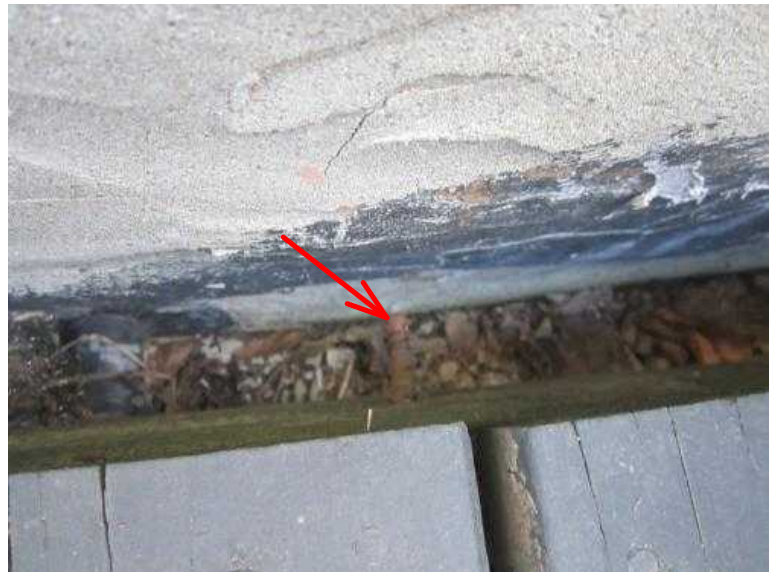
Deck: Wood: There is some shifting along the side deck, away from the wall. The anchorage points of the posts cannot be confirmed as being concrete and below the frost line without excavation. Given the age of the deck structure and the grading, it is suggested that further investigation be undertaken to make repairs as needed.

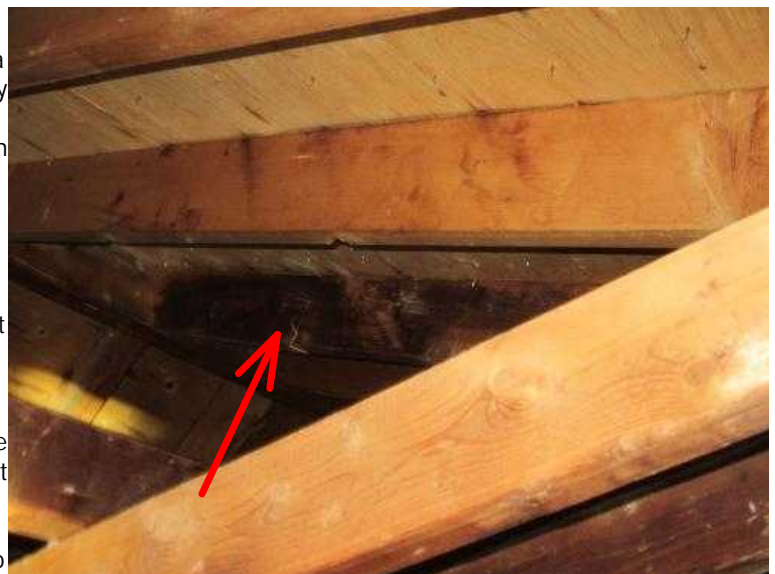
- 3. Acceptable Unable to Inspect: 40%
- 4. Acceptable Roof Framing: Rafter
- 5. Acceptable Sheathing: Plywood
- 6. Acceptable, Investigate Ventilation: Roof vents: Ventilation was a problem, as evidenced by stains on wood in attic, but appears to have been corrected (turbine vents have been added). Watch for ice or frost on the nails in the attic in the winter. Cannot determine if soffit vents are blocked or unblocked by insulation. They should not be restricted, allowing intake air to enter the attic. Best configuration is a ridge vent with unobstructed soffit intake vents and no other vents.

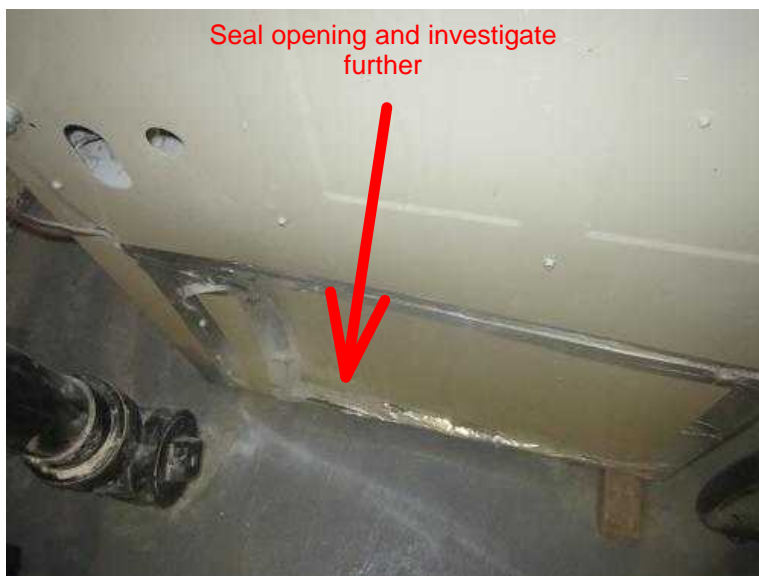
1. Investigate Heating System Operation:
Appears functional: Consult a heating technician to develop an annual maintenance program to maximize the life of the unit. Average life span of a furnace is 20-25 years. Cleaning recommended. No gas-fitters tag so cannot confirm installed by licensed gas fitter. Ensure that the previously sealed opening in the side of the furnace, which has been sealed with metallic tape, is sound and that it does not affect the viability of the furnace. Have evaluated by an HVAC specialist.

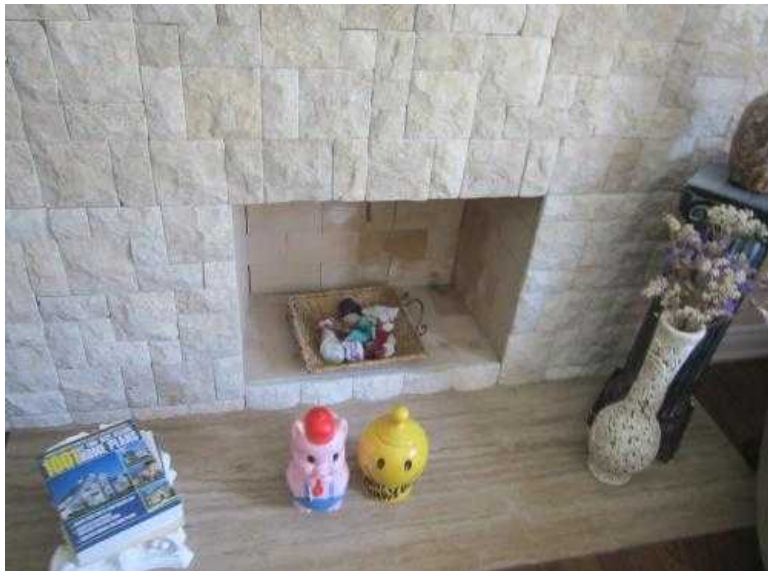
2. Acceptable Fireplace Construction:
Brick: Unit has not been used

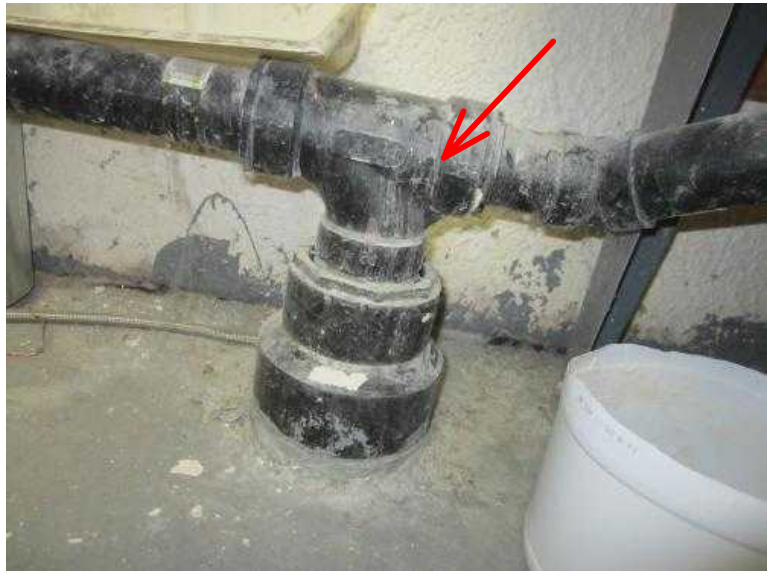
1. Acceptable Laundry Tub: PVC
2. Acceptable Laundry Tub Faucet: No shutoffs
3. Acceptable Laundry Tub Drain: ABS plastic: Noted for completeness but not anticipated to cause any issues: the sideways T fitting to the left of the laundry tub should be oriented vertically - can restrict water flow from the right side (laundry tub)

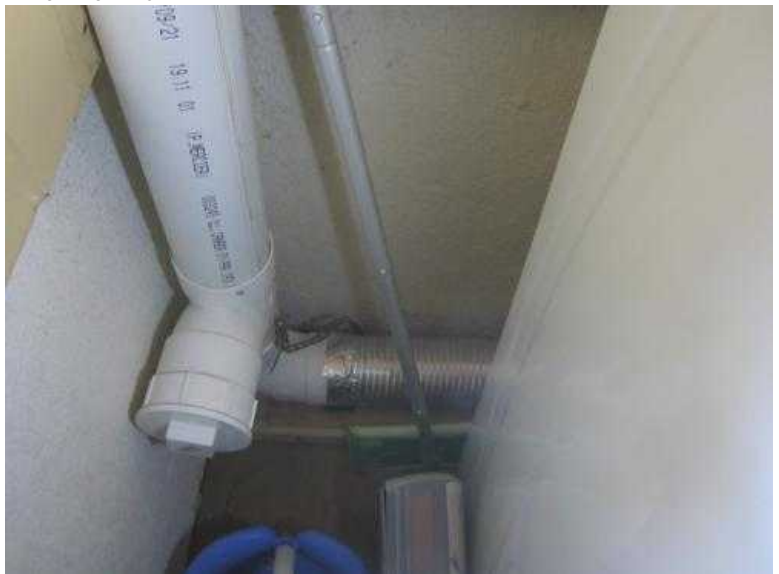
4. Acceptable Washer Hose Bib: Ball valves
5. Acceptable Washer and Dryer Electrical: 110-220 VAC
6. Acceptable Dryer Vent: Metal flex, Plastic: Clean annually.

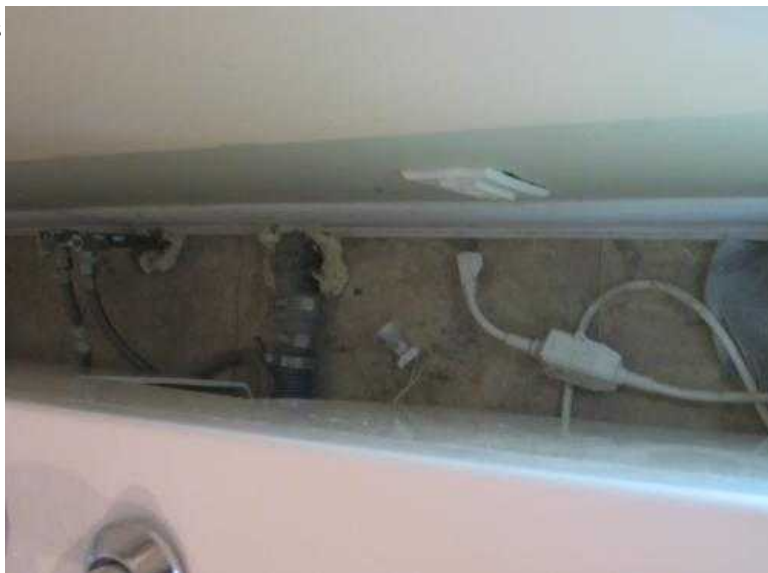
34. Investigate Spa Tub/Surround: Fiberglass tub, Water jets: Unit unplugged and plug should not be accessible from tub as it is now. Hot water faucet not connected. Installations should be completed safely before use. Every week under normal use, recommend adding spa conditioner to the water and running as directed to clean out water within hoses and motor.

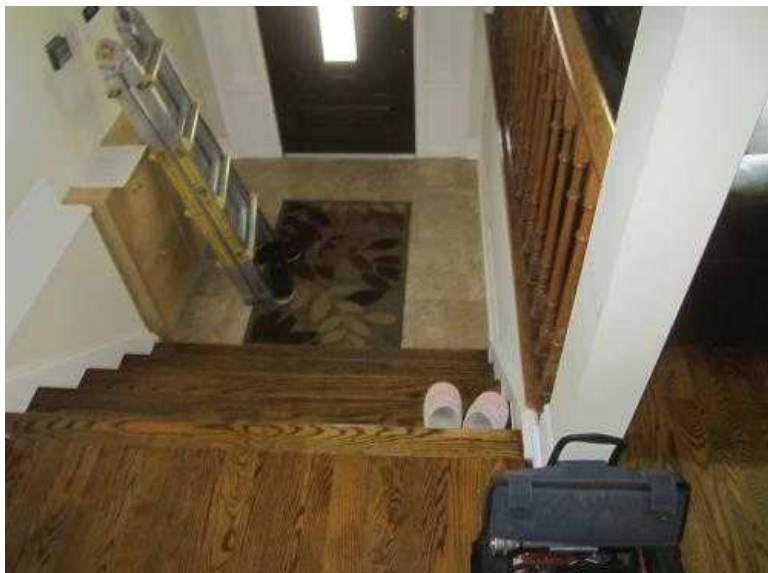
3. Defective Handrails No railing: **Liability issue and safety hazard that should be addressed**
