Blueprint Building Inspections  
60 Symons Street  
Toronto, ON M8V 1T9

# Inspection Report

43 Denison Avenue  
Toronto, ON

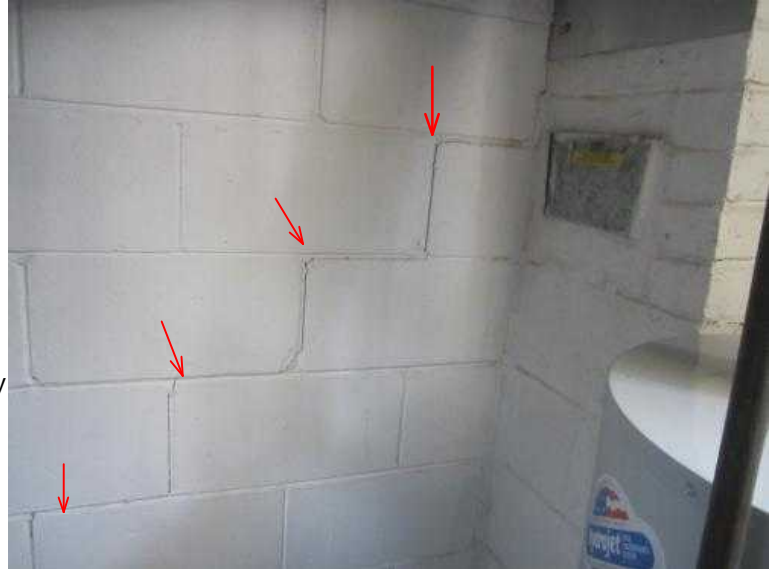
### 4. Acceptable, Investigate Differential

**Movement:** Stair step cracks, No movement or displacement noted: Not an uncommon issue. Does not have the appearance of a significant problem and may never need repair. However, cracks will require monitoring, Suggest tuckpointing first. There is a possibility that the cracks were caused by settlement of the foundation, but over 40 years, there has not been a lot of movement. If they show changes after tuckpointing, then further investigation will be required.
