Blueprint Building Inspections  
60 Symons Street  
Toronto, ON M8V 1T9

# Inspection Report

18 Kilbarry Road  
Toronto, ON

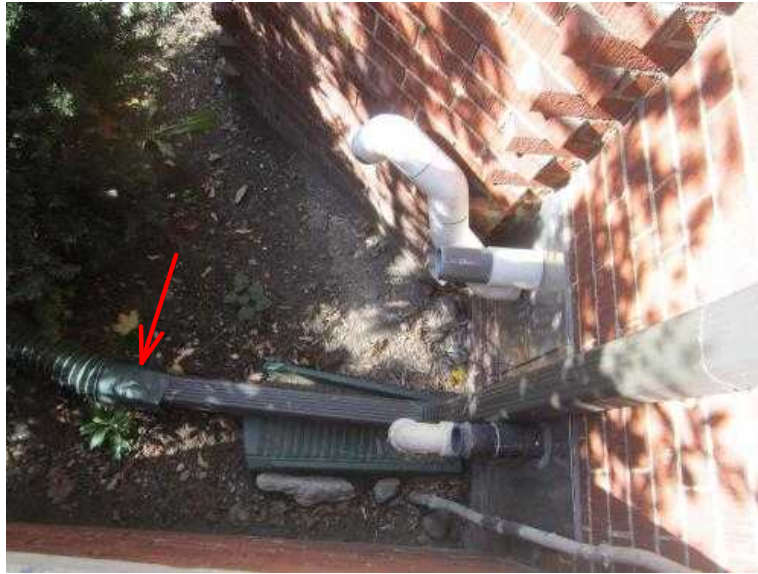
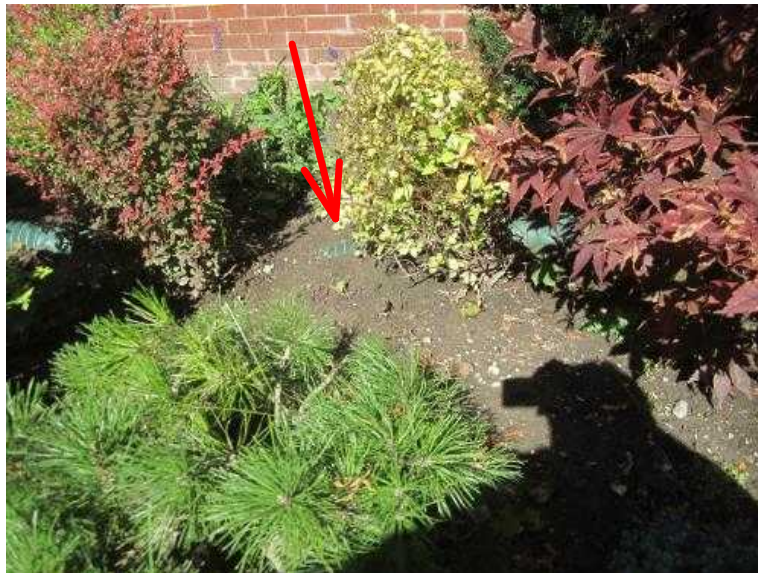
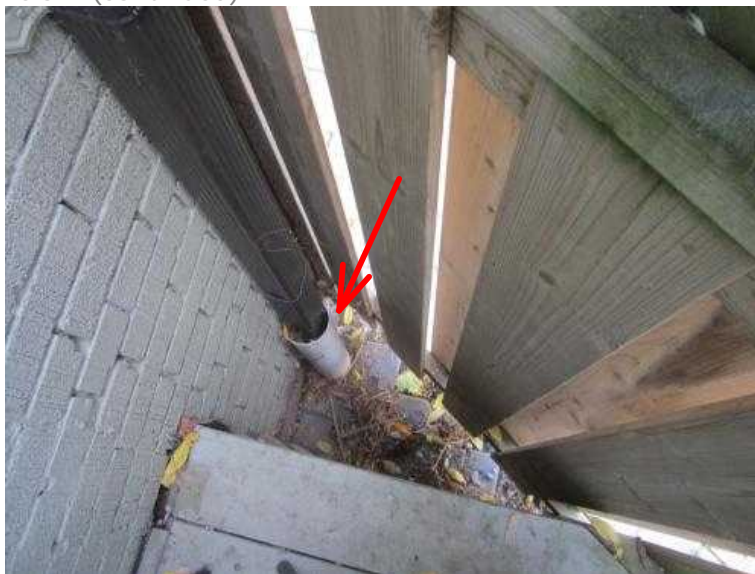
Leader/Extension: (continued)

Leader/Extension: Extensions, Underground pipes: The front downspouts are discharging into a plastic extension that eventually runs upwards against gravity. As a result water is leaking into the soil against the front of the house and some dampness is in evidence along the front wall of the basement. Correct this situation to prevent any or any further issues with the basement front wall. See Structure and Basement notes for more information on this topic.

Extend downspouts to move water away from foundation, Monitor the function of the downspout extensions in winter and during heavy rains to confirm that downspouts move water away from foundation, Make angle of extension steeper to discourage icing up in winter.

In the City of Toronto, it is contrary to bylaws to allow roof drainage to discharge into underground pipe and then into the sewer system. Recommend disconnecting downspouts from underground drains to discharge onto soil 3-6 feet away from foundation. When roof water runs into underground pipes, the possibility exists for water to spill through any openings into surrounding soil. This water puts hydrostatic pressure on the foundation and can enter the basement. If the downspout drainage appears to be running into the soil, then they should be disconnected from the underground pipes and directed 3-6 feet away from the foundation.

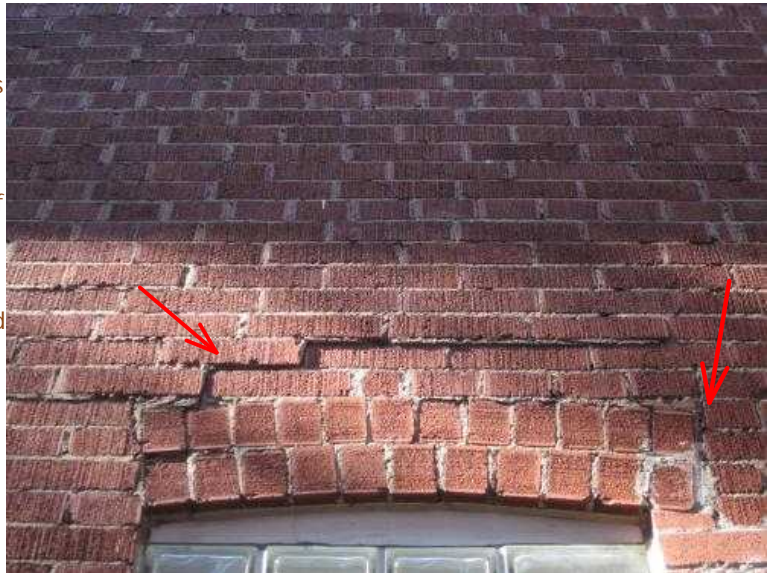
2. Acceptable, Improve Type: Brick: Brick and structure appears sound at this time within the confines of this one-day inspection, but minor tuck point mortar repairs are suggested over the front porch and some of the window arches. There has been a fair amount of change to the brickwork, with bricked in windows and other repairs. Some of the bricks have shifted outside of the vertical plane so that they stick out, but have been re-secured by the tuckpointing repairs. They do not move when tapped so are not suspect for ongoing problems. Nonetheless, any time mortar repairs have been undertaken, they should be monitored for any future movement/change. Consider having evaluated further by a masonry specialist.

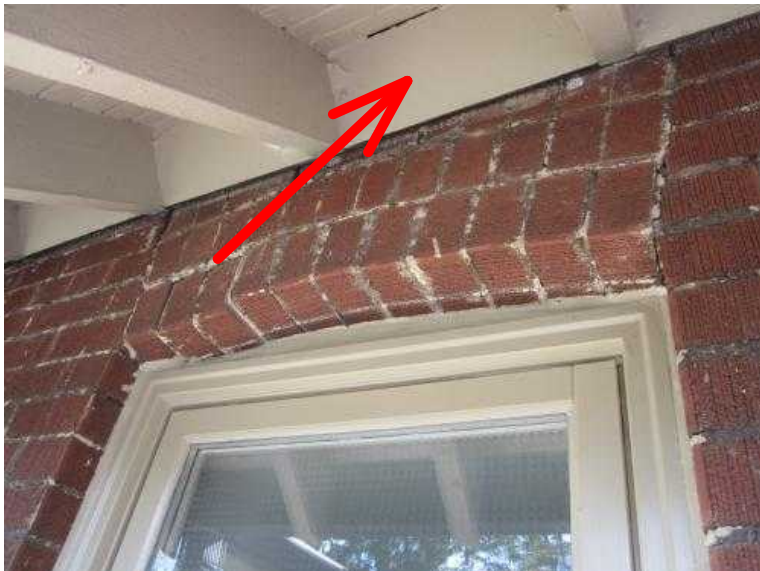
**Soffits: Open framing:** Ideally, soffits have unblocked soffit vents that allow air flow into the attic space from below, aiding attic ventilation. These would have to be installed in the vertical plane of the wall above the brick. From within attic, the vents would have to be uncovered where blocked by insulation.

Also, there is some rot evidence at the rear of the house, specifically at the bottom edge of the roof boards that may warrant some board replacement when re-roofing.

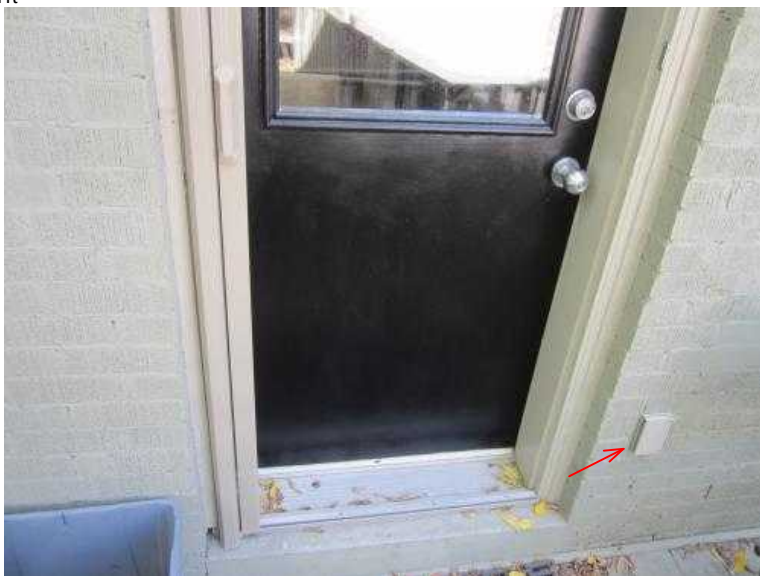
**VAC GFCI:** Inoperative GFCI protection at time of inspection - suggest replacement of receptacle, Test the GFCI "test" and "reset" buttons every month or two to ensure they are able to provide the safety protection they are designed for.

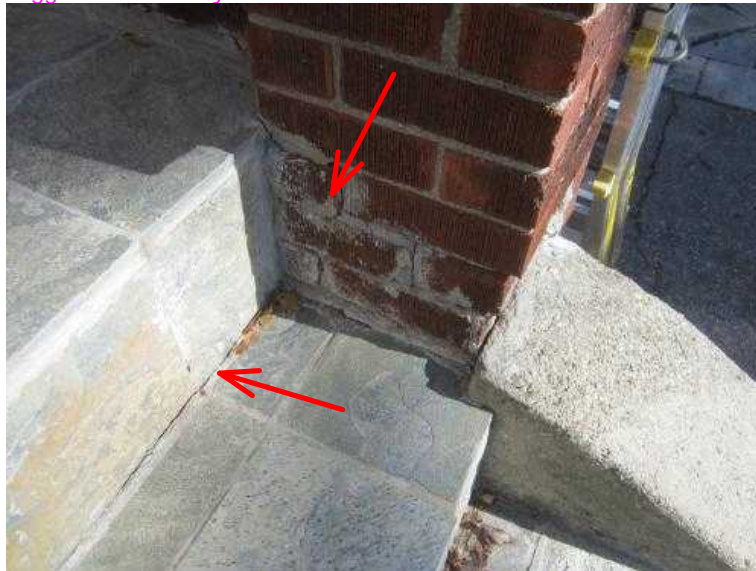
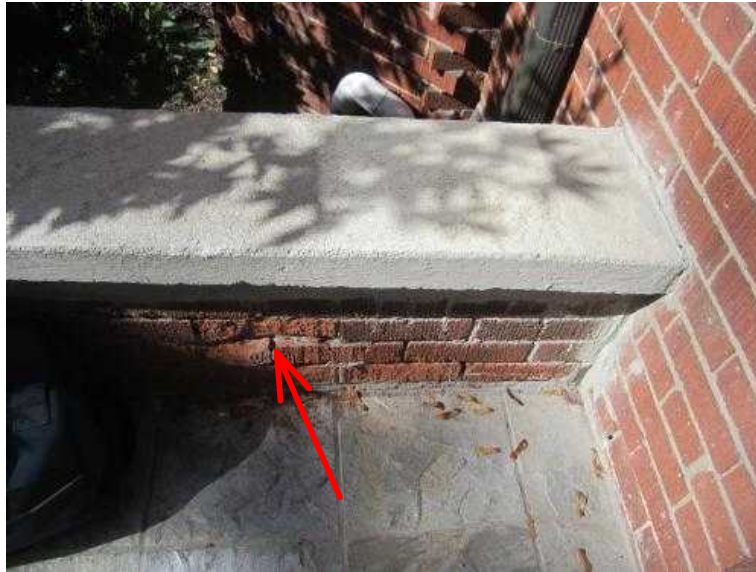
1. Restrictions: Vegetation
2. Acceptable Driveway: Asphalt, Paving stone
3. Marginal Steps: Concrete, Stone tiled: Stairs are separate from the porch and as a result, there is some shifting relative to each other. This sometimes happens if the stairs are not anchored deeply (ie - below the frost line), or if the soil is saturated with water, which freezes and lifts the stairs. Also note that exterior tiles are prone to loosening (two tiles are off at the bottom riser), Missing handrails (safety, liability)
4. Marginal Porch: Concrete, Brick, Stone tiled: Brick spalling and mortar cracking - monitor, Missing guardrails - suggested for safety's sake

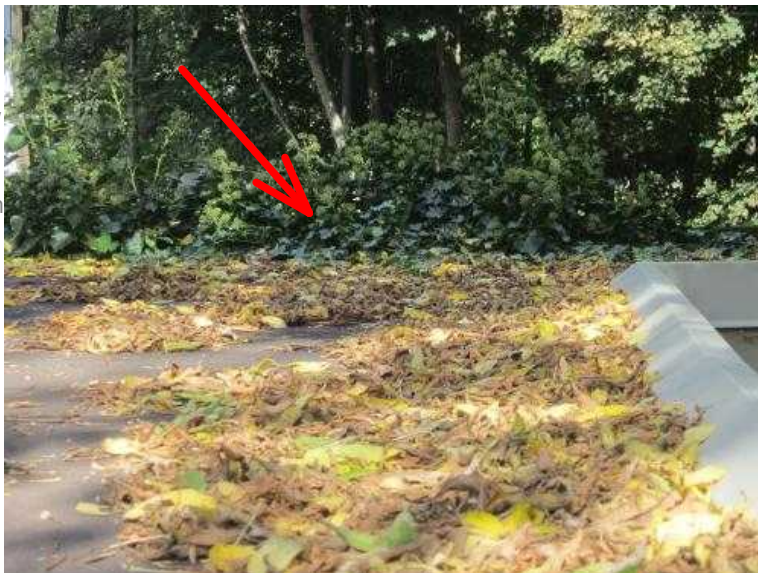
There are moisture stains in the garage roof, visible from below. The roof surface appears relatively new and in good condition, so suspect this is from a previous leak. However, there is vegetation which is growing onto the roof at the rear, and this can cause the roof to leak in the future. Keep all vines well trimmed and away from the roof and any wood surfaces.

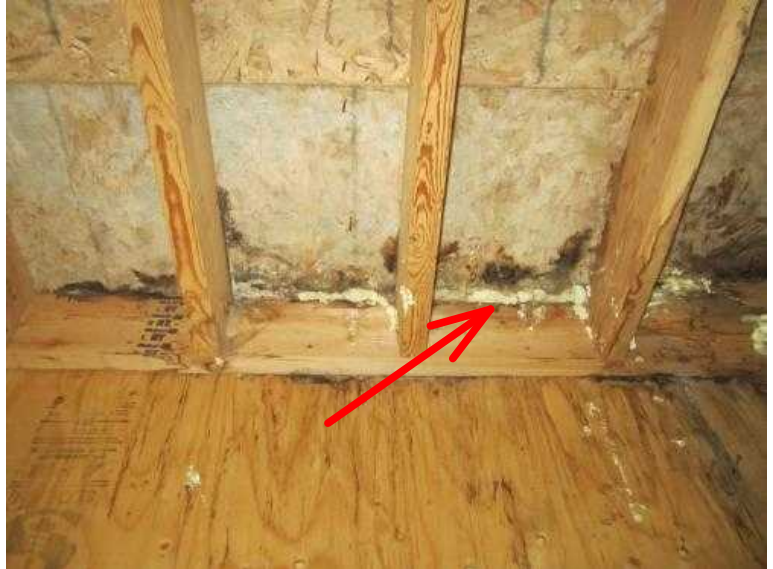
7. Investigate Roof Structure: Wood joists, Oriented strand board (OSB) decking: Water damage in roof near the rear but appears sound enough to hold nails. Monitor for any changes, and consider evaluation by a professional contractor to determine best course of action (it may be best to do nothing).

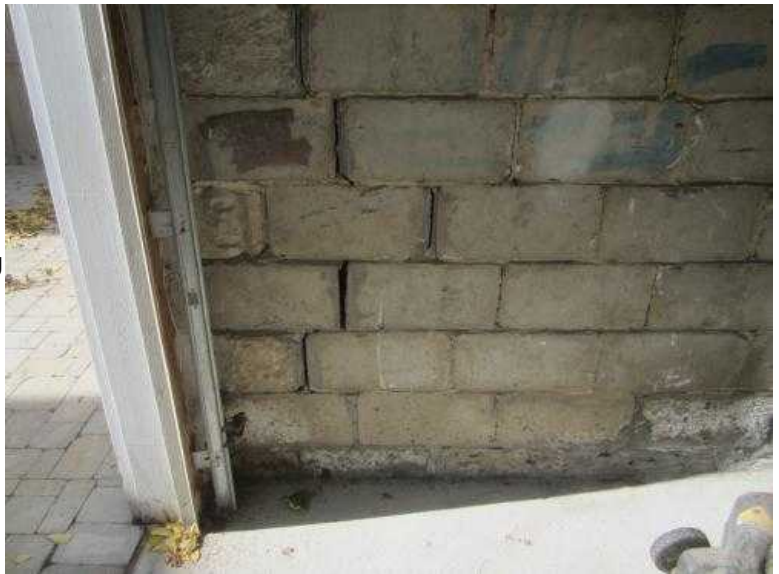
8. Acceptable, Investigate Walls: Plywood, Block: There are cracks in the older block walls, but these are not significant given the age and the fact that this is a garage. Monitor for now, or repair by a minimum of tuckpointing the mortar gaps at your own pace/discretion. If after tuckpointing, the mortar cracks again, then the garage wall will need further investigation.

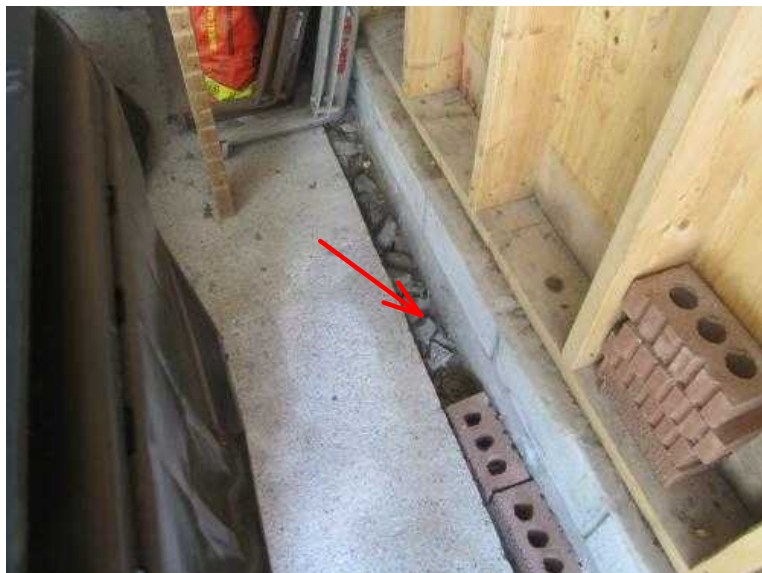
Concrete: There is a gap at the eastern edge of the garage slab, likely caused by rebuilding of the wall that has been done in the past. Feel free to fill this gap with concrete.

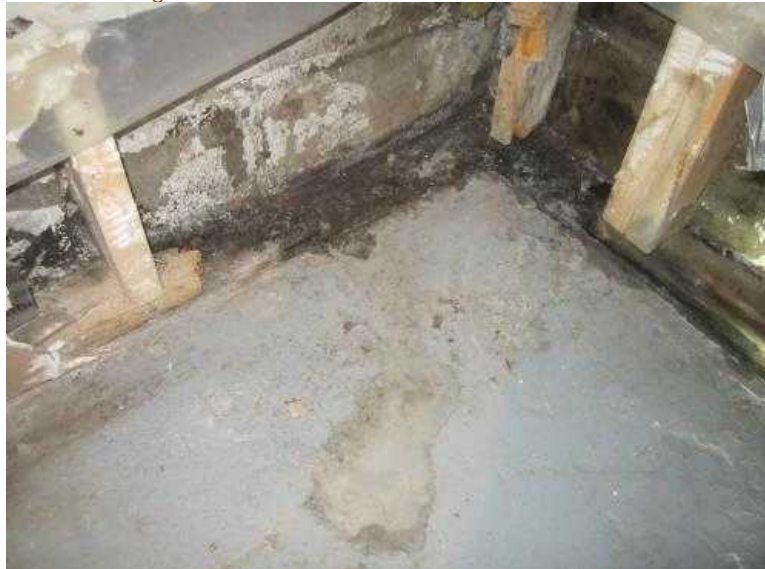
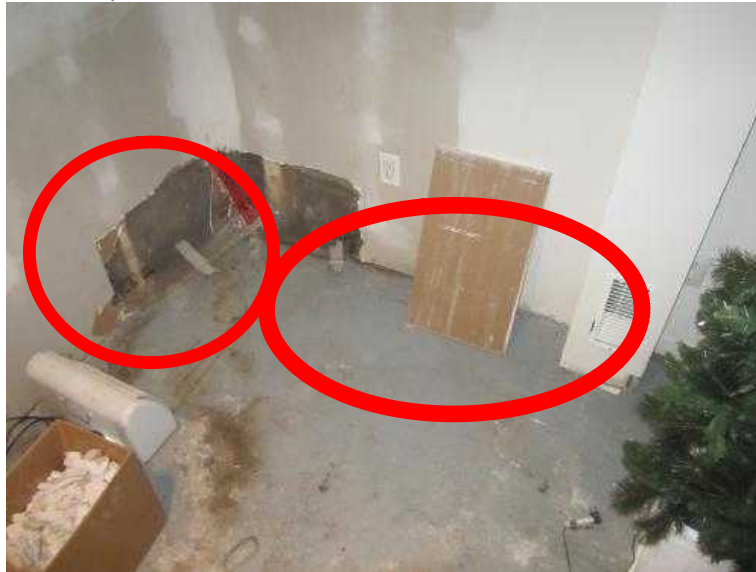
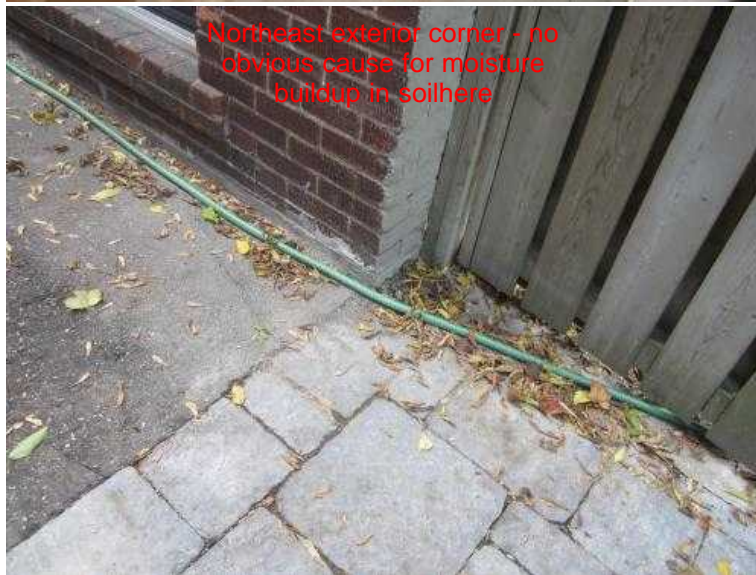
NE corner Invasive Testing(Moisture Probe)

14. Investigate Reading: 24-90%: Moisture is within 3-4 feet of corner but no obvious cause at exterior. Moisture accumulation could be caused by downspout that discharges into ground in the NW corner, or by overflowing eavestroughs. If those exterior repairs don't solve the problem, then a more comprehensive and exhaustive approach will be required. Moisture readings below 20% are desirable, because mold, mildew and fungi start to grow (especially on wood or cellulose based products) at around the 20% mark. During wet spring conditions, moisture levels can rise. Monitor exterior drainage to ensure that water runs away from foundation. Older homes usually have basements that are more likely to have moisture penetration, so it is even more important to control exterior water management as noted in "Lots and Grounds" and "Roof" sections. Moisture/humidity readings tend to be higher in the spring - since inspection is a one-day snapshot, you must monitor relevant changes over time.

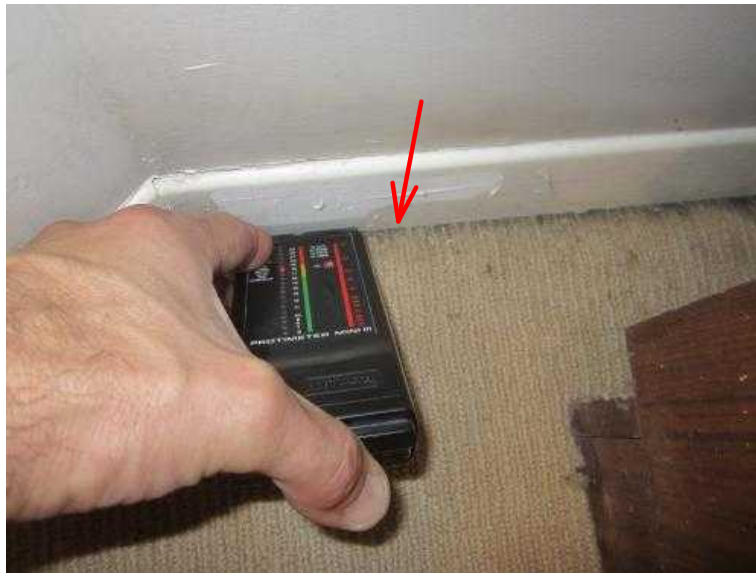
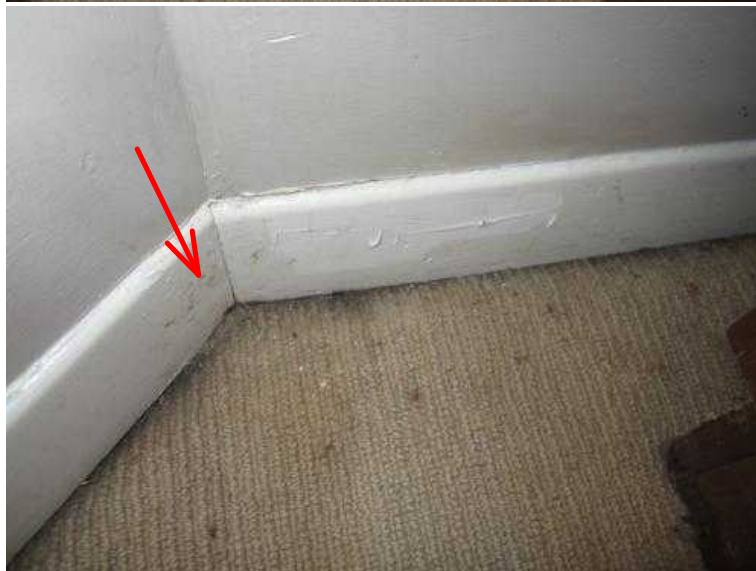
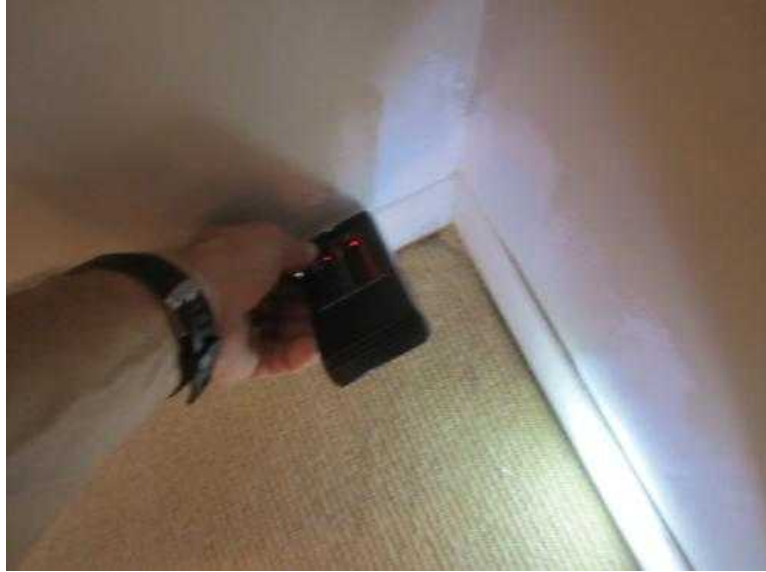
Front wall (under bay window and in SW corner) Invasive Testing(Moisture Probe)

15. Investigate Reading: 60-70%: Strongly consider the possibility that the exterior downspout is causing this high reading. Moisture readings below 20% are desirable, because mold, mildew and fungi start to grow (especially on wood or cellulose based products) at around the 20% mark. During wet spring conditions, moisture levels can rise. Monitor exterior drainage to ensure that water runs away from foundation. Readings above 50% indicate a significant finding, Needs further investigation, as conditions are conducive to rot/microbial growth. Older homes usually have basements that are more likely to have moisture penetration, so it is even more important to control exterior water management as noted in "Lots and Grounds" and "Roof" sections, Dealing with the exterior source is one step, but the conditions behind the drywall are conducive to microbial growth.

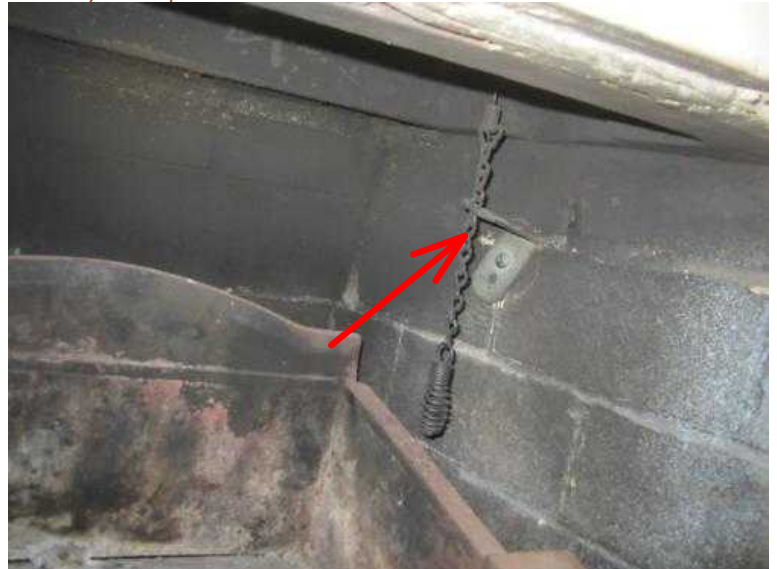
5. Investigate Flue: Not visible: Recommend cleaning and reinspection, Clay liner may only exist at top of chimney and the chimney liner may need upgrade or repair. Investigate before use. A qualified contractor is recommended to evaluate what action may be required.

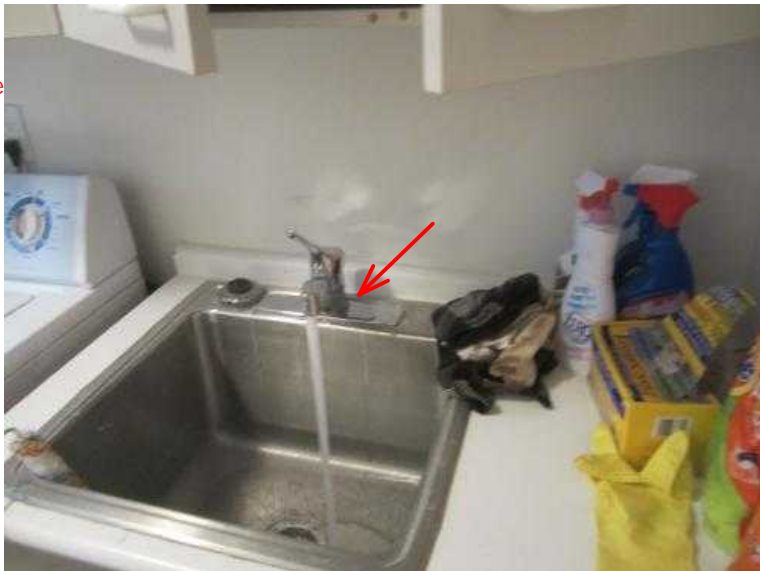
3. Defective Laundry Tub Faucet: With shutoffs: **Faucet is leaking at the stem and dripping water below the sink - minor repair.**
