Blueprint Building Inspections
60 Symons Street
Toronto, ON M8V 1T9

Inspection Report

64 Brentwood Road South
Toronto, ON

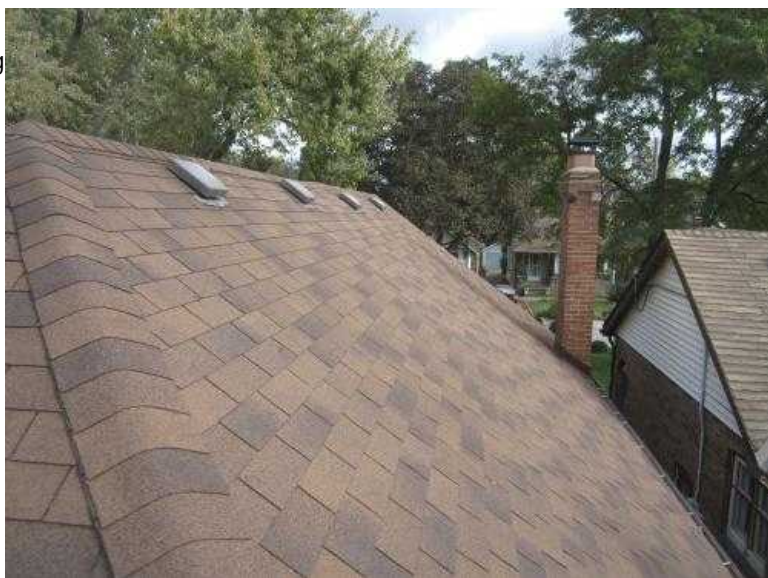
Main Roof Surface

1. Method of Inspection: On roof
2. Acceptable Material: Asphalt shingle:
Typical wear and tear - expanding seams, edges wearing, minor edge curl, commencement of brittleness. Expect replacement in next 5 years approximately

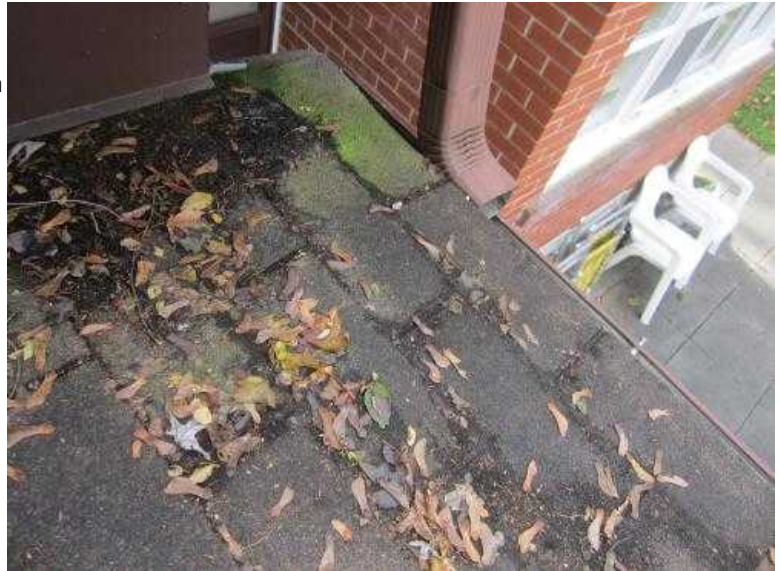
Garage Roof Surface

7. Acceptable, Investigate Material: Asphalt shingle: Mossy growth and accelerated wear on the rear slope of the garage - will likely need repairs within next 2-3 years

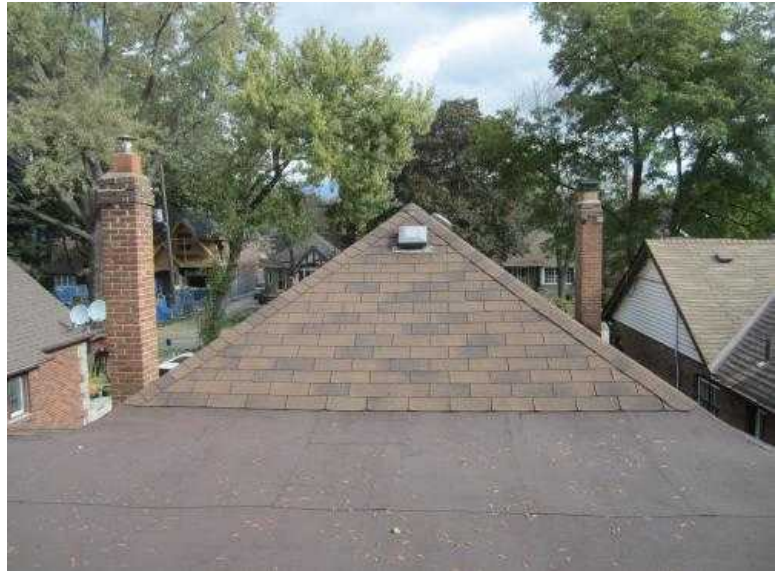
Back flat Roof Surface

12. Acceptable Material: Rolled roof material
(Modified Bitumen)

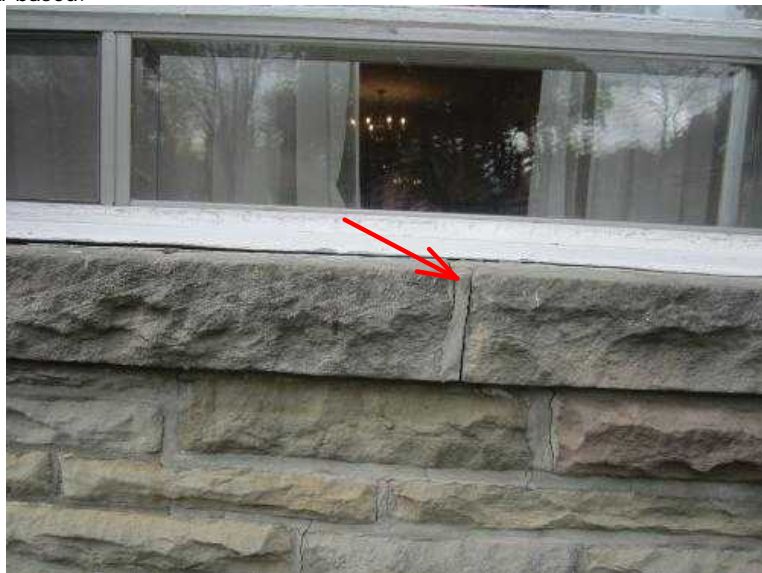
9. Acceptable, Improve Window Sills Jointed: Joints in sills frequently crack and allow moisture to penetrate - monitor regularly

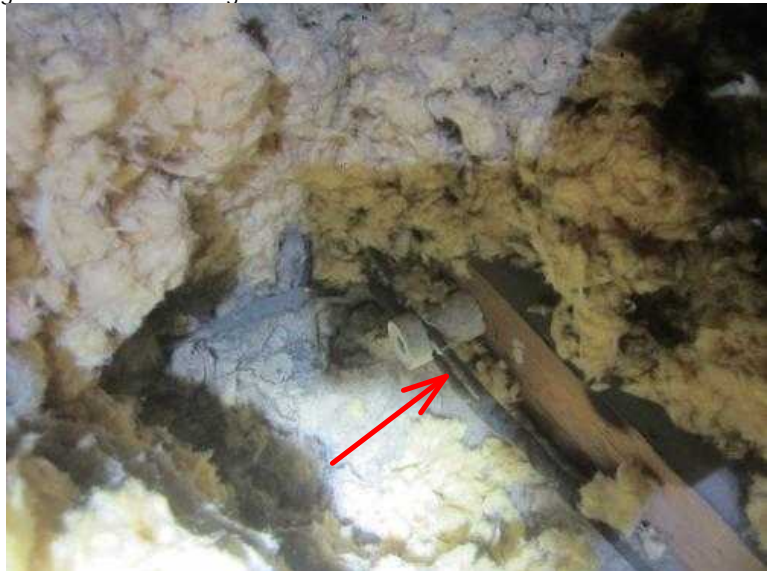
8. Defective Wiring/Lighting: Knob & tube:
Knob & tube is air cooled wiring and should not be covered with insulation (fire hazard). The wire in the attic and ceiling must be replaced. Evaluation by a licensed electrician is recommended

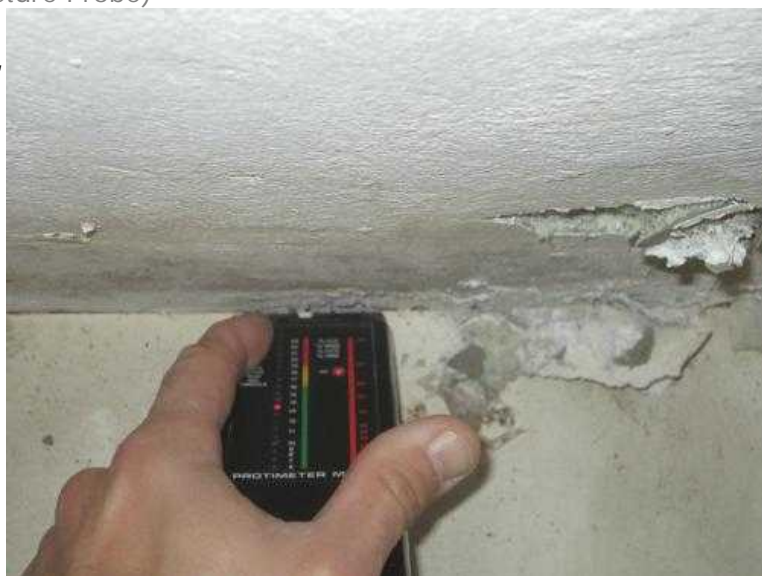
SW corner of addition Invasive Testing(Moisture Probe)

16. Investigate Reading: 40%: Moisture readings below 20% are desirable, because mold, mildew and fungi start to grow (especially on wood or cellulose based products) at around the 20% mark. During wet spring conditions, moisture levels can rise. Monitor exterior drainage to ensure that water runs away from foundation.

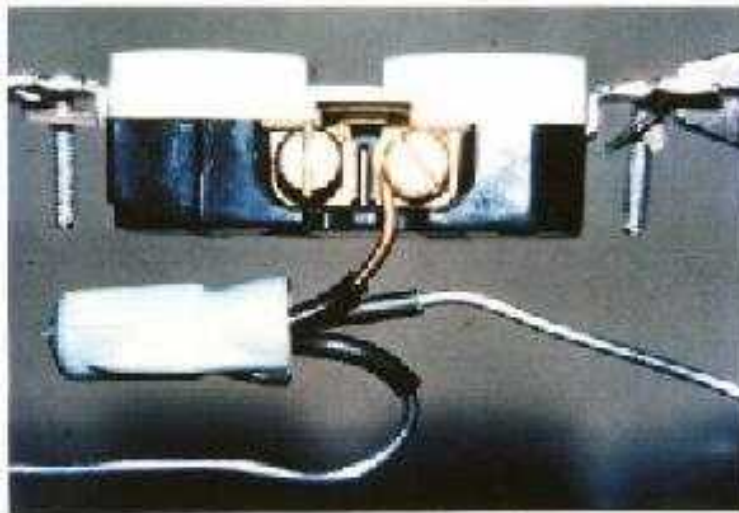
1. Restrictions: Throughout all buildings, wall and ceiling finishes restrict complete evaluation - hidden defects usually go undetected during inspections
2. Service Size Amps: 100
3. Acceptable Service: Overhead
4. Acceptable 120 VAC Branch Circuits: Copper
5. Acceptable 240 VAC Branch Circuits: Copper
6. Investigate Aluminum Wiring: Appears to be present: Aluminum wiring is higher maintenance because connectors need to be tightened every few years. Recommend wiring update for aluminum wiring by a licensed electrician. This means that the terminations need to be tightened at each terminal screw. Aluminum paste must also be used at any copper connections, along with connectors rated specifically for aluminum wiring. This "tune-up" should be performed every 4-5 years.

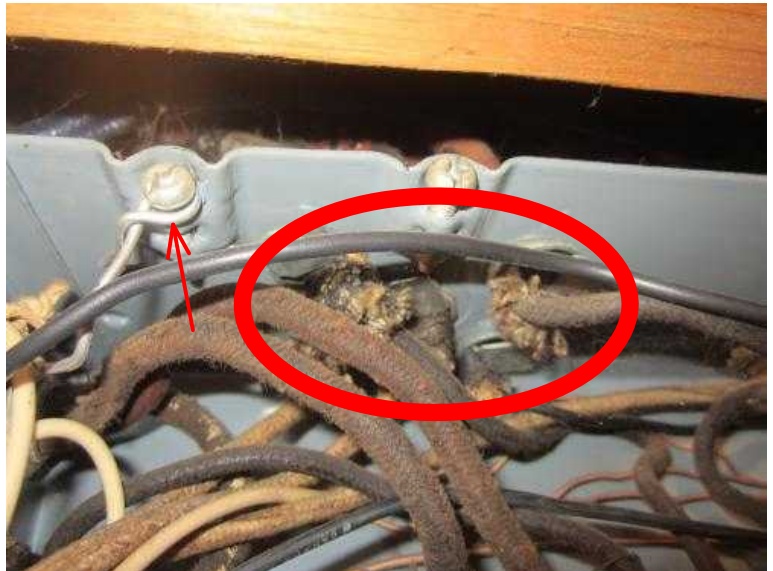
7. Investigate Knob & Tube Wiring: Present:

Knob & tube wiring is ungrounded older wiring that has become an insurance issue. Although the wire itself is not unsafe (as per various regulatory bodies), it can be unsafe if altered improperly. Generally, it is accepted that exposed knob & tube be replaced, and that ungrounded receptacles be made safe by grounding or GFCI installation. Most insurance companies charge a premium where knob & tube exists, or demand upgrades (partial or complete) within a set time frame. Contact your insurance carrier to determine any conditions they might impose. They may simply ask for an inspection from the ESA (Electrical Safety Authority). Generally, it is accepted that exposed knob & tube be replaced, and that extra circuits and

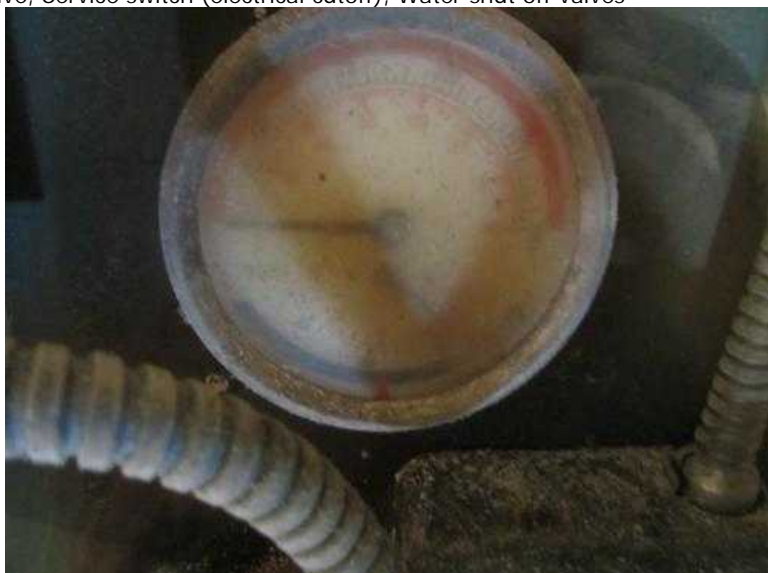
- 5. Area Served: Whole building Approximate Age: 10
- 6. Fuel Type: Oil
- 7. Acceptable Blower Fan: Below heat exchanger
- 8. Acceptable Distribution: Hot water, Two pipe
- 9. Acceptable Circulator: Pump
- 10. Acceptable Draft Control: Naturally induced, Barometric damper
- 11. Acceptable Flue Pipe: Metal
- 12. Acceptable Thermostats: Mechanical: Switching to a programmable thermostat will save up to 20% energy.
- 13. Acceptable Controls: Limit switch, Relief valve, Service switch (electrical cutoff), Water shut off valves
- 14. Improve Devices: Auto -fill valve, Backflow preventer, Expansion tank, Pressure gauge, Temp gauge: Gauge has a cloudy face and cannot be read - a new gauge is suggested

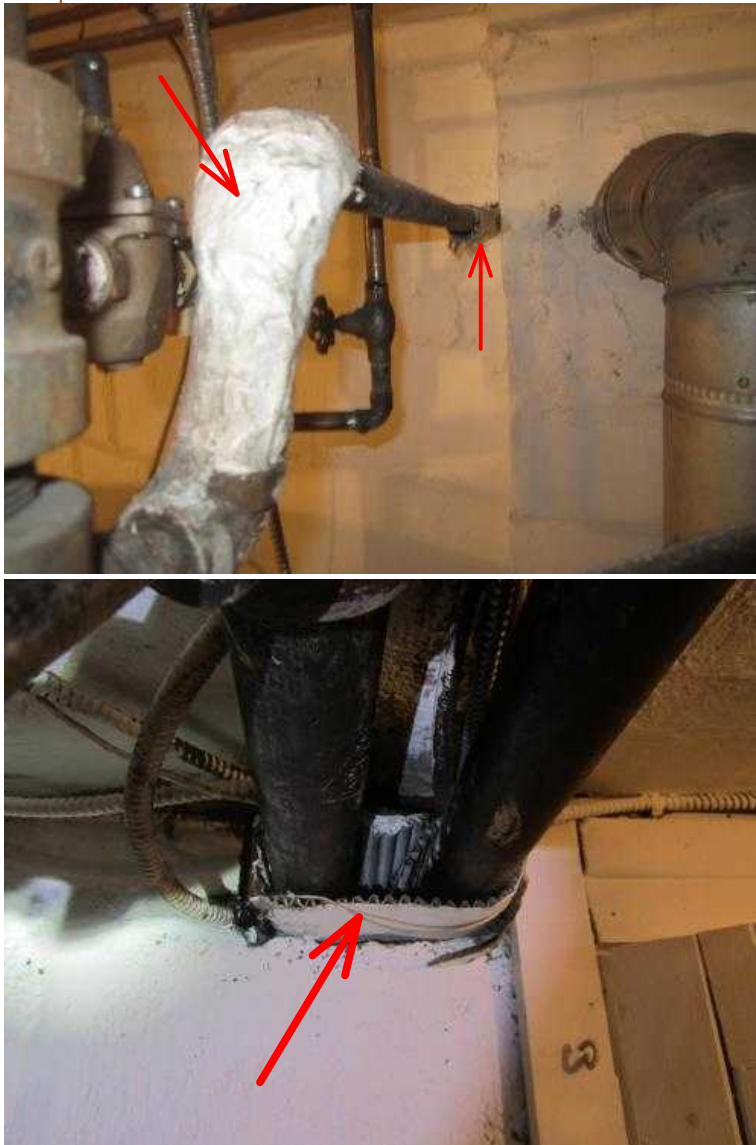
17. Suspected Asbestos: Yes: A small amount of asbestos paper insulation exists at the boiler pipes over the oil tank and over the boiler. It is friable, which means particles can escape into the air. Suggest removal or encapsulation. Note that there may be more asbestos above the ceiling finishes in the basement, but since it is encapsulated, no action is required.

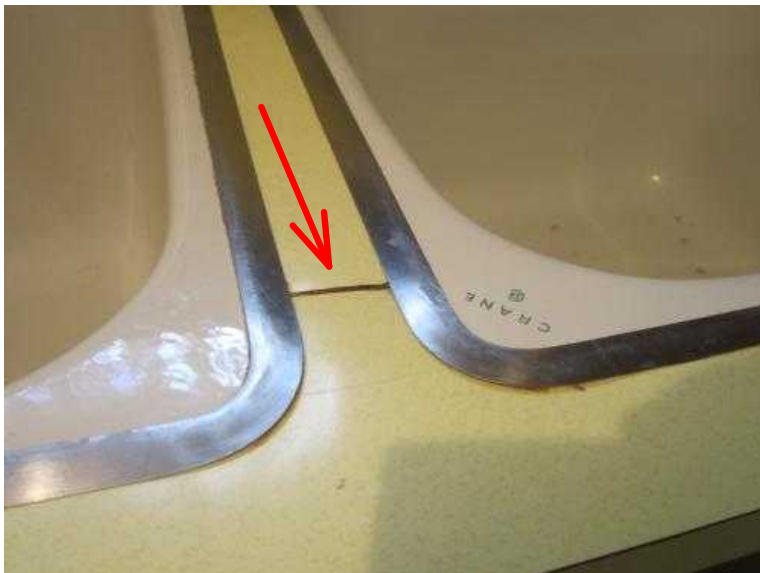
4. Acceptable, Improve Counter Tops: Laminate:
Lifting seam in laminate surface between the sinks, which is the result of moisture penetration. This can cause unsanitary conditions.

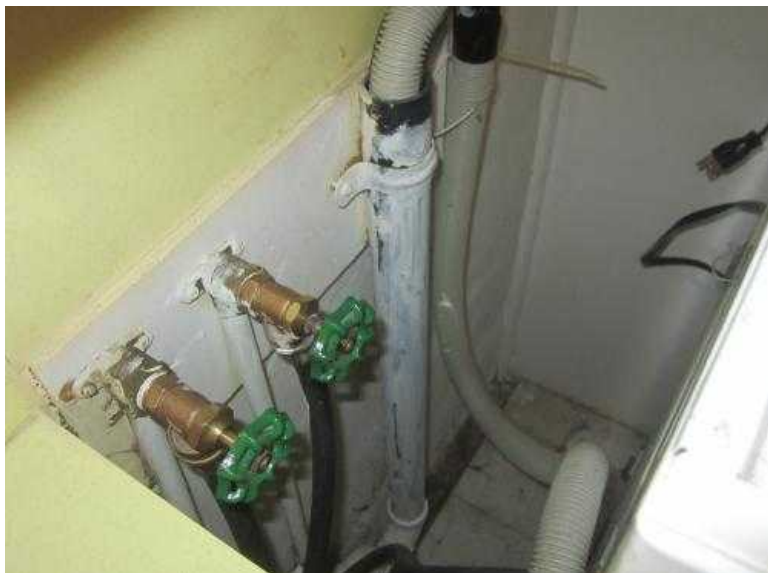
9. Investigate Washer Drain: Drains to ABS drain pipe: No trap visible for the washer drain pipe. May allow sewer gas into house if not trapped. A licensed plumber is recommended to evaluate and estimate repairs if a smell of methane is detected in future.

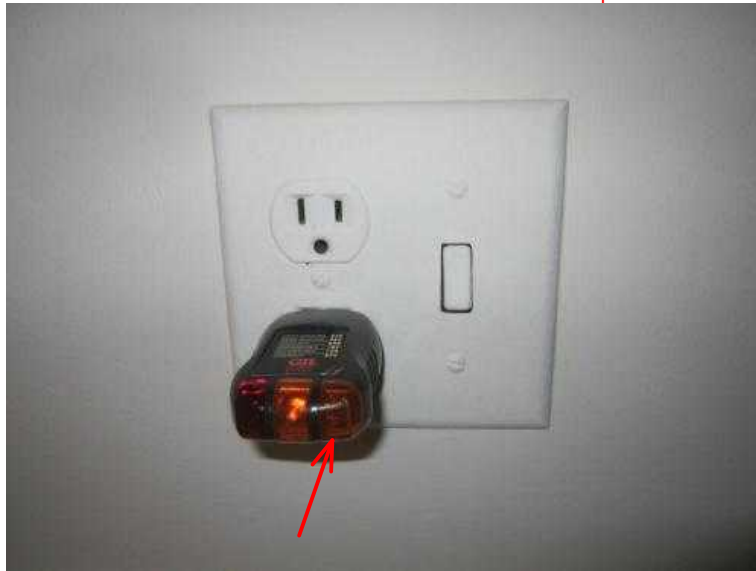
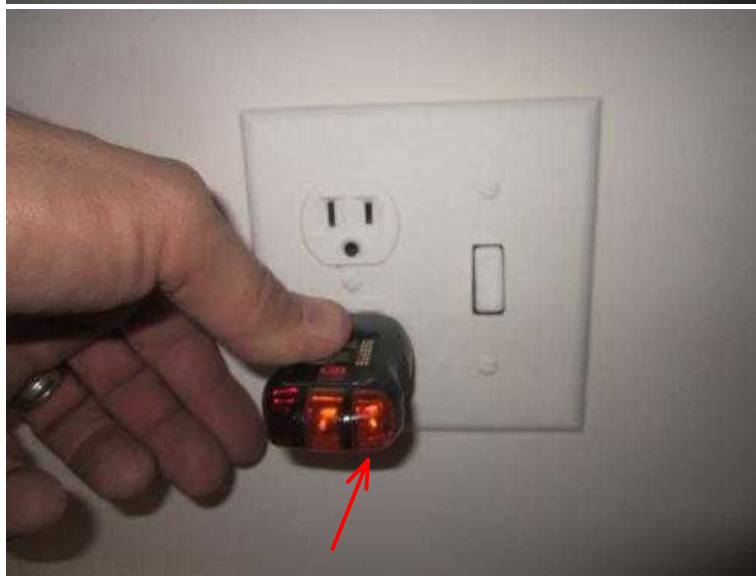
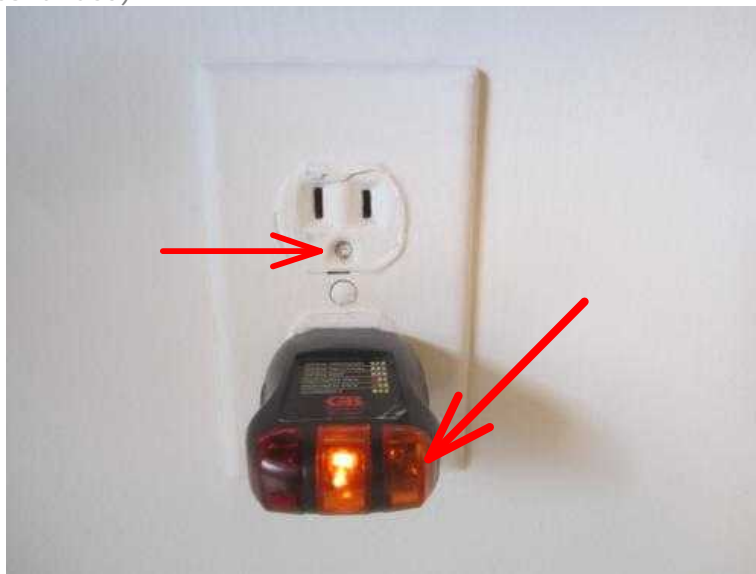
4. Defective Electrical: 110 VAC outlets and lighting circuits, 15 amp 3 prong receptacles: Receptacle has a loose wire inside it and should be replaced - bottom outlet has a loose ground. Another receptacle is ungrounded and may be served by ungrounded knob & tube wire (the top outlet has a filled in ground pin hole, which is actually good because a grounded cord cannot be plugged into it). A licensed electrician is recommended to evaluate and estimate repairs

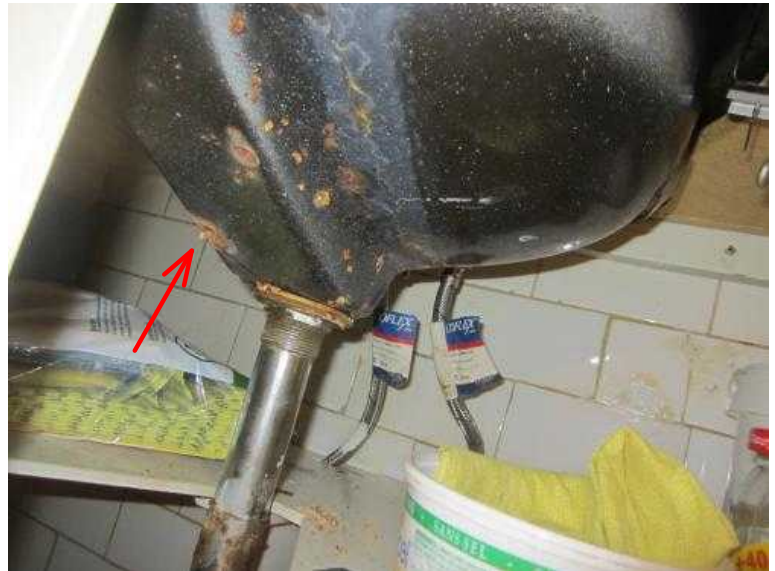
1st floor Bathroom

2. Acceptable Ceiling: Drywall or plasterboard
3. Acceptable Walls: Drywall or plasterboard, Tile: Paint on ceramics on walls by toilet
4. Marginal Floor: Linoleum/resilient: Tiles peeling and damaged
5. Acceptable Doors: Hollow
6. Defective Electrical: 110 VAC outlets and lighting circuits: Open or missing ground, Non-GFCI circuit
-recommend GFCI circuit be installed
7. Acceptable Counter/Cabinet: Laminate
8. Marginal Sink/Basin: Porcelain/enamel coated: Minor corrosion underneath the sink at the overflow - suggest replace

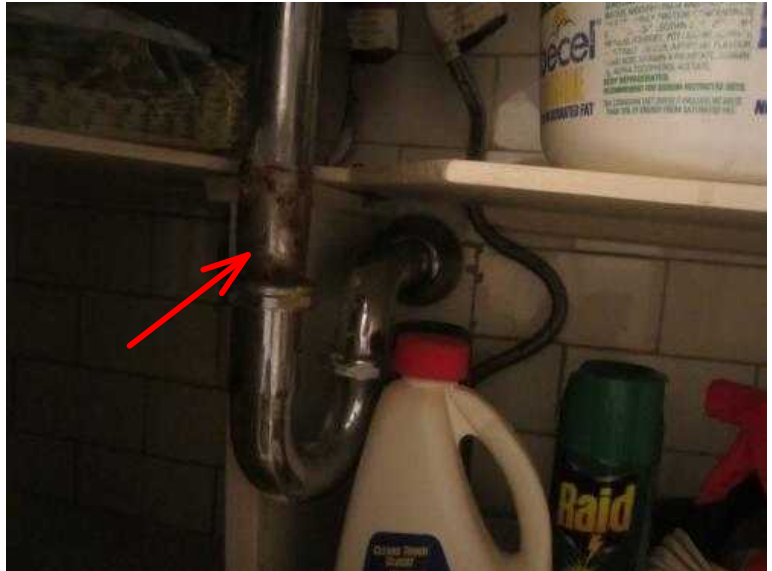
10. Marginal

Traps: Trap can be opened (locknuts): **Pitting/corrosion at drain line/trap - recommend replace**

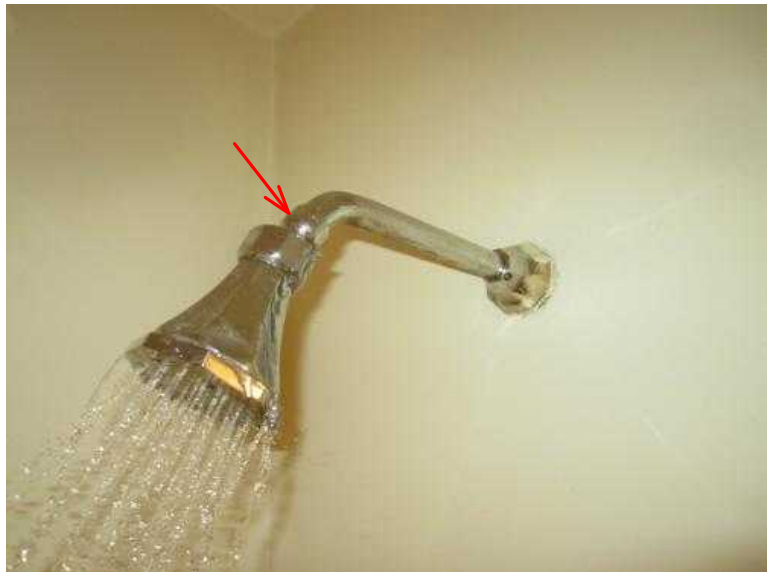
11. Marginal

Tub/Surround:
Porcelain/enamel tub, Tile surround: **Tub had been painted and the paint is peeling. Worn finish is visible beneath paint. Showerhead spurts water at top - minor.**
