Blueprint Building Inspections  
60 Symons Street  
Toronto, ON M8V 1T9

# Inspection Report

33 Jellicoe Avenue  
Toronto, ON

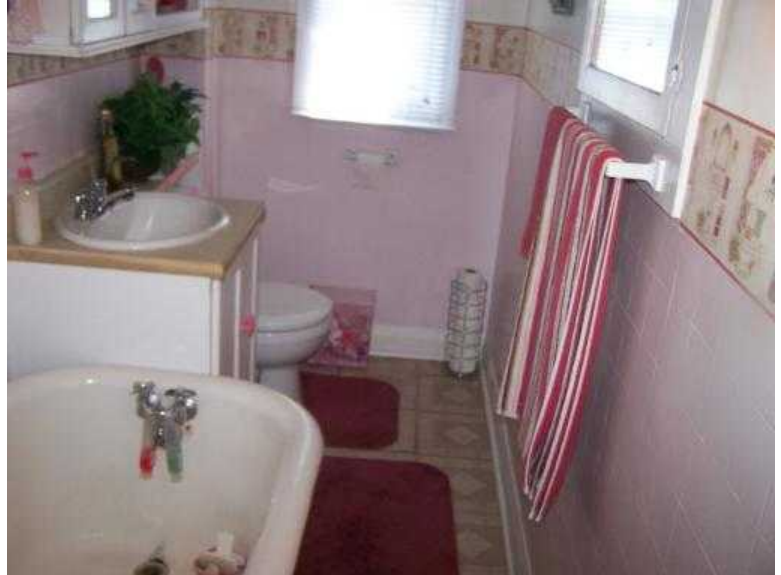
3. Acceptable Walls: Drywall/plaster
4. Acceptable Floor: Linoleum/resilient
5. Acceptable Doors: Panel
6. Marginal Electrical: 110 VAC lighting circuits: No receptacle in washroom

7. Acceptable Counter/Cabinet: Laminate
8. Acceptable Sink/Basin: Molded single bowl
9. Acceptable Faucets: With shutoffs
10. Investigate Traps: Trap can be opened (locknuts): "S" Type drain traps are often unvented. Watch for sewer gas smell. Suspect unvented - gurgling sound exists after water drains from sink but no methane smell was detected. A licensed plumber recommended to estimate repairs but can likely wait to be undertaken should bathroom be renovated.
