Blueprint Building Inspections  
60 Symons Street  
Toronto, ON M8V 1T9

# Inspection Report

87 Edgecroft Road  
Etobicoke, ON

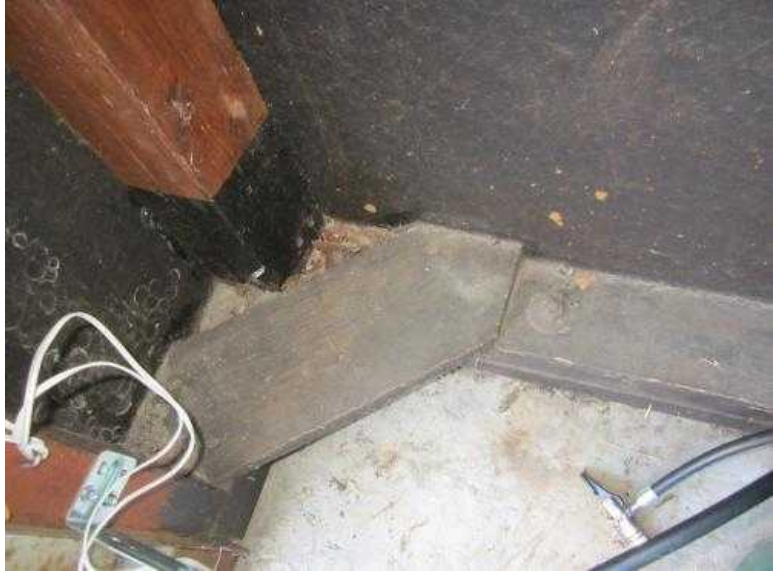
8. Acceptable Walls: Wood frame: The few areas of exposed framing were sound - no obvious signs of rot or decay.

9. Acceptable Floor/Foundation: Concrete: Unable to confirm depth of footings. May just be slab on grade. Keep water away from structure to lessen risk of water creating any adverse effects on the garage. Lower lying areas need addition of soil and downspouts should be extended. Some green stains were visible at concrete where it touches the ground, indicating moisture accumulates in this area.

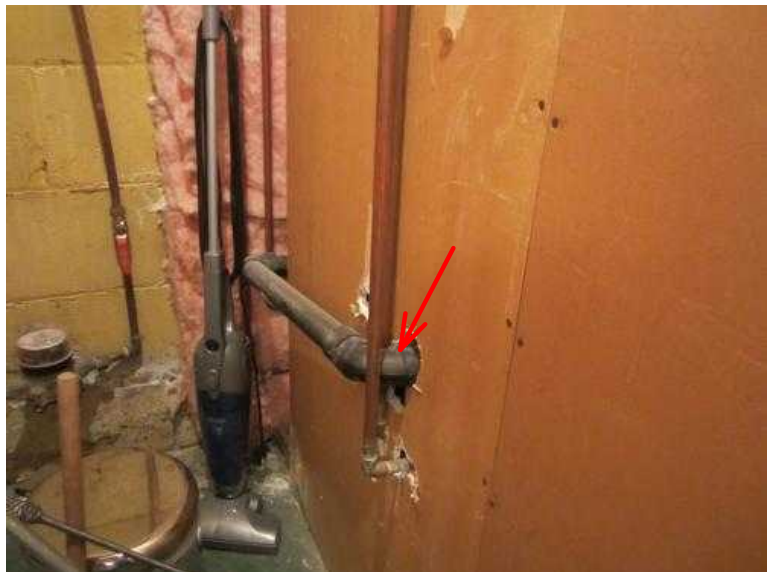
5. Acceptable Doors: Hollow  
6. Acceptable Electrical: 110 VAC outlets and lighting circuits, GFCI protected receptacle  
7. Acceptable Sink/Basin: Pedestal  
8. Acceptable Faucets: With shutoffs  
9. Investigate Traps: Trap can be opened (locknuts): Unable to confirm vented correctly, but no vent visible behind the wall in the electrical closet - see plumbing venting section.

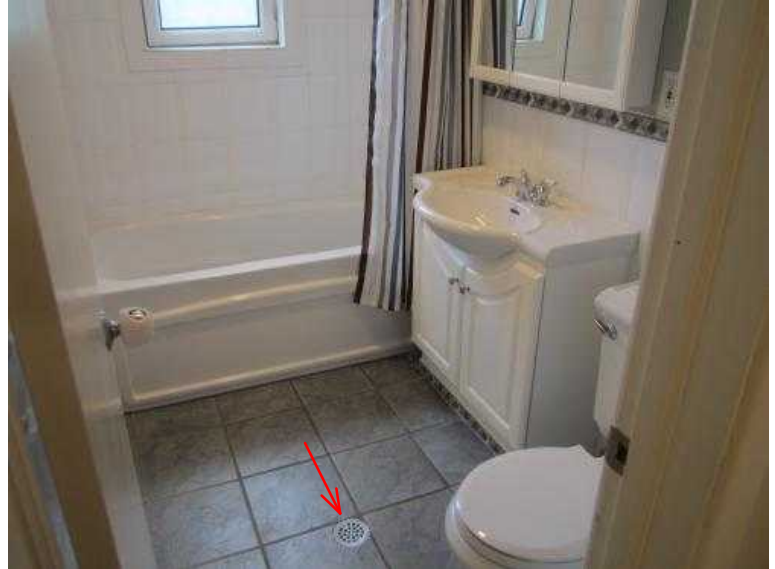
17. Acceptable

Floor Drain: Surface drain:  
Pour a bucket of water into the  
drain monthly, with a teaspoon of  
bleach, to keep water in the trap  
and smells out of the house.
