Inspection Report

71 Braeburn Drive
Markham, ON

Inspection Date 05/06/2013

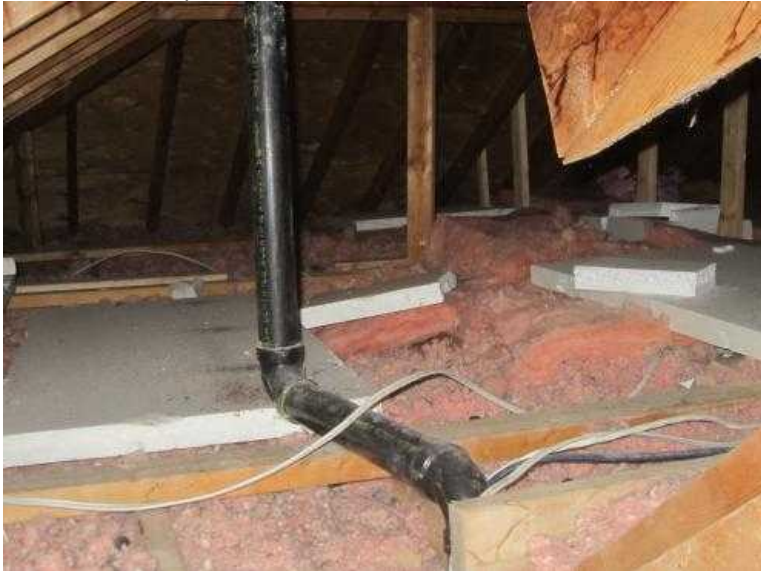
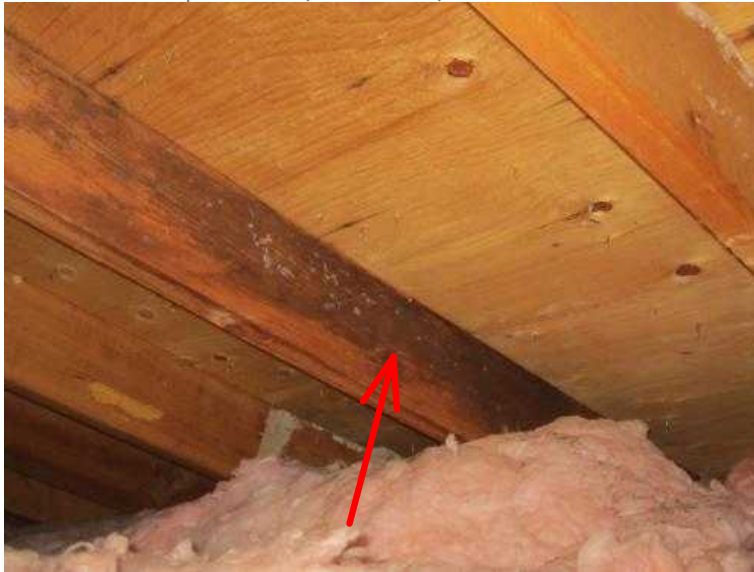
- 3. Acceptable Unable to Inspect: 40%
- 4. Acceptable Roof Framing: Rafter
- 5. Acceptable Sheathing: Plywood
- 6. Acceptable, Investigate Ventilation: Roof vents: Ventilation was a problem, as evidenced by stains on wood in attic, but appears to have been corrected (turbine vents have been added). Watch for ice or frost on the nails in the attic in the winter. Cannot determine if soffit vents are blocked or unblocked by insulation. They should not be restricted, allowing intake air to enter the attic. Best configuration is a ridge vent with unobstructed soffit intake vents and no other vents.
