Blueprint Building Inspections  
60 Symons Street  
Toronto, ON M8V 1T9

# Inspection Report

18 Kilbarry Road  
Toronto, ON

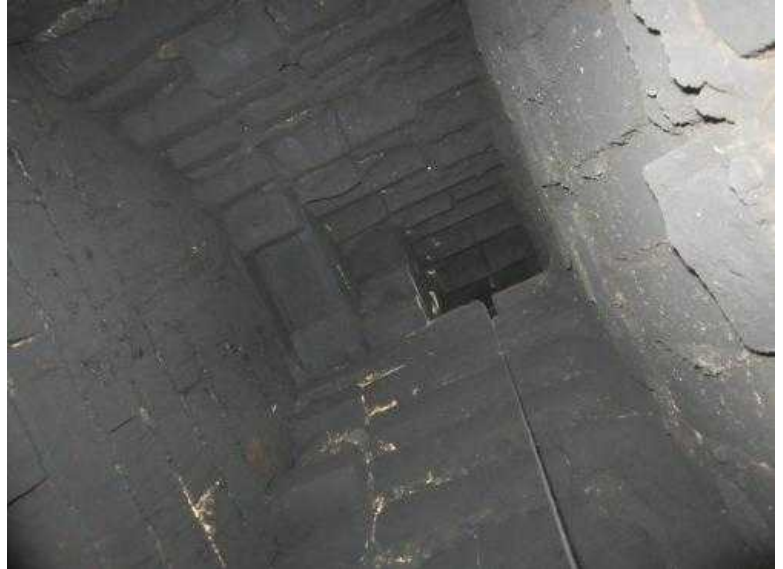
4. Acceptable Smoke Chamber: Brick

5. Investigate Flue: Not visible: Recommend cleaning and reinspection, Clay liner may only exist at top of chimney and the chimney liner may need upgrade or repair. Investigate before use. A qualified contractor is recommended to evaluate what action may be required.
