Blueprint Building Inspections
60 Symons Street
Toronto, ON M8V 1T9

Inspection Report

64 Brentwood Road South
Toronto, ON

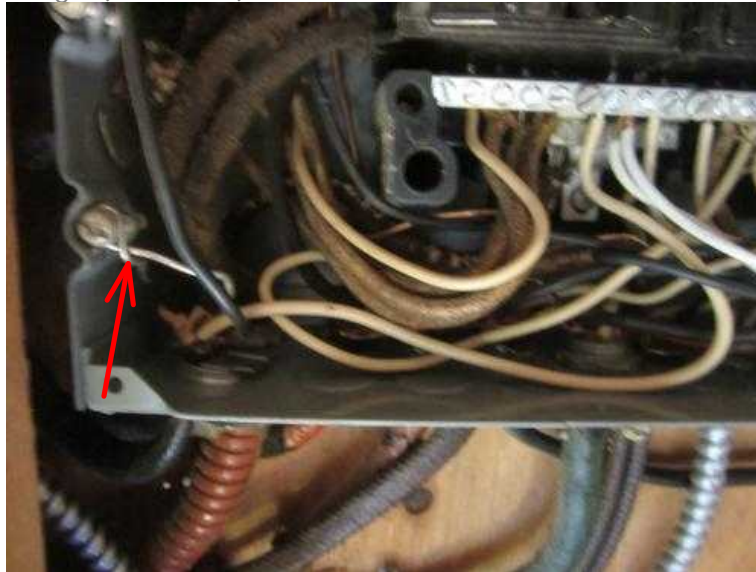
7. Investigate Knob & Tube Wiring: Present:

Knob & tube wiring is ungrounded older wiring that has become an insurance issue. Although the wire itself is not unsafe (as per various regulatory bodies), it can be unsafe if altered improperly. Generally, it is accepted that exposed knob & tube be replaced, and that ungrounded receptacles be made safe by grounding or GFCI installation. Most insurance companies charge a premium where knob & tube exists, or demand upgrades (partial or complete) within a set time frame. Contact your insurance carrier to determine any conditions they might impose. They may simply ask for an inspection from the ESA (Electrical Safety Authority). Generally, it is accepted that exposed knob & tube be replaced, and that extra circuits and
